# Preventative Conservation & Maintenance Theory; its application to the Hereford City Conservation Area. Part 2 - Appendices

**August 2014**

**JS Conservation Management  
& Town Planning Ltd**  
t: 07741091719  
e: [john@jsconservationplanning.com](mailto:john@jsconservationplanning.com)  
w: [www.jsconservationplanning.com](http://www.jsconservationplanning.com)

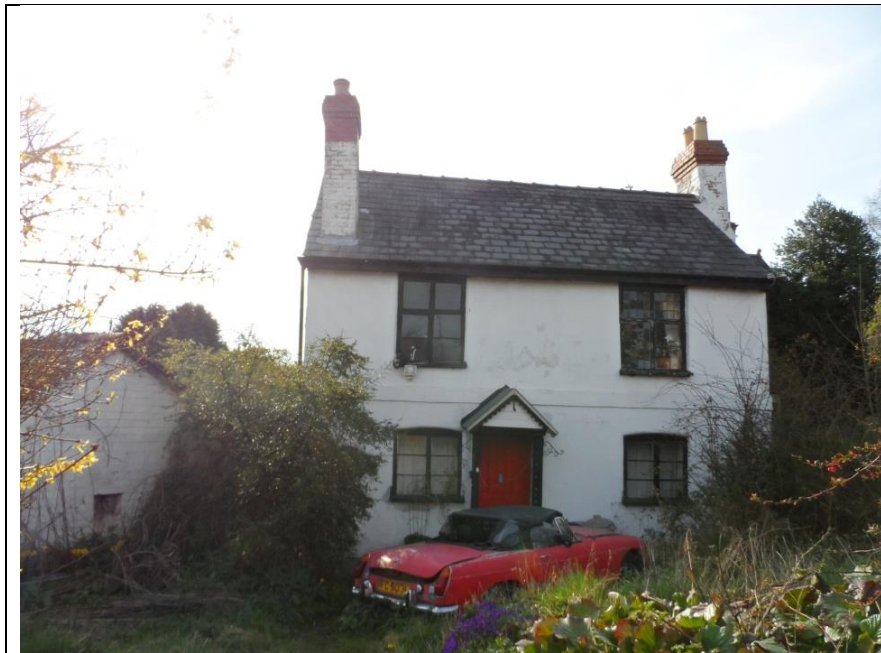
**Ref No:** BR1

**HAR Assessment:** Building appears to be derelict and unoccupied, with overgrown garden and building having deteriorating render, and signs of lack of general maintenance.

**Recommendations:** Secure occupancy of building and bring building to good repair.

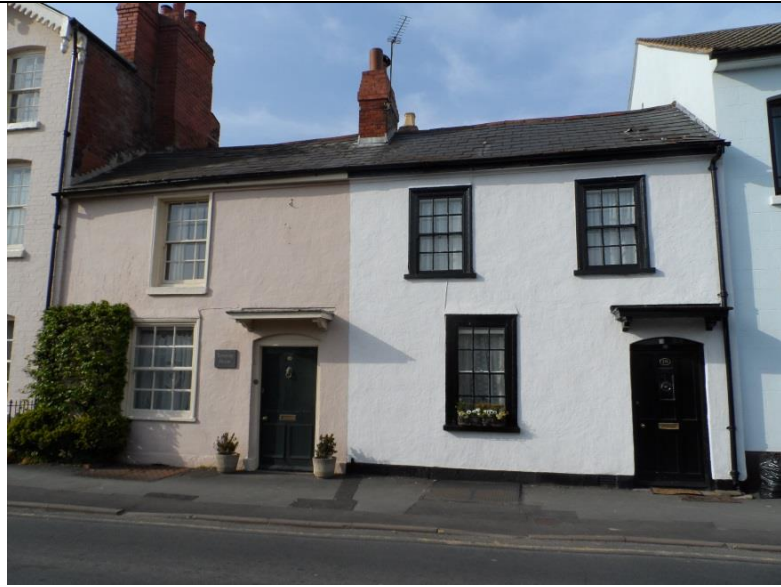
**Ref No:** BR4

**HAR Assessment:** Guttering has become detached from façade and missing slates.

**Recommendations:** Guttering needs replacement/re-attachment, and missing slates replaced. Continue to monitor and maintain building

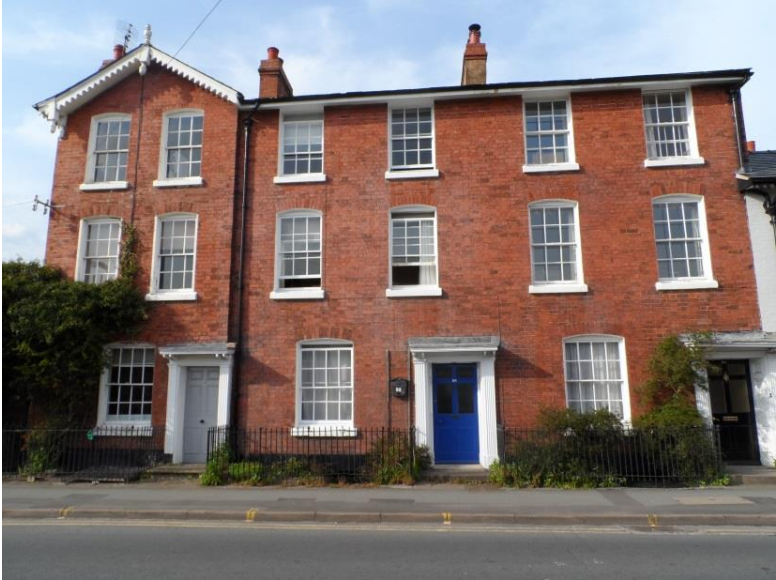
| | <b>Ref No:</b> BR7 | <b>Description:</b> Mid 19 <sup>th</sup> Century houses constructed of brick with Welsh slate roof. Three storeys and cellar.<br><br><b>HAR Assessment:</b> Exterior window frames deteriorating.<br><br><b>Recommendations:</b> repair and repaint window frames, continue to monitor and maintain building.<br><br><h2>NOT AT RISK</h2> |

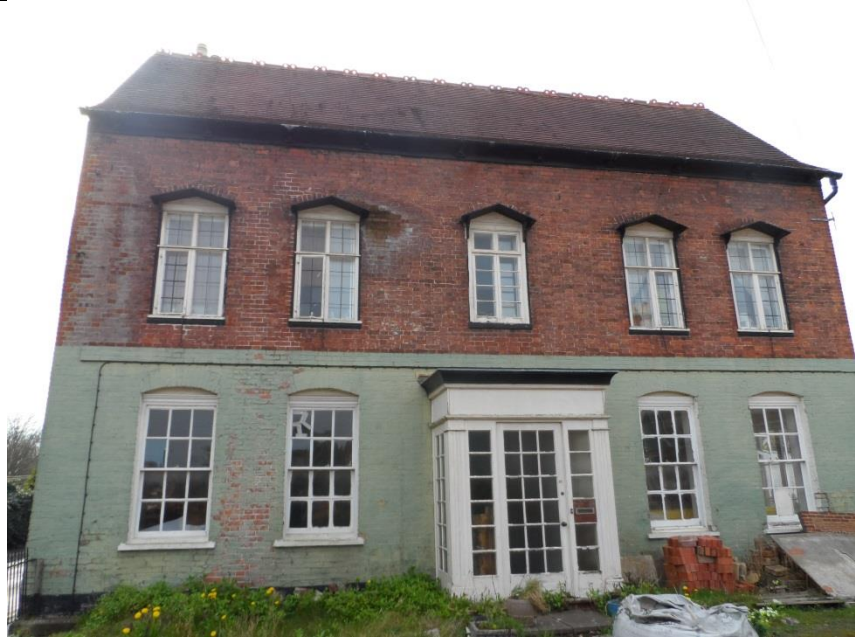
| <b>Ref No:</b> BR9 |

**HAR Assessment:** Extensive renovations and remodelling taking place, part of rear wing removed, but will be reinstated. Smaller maintenance issues such as blocked gutters, deteriorating window sills and brickwork, however due to be repaired with listed building consent in hand to bring building into better state.

**Recommendations:** Complete works and continue to monitor and maintain building.

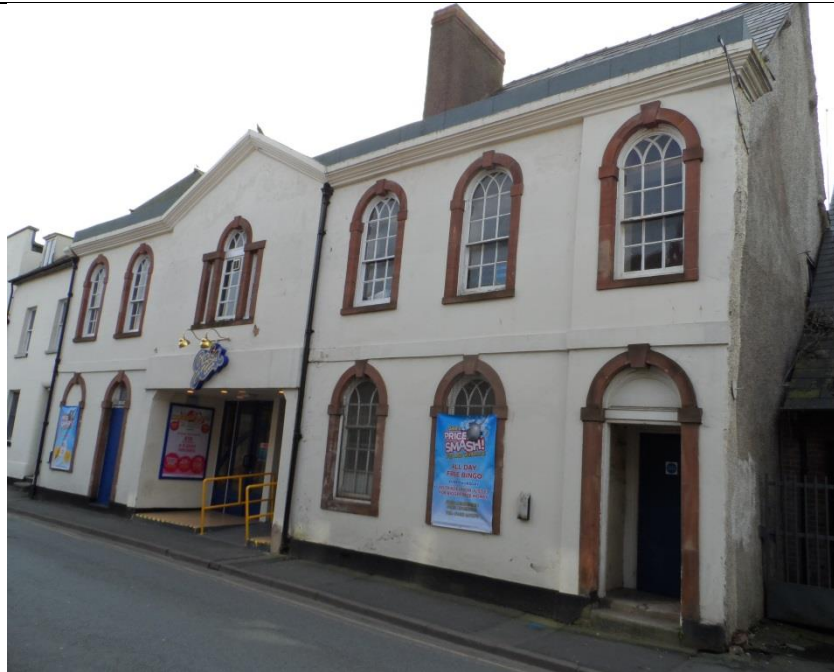
| <b>Ref No:</b> BS1 |

**HAR Assessment:** Window sills and frames deteriorating and render on façade is blistering and cracking, possibly as a result of water rising between block work and render.

**Recommendations:** Window sills and frames require repair and repainting; undertake survey to investigate causes to cracked render. Continue to monitor and maintain building.

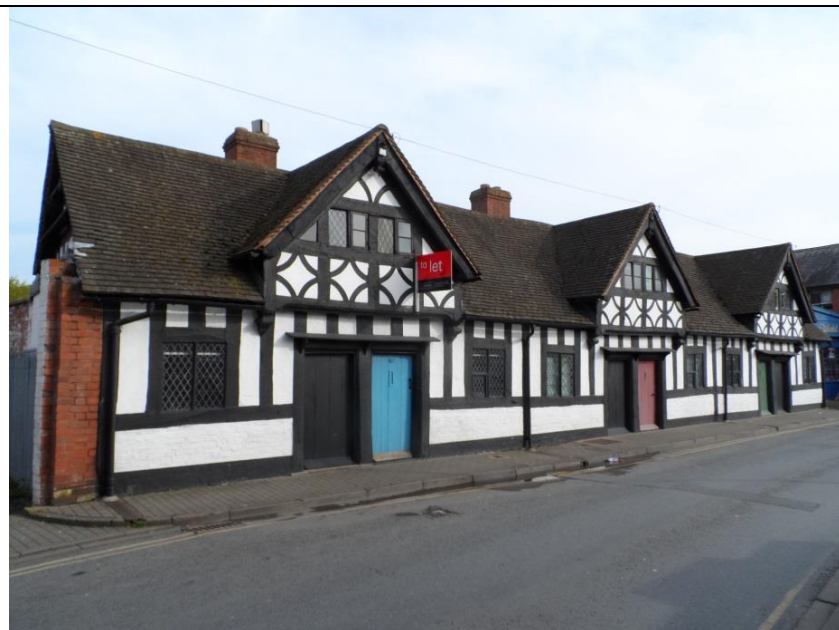
| <b>Ref No:</b> BS2 | <p><b>Description:</b> Circa 1630 Almshouses, formerly six dwellings, now three. Timber frame with brick plinth; plaster infills; plain tile roof with 3 gables to front; Single storey and attic;</p> <p><b>HAR Assessment:</b> Currently two of the dwellings are unoccupied which places buildings as low risk, however tenants are being sought.</p> <p><b>Recommendations:</b> Seek tenants as soon as possible, and continue to monitor and maintain buildings.</p> <p><b>LOW RISK</b></p> |

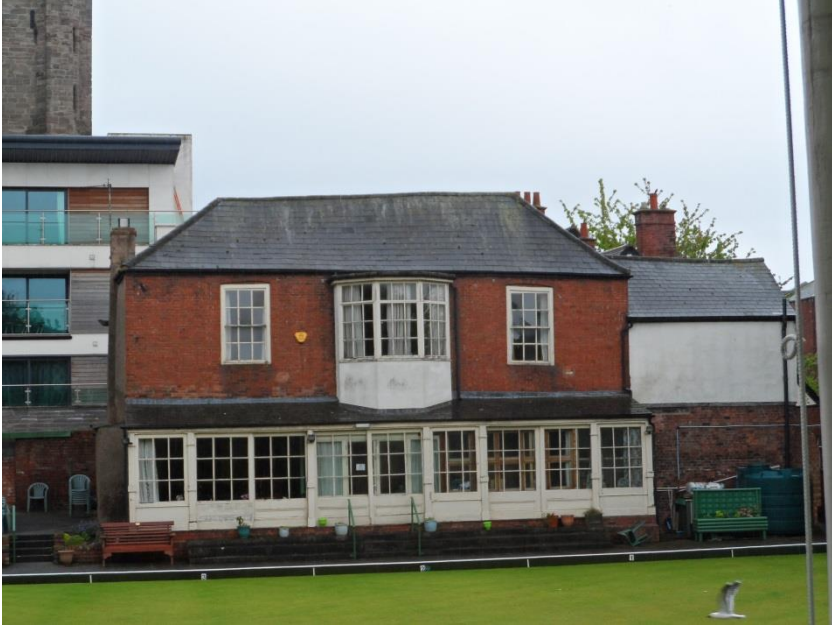
| | <b>Ref No:</b> BWS2 | <b>Description:</b> Late 18 <sup>th</sup> Century – Early 19 <sup>th</sup> Century House, now pub and clubhouse. Late 19 <sup>th</sup> Century verandah to ground floor with composite tile roof. Steps to bowling green. The adjoining bowling green is reputed to be the second oldest in England, dating from 1484; the first reference is in 1697.<br><br><b>HAR Assessment:</b> Window sills and frames deteriorating with water build up staining brickwork below sill.<br><br><b>Recommendations:</b> Repair and repaint window frames and sills, continue to monitor and maintain building. |

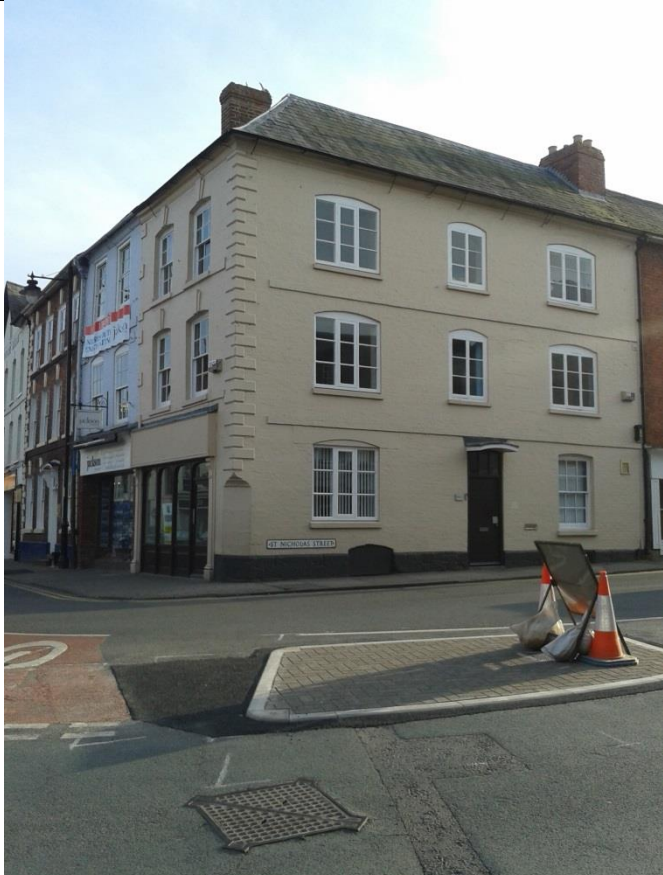
| | <b>Ref No:</b> BG1 | <p><b>Description:</b> 18<sup>th</sup> Century house, now offices. Three storeys, painted brick with a 20<sup>th</sup> Century slate roof and shop front.</p> <p><b>HAR Assessment:</b> Good condition, upper levels appear occupied, however shop is empty, which can have negative impacts to maintenance of the building. Currently seeking a tenant which would make the building 'not at risk' however due to the empty shop, the building is at 'Low Risk'</p> <p><b>Recommendations:</b> Secure occupancy of shop, continue to monitor and maintain building.</p> <p><b>LOW RISK</b></p> |

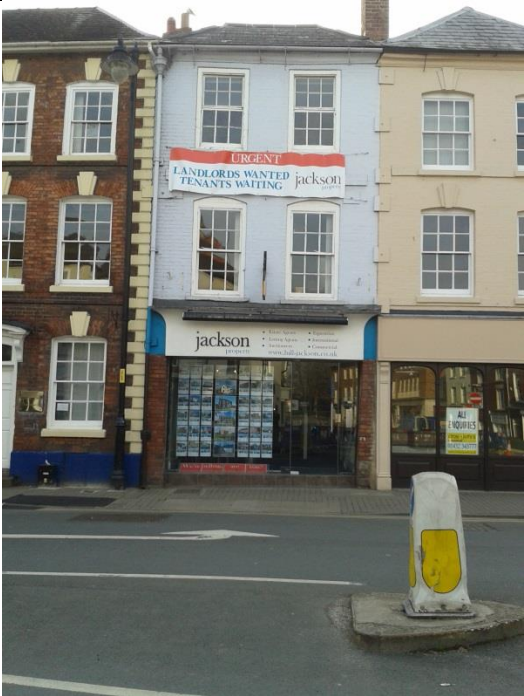
| | <b>Ref No:</b> BG2 | <b>Description:</b> Late 19 <sup>th</sup> Century house, now offices. Three Storeys, painted brick with a hipped slate roof and 20th Century shop front.<br><br><b>HAR Assessment:</b> Window frames deteriorating.<br><br><b>Recommendations:</b> Repair and re-paint window frames, continue to monitor and maintain building.<br><br><h1>NOT AT RISK</h1> |

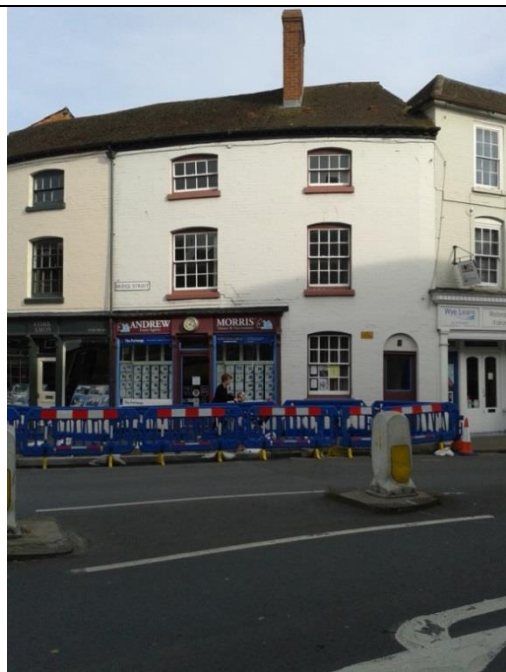
| <b>Ref No:</b> BG15 | <b>Description:</b> Early 19 <sup>th</sup> Century house, now shop. Three storeys and cellar, painted brick with plain tile roof.<br><br><b>HAR Assessment:</b> Weeds growing in gutters.<br><br><b>Recommendations:</b> Clear gutters. Continue to monitor and maintain building.<br><br><b>NOT AT RISK</b> |

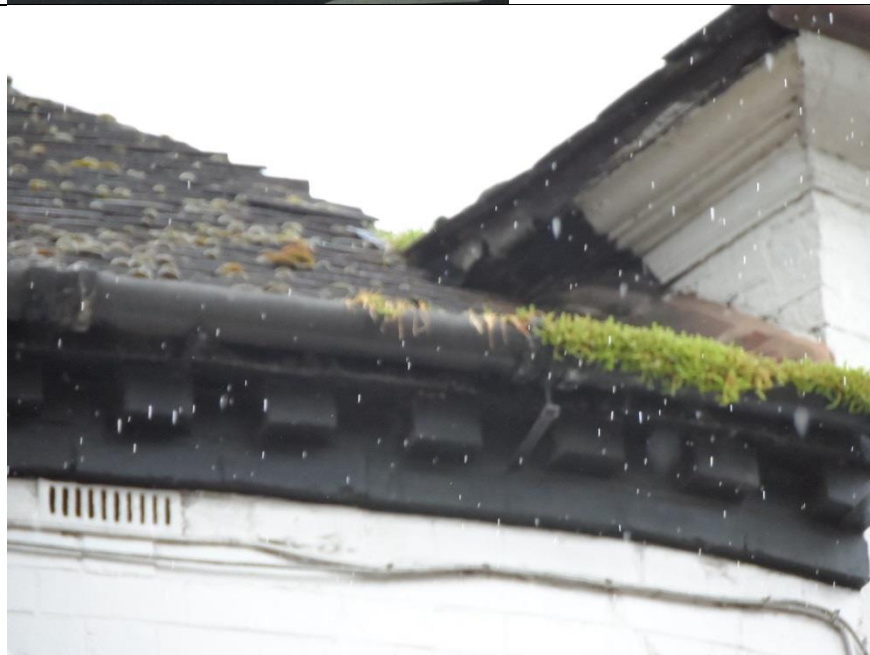
| | <b>Ref No:</b> BG16 | <b>Description:</b> 18 <sup>th</sup> Century houses, now shops. Three storeys, painted brick, with hipped plain tile roof. Two 20 <sup>th</sup> Century shop fronts<br><br><b>HAR Assessment:</b> Window frames are deteriorating.<br><br><b>Recommendations:</b> Repair and repaint window frames, continue to monitor and maintain building.<br><br><h2>NOT AT RISK</h2> |

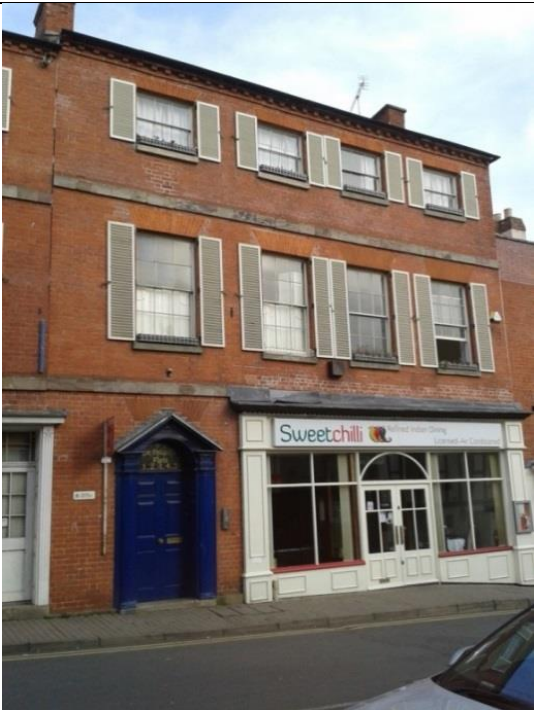
| | <b>Ref No:</b> BG21 | <p><b>Description:</b> Late 18<sup>th</sup> Century house, now shops. Previously painted brick, with paint now removed. Three storeys, 20<sup>th</sup> Century shopfront with evidence of brick repair.</p> <p><b>HAR Assessment:</b> repairs and stripping of paint from brick have caused damage to the fire-skin of the bricks, along with poor oversized re-pointing in places, particularly above shopfront.</p> <p><b>Recommendations:</b> Although not causing problems, future opportunities should be taken to properly repair brickwork and undertake pointing with a conservation approach. Continue to monitor and maintain building</p> <p><b>NOT AT RISK</b></p> |

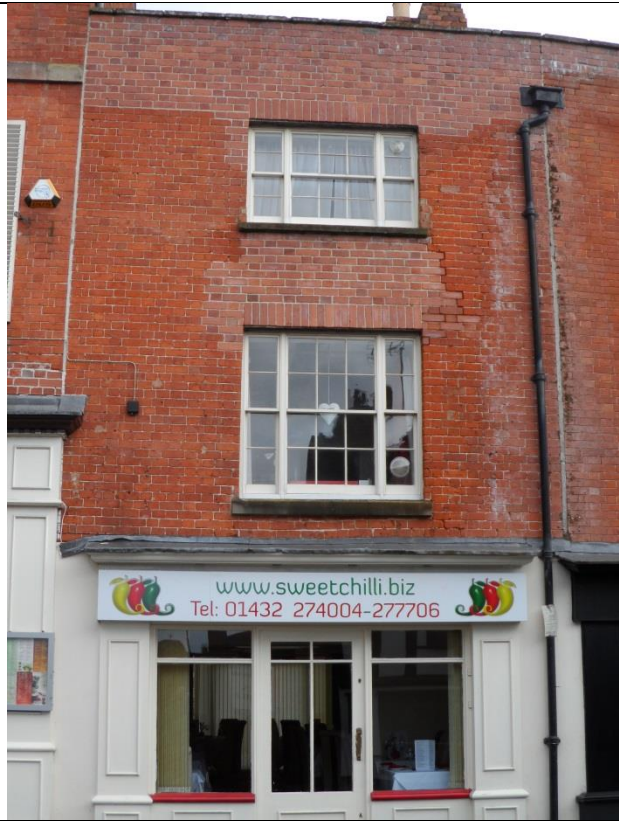
| | <b>Ref No:</b> BG22 | <p><b>Description:</b> Early 19<sup>th</sup> Century House and shop to possible 17<sup>th</sup> Century core, now shop only. Three storeys, constructed of brick. Previously painted, but some original brick has been subject to angle-grinding which has removed the fire-skin, and new remodelling of front has also taken place. 20<sup>th</sup> Century shop front. Included for group value.</p> <p><b>HAR Assessment:</b> Loss of fire-skin from brick can lead to further deterioration of brick. Continue to monitor brick work, consider re-painting with a breathable paint. Continue to monitor and maintain building.</p> <p><b>NOT AT RISK</b></p> |

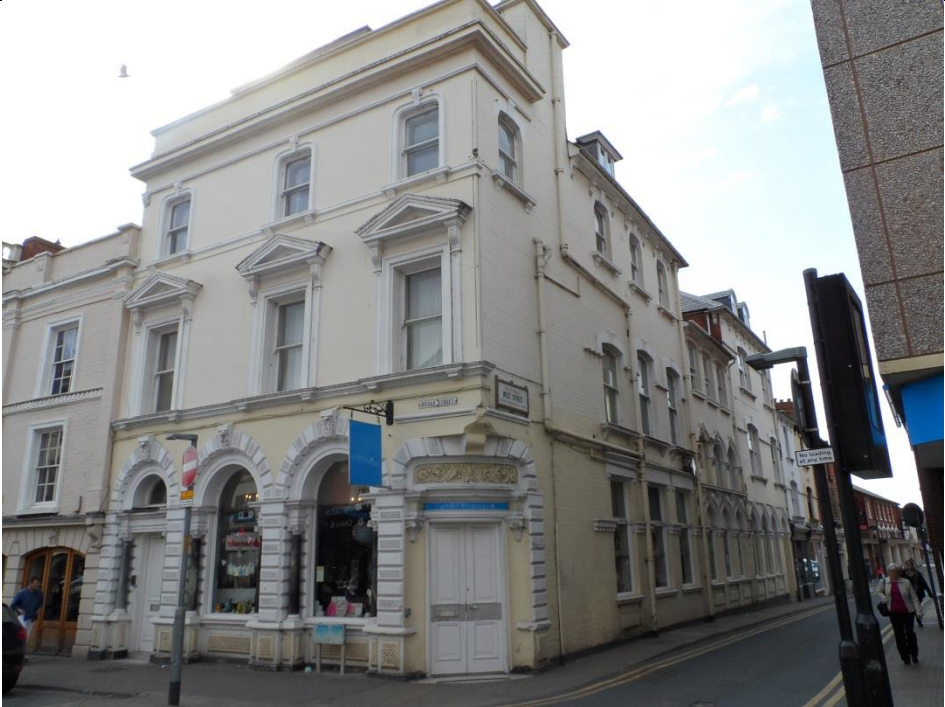
| | <b>Ref No:</b> BD2 | <p><b>Description:</b> Late 19<sup>th</sup> Century shop and offices. Finished in stucco with hipped Welsh slate mansard roof. Three storeys and attic; front to West street has roof dormers.</p> <p><b>HAR Assessment:</b> Water running off pediments above windows is staining stucco, can lead to further deterioration of the façade.</p> <p><b>Recommendations:</b> Clean façade to ensure smooth flow of water, repair and repaint with breathable paint. continue to monitor and maintain building.</p> <p><b>NOT AT RISK</b></p> |

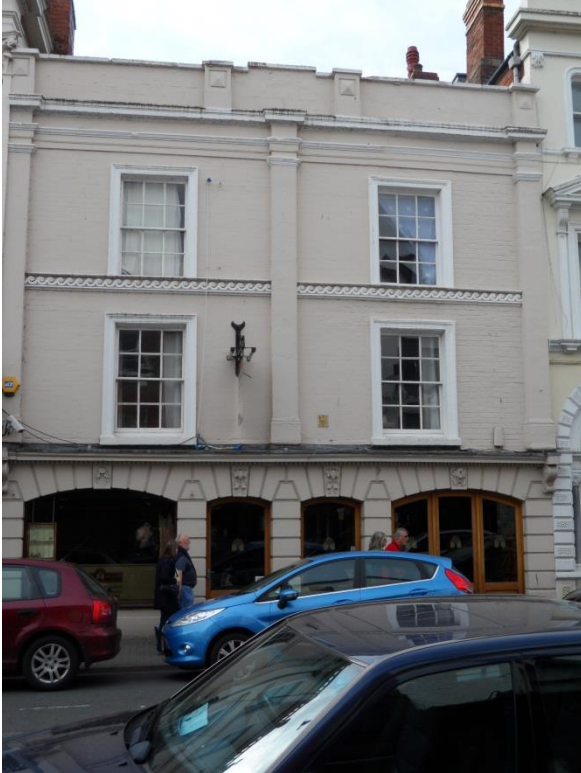
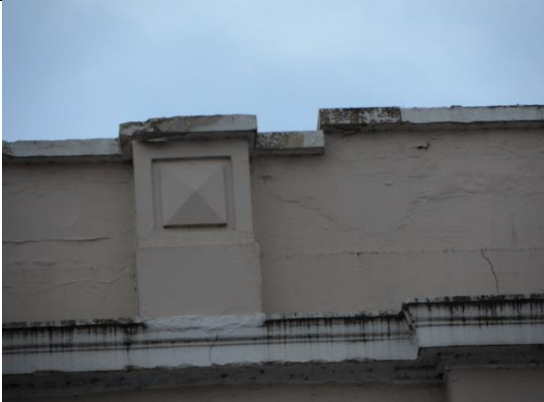
| | <b>Ref No:</b> BD3 | <b>Description:</b> 17 <sup>th</sup> Century Shops and dwellings with early 19 <sup>th</sup> Century front. Three Storeys, Stucco; painted brick and a slate roof. Ground floor has engraved stucco; central entrances: 20 <sup>th</sup> Century glazed doors.<br><br><b>HAR Assessment:</b> water staining on cornices and parapet, blistered paintwork which may be a result of water penetrating between block work and render caused by possible failed coping or failing lead work/ guttering behind the parapet.<br><br><b>Recommendations:</b> Undertake a roof level inspection and when redecorated, the opportunity is taken to clean any impermeable paint from the building and repaint with a breathable finish. Continue to monitor and maintain building.<br><br><b>LOW RISK</b> |
| | <b>Condition:</b> Fair | |

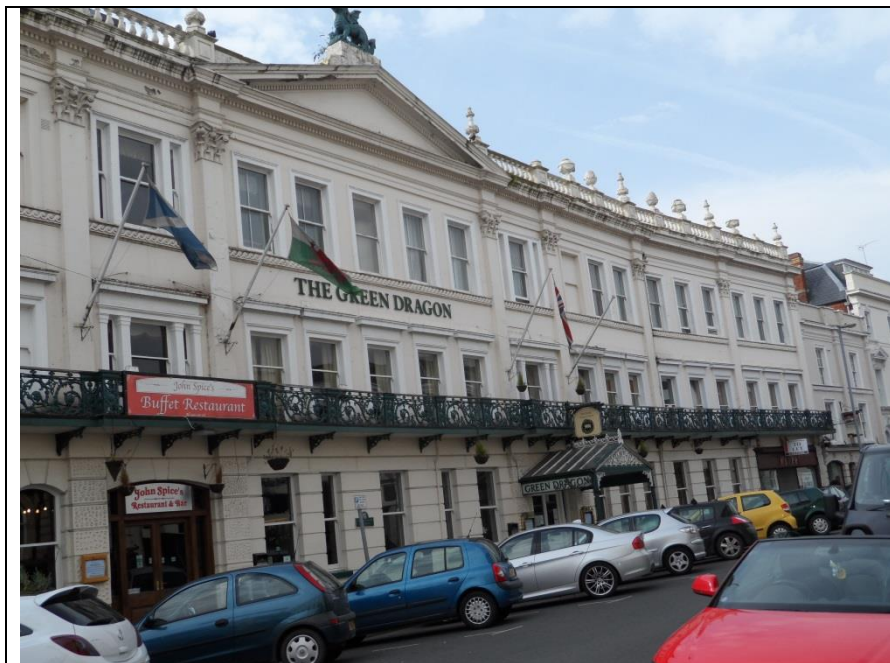
**Ref No:** BD4

**Address:** The Green Dragon Hotel, 47 Broad Street, Hereford

**Condition:** Fair

**HAR Assessment:** Showing lack of general maintenance with weed growth on façade and behind dragon motif, water staining to façade and broken parts of pediment.

**Recommendations:** Possible water build up behind parapet allowing weed growth, undertake roof survey, façade requires repair and redecoration with breathable paint/stucco

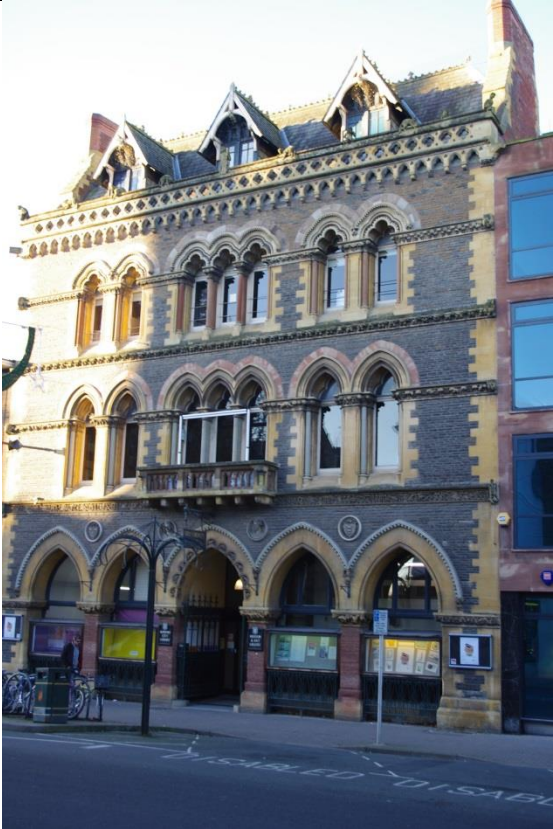
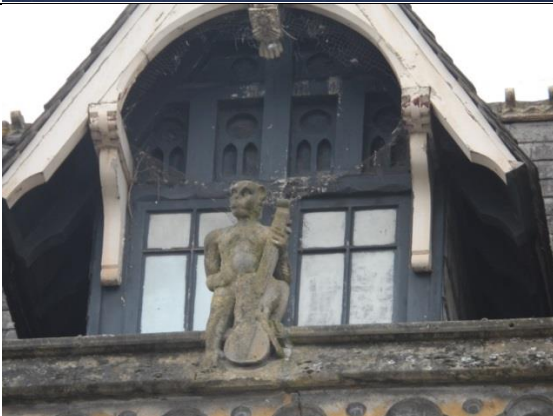
| | <b>Ref No:</b> BD5 | <p><b>Description:</b> 1874 Library, Art Gallery and Museum by FR Kempson. Three storeys with attic and cellar, coursed dressed stone with ashlar dressings; hipped Welsh slate roof; brick end stacks. Three large gable dormers with deep eaves on carved brackets; ornamental ridge tiles. Arcade of 5 pointed arches with wrought-iron gate to central entrance; enriched capitals and architrave; figures and arms over.</p> <p><b>HAR Assessment:</b> Good condition, not at risk. Previous repairs in cellar to deal with subsidence, netting on façade with large hole cause by jackdaw nesting on façade.</p> <p><b>Recommendations:</b> Repair netting to prevent further birds nesting, continue to monitor and maintain.</p> <p><b>NOT AT RISK</b></p> |

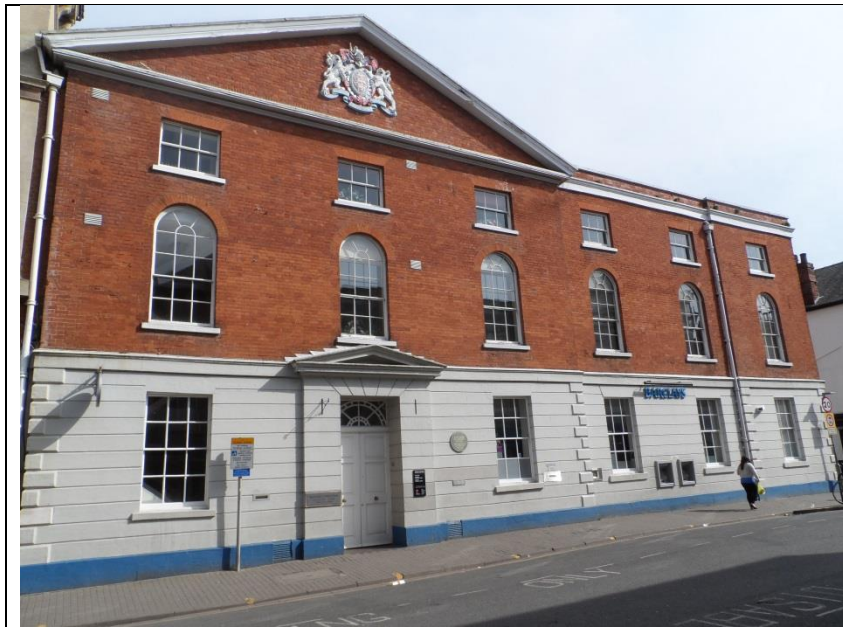
**Ref No:** BD6

**Address:** Premises Occupied by Barclays Bank and County Court, 70 Broad Street, Hereford

**HAR Assessment:** Window frames deteriorating, weed growth in cornice.

**Recommendations:** Repair and repaint window frames and remove weed growth from cornice, continue to monitor and maintain building.

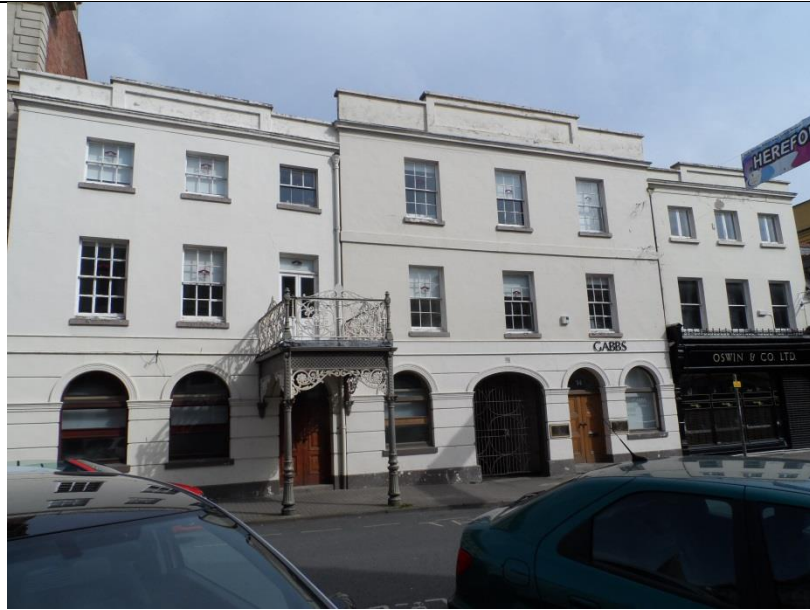
| <b>Ref No:</b> BD9 |

| <b>Address:</b> 13 & 14 Broad Street, Hereford |
| <b>Condition:</b> Fair |

| <p><b>Description:</b> Early 19<sup>th</sup> Century offices and dwellings, now bank, offices and shop. Three storeys, finished in painted stucco with hipped Welsh slate roof. Right-hand element has late 19<sup>th</sup> Century shop front. Left hand element has awning-hood with cast-iron guard.</p> <p><b>HAR Assessment:</b> Parapet showing deterioration and blistering and flaking paint on façade, possibly cause by failing parapet guttering, leadwork or failing coping. As such water is entering between block work and render.</p> <p><b>Recommendations:</b> Undertake survey of roof and parapet guttering to determine problem, repaint with breathable paint. Continue to monitor and maintain building.</p> |

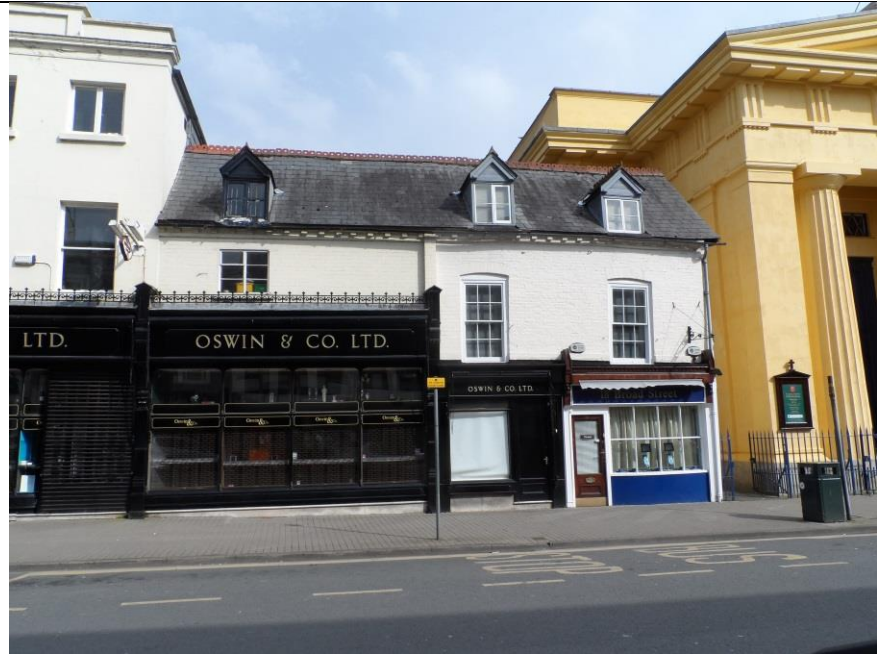
| <b>Ref No:</b> BD10 |

| <b>Address:</b> 15-18 Broad Street, Hereford |
| <b>Condition:</b> Fair |

| <b>HAR Assessment:</b> Roof slates and dormer deteriorating, rusted guttering and deteriorating flashing. |

| <b>Recommendations:</b> Repair roof slates and repair and repaint dormer and replace guttering. |

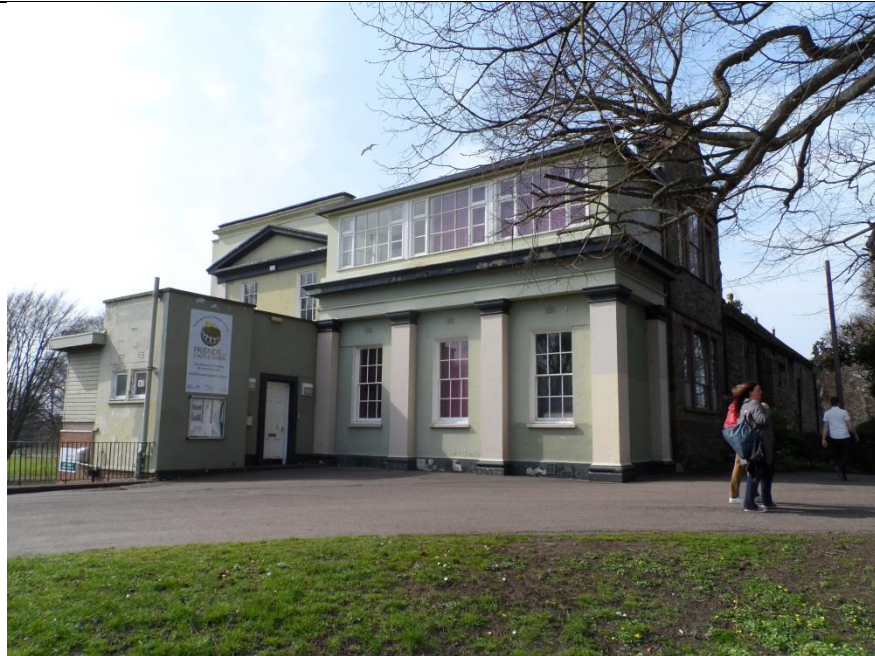
| <b>Ref No:</b> CG3 |

| <b>Address:</b> Castle Cliffe, Hereford<br>Association of Youth Clubs Technical<br>College Annexe,14-16 Castle Green,<br>Hereford |

| <p><b>Description:</b> 19<sup>th</sup> Century Houses with medieval origins, now in part College Annexe and offices.</p> <p><b>HAR Assessment:</b> Undergoing restoration for community use. Some blistering and flaking of paint, however should be repaired during restoration.</p> <p><b>Recommendations:</b> Undertake survey of roof and guttering whilst renovating, Continue to monitor and maintain building.</p> |

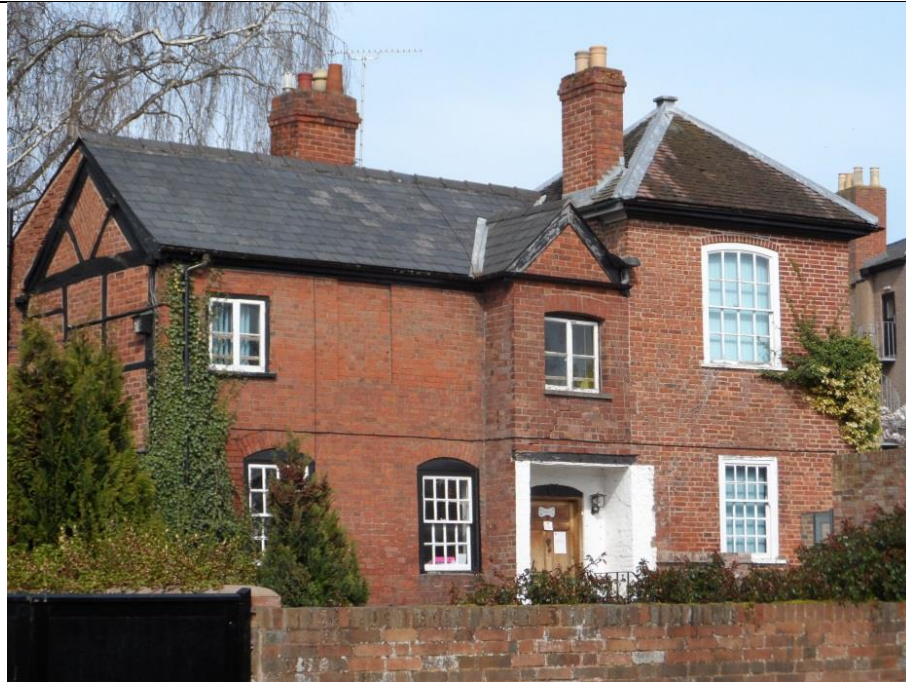
| <b>Ref No:</b> CH3 | <b>Description:</b> 17 <sup>th</sup> and 18 <sup>th</sup> Century Summerhouse and cottage with 19 <sup>th</sup> Century additions to the rear. Two storeys constructed of brick, with left gable end containing 18 <sup>th</sup> Century timber framing. The cottage was added to a 17 <sup>th</sup> Century summerhouse, formerly in the garden of No.30 Castle Street (CS5), and resembling that of No.29 Castle Street (CS6).<br><br><b>HAR Assessment:</b> Good condition, not at risk<br><br><b>Recommendations:</b> Continue to monitor and maintain building<br><br><b>NOT AT RISK</b> |

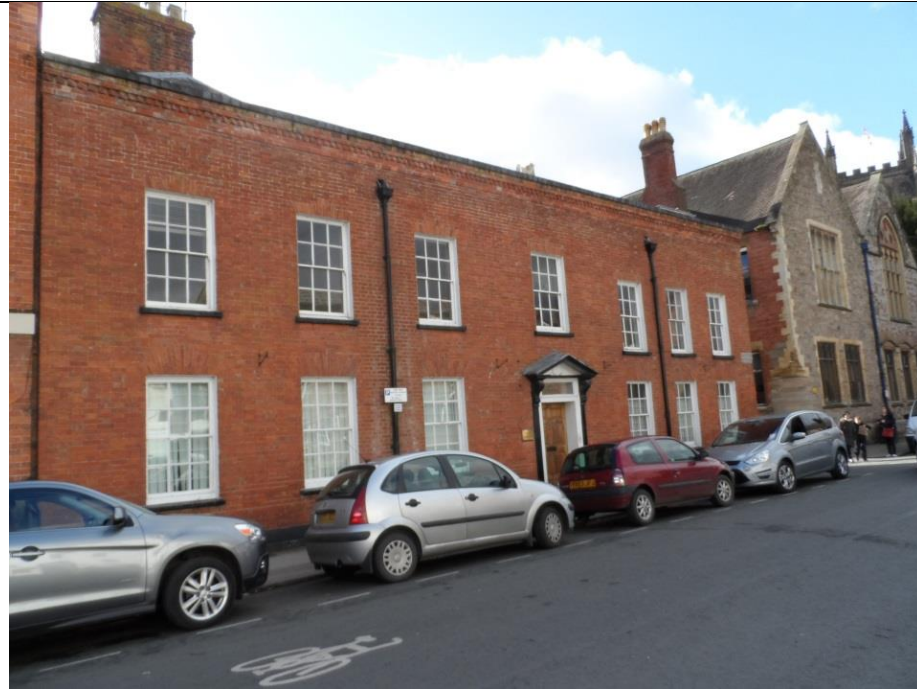
**Ref No:** CS2

**Address:** 34 Castle Street, Hereford

**Condition:** Fair

**HAR Assessment:** Showing a number of signs of lack of general maintenance, including weed and moss growth around chimney, cracked window sills and displaced slates.

**Recommendation:** Repair and repaint window sills, remove weed growth and re-fix, repair and replace slates. Continue to monitor and maintain building.

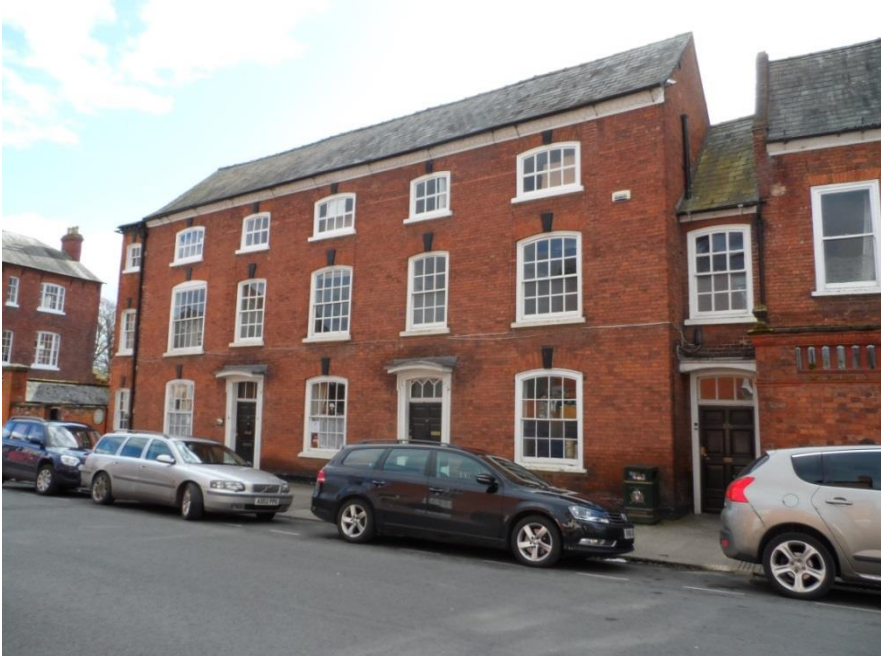
| | <b>Ref No:</b> CS5 | <b>Description:</b> Early 18 <sup>th</sup> Century houses, now part of the Cathedral School. Constructed with brick with a welsh slate roof.<br><br><b>HAR Assessment:</b> Good condition, not at risk.<br><br><b>Recommendation:</b> Continue to monitor and maintain building.<br><br><b>NOT AT RISK</b> |

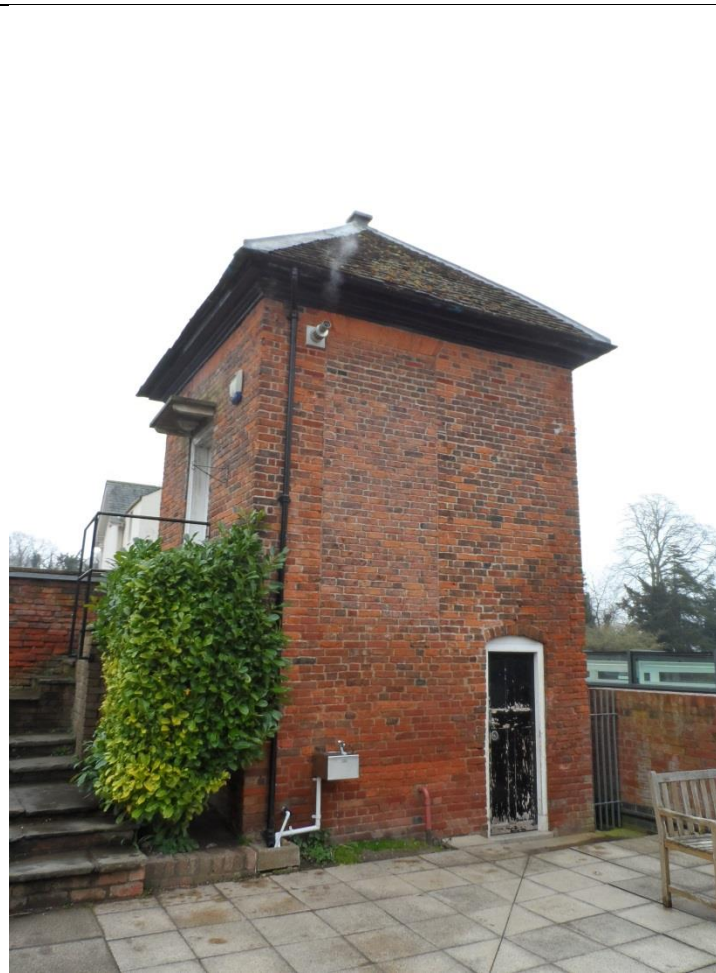
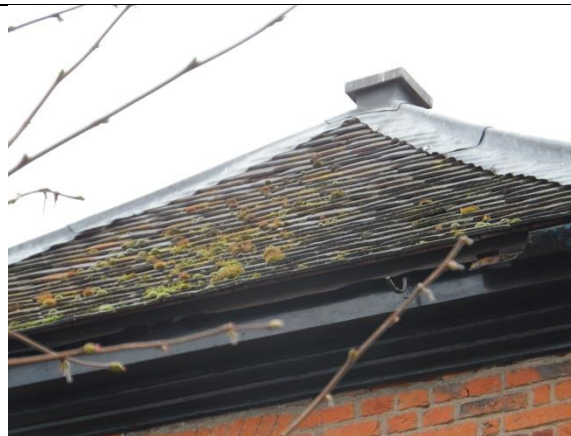
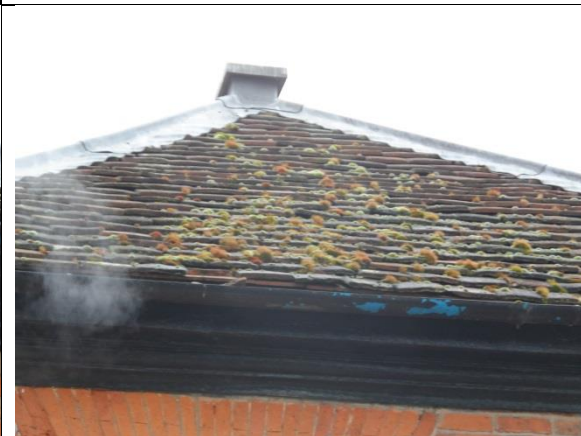
| <b>Ref No:</b> CS6 |

| <p><b>Description:</b> 17<sup>th</sup> Century brick Gazebo, now offices/storage associated with Junior Cathedral School. Two Storeys, plain tiles with pyramid roof.</p> <p><b>HAR Assessment:</b> Part of guttering missing and windows and door frames deteriorating.</p> <p><b>Recommendation:</b> Replace missing guttering, repair and repaint door and window frames with a breathable paint. Continue to monitor and maintain building.</p> |

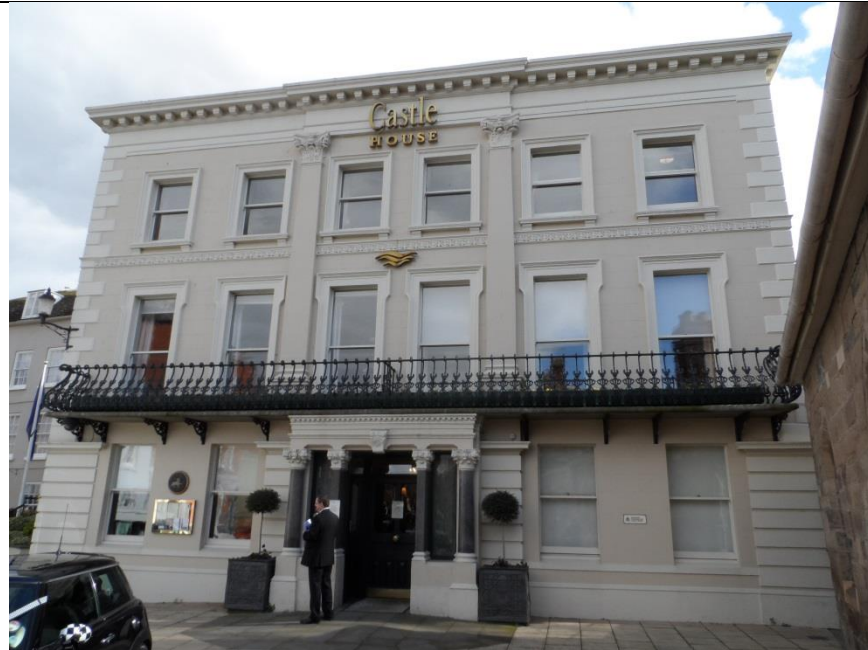
| <b>Ref No:</b> CS11 | <b>Description:</b> Mid-19 <sup>th</sup> Century former house, now hotel. Three storeys with hipped roof of plain tiles. Façade in stucco. hipped plain tile mansard roof; stucco lateral stacks; stack to rear.<br><br><b>HAR Assessment:</b> Visually in good condition, not at risk.<br><br><b>Recommendation:</b> Continue to monitor and maintain.<br><br><h2>NOT AT RISK</h2> |

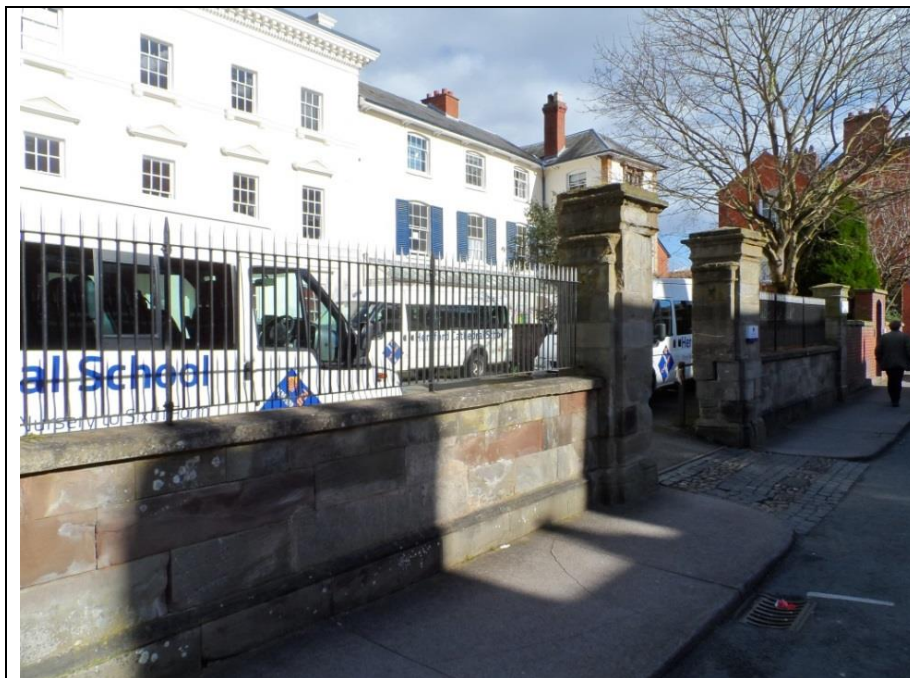
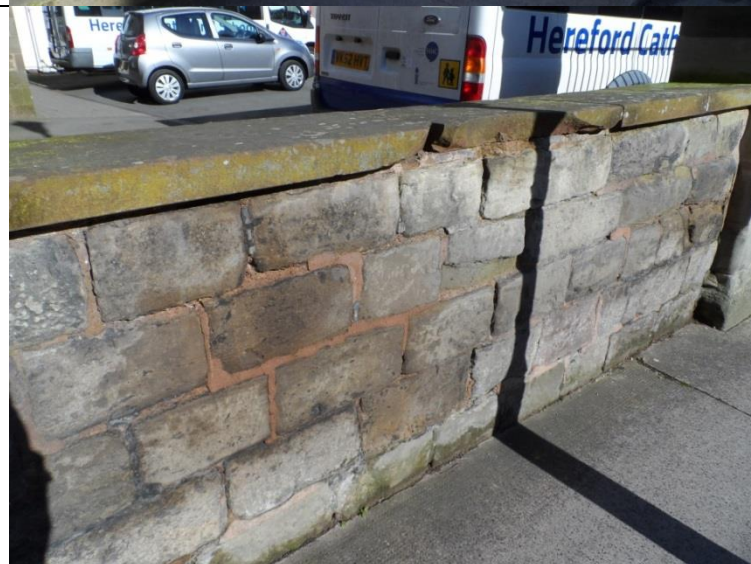
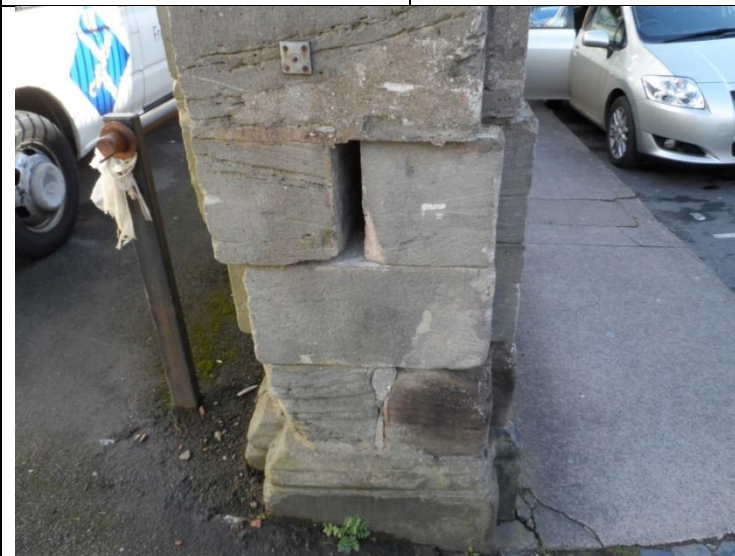
**Ref No:** CS21

**HAR Assessment:** Previous poor cement repairs, cracking and scaling stones and pointing missing (see below).

**Recommendation:** Previous cement repairs need to be removed and repaired properly with breathable mortar, some stones require replacement and re-pointing. Continue to monitor and maintain

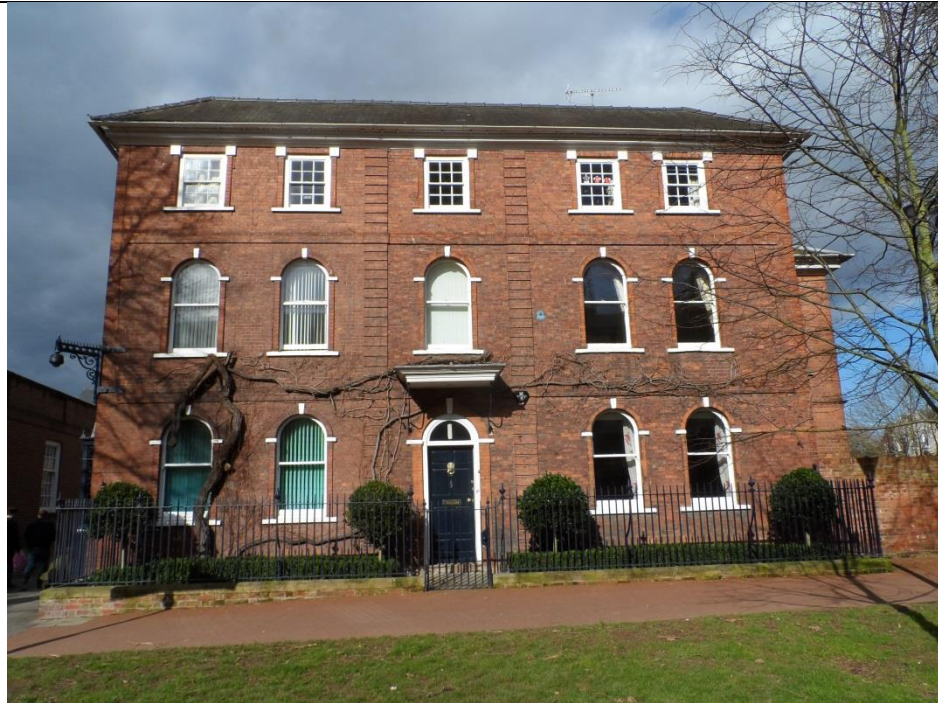
| <b>Ref No:</b> CC1 | <b>Description:</b> Late 18 <sup>th</sup> Century house constructed of brick with hipped Welsh slate roof. Symmetrical three storeys, 5 window range with late 19 <sup>th</sup> Century semicircular windows.<br><br><b>HAR Assessment:</b> Fair condition, however has cracked guttering.<br><br><b>Recommendation:</b> Cracked guttering requires replacement. Continue to monitor and maintain building. |

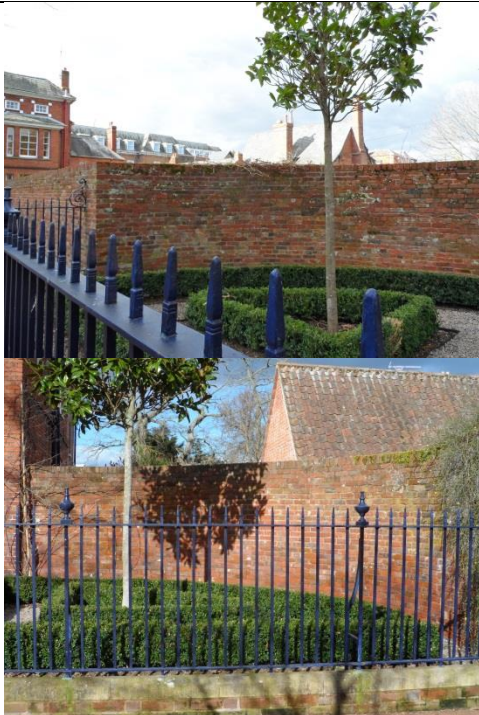
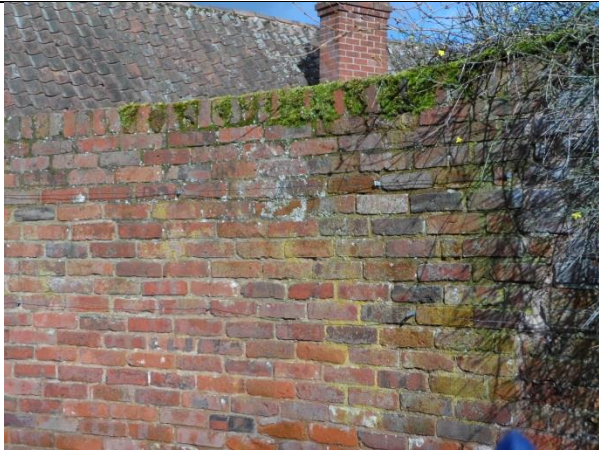
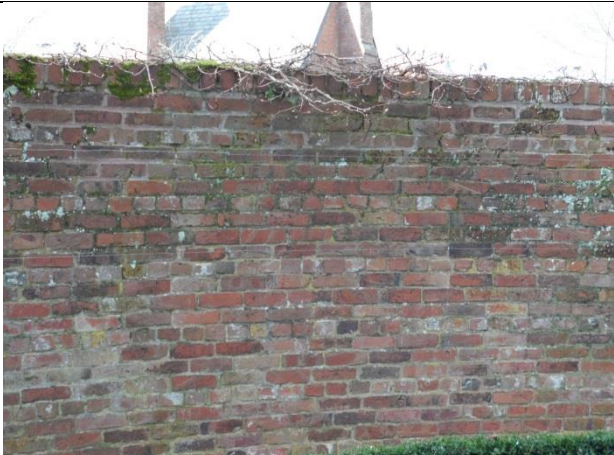
| | <b>Ref No:</b> CC2 | <p><b>Description:</b> 18<sup>th</sup> Century Walls. Constructed of red brick, curved wing walls and boundary walls to left and right. Approximately 2m high.</p> <p><b>HAR Assessment:</b> Fair condition however lack of maintenance to the wall which has cracking, weed and moss growth and water staining to wall.</p> <p><b>Recommendation:</b> The wall requires to be cleaned, and herbicide applied to prevent further weed growth. Monitor wall and repair and replace bricks if necessary. Continue to monitor and maintain</p> <h1>LOW RISK</h1> |

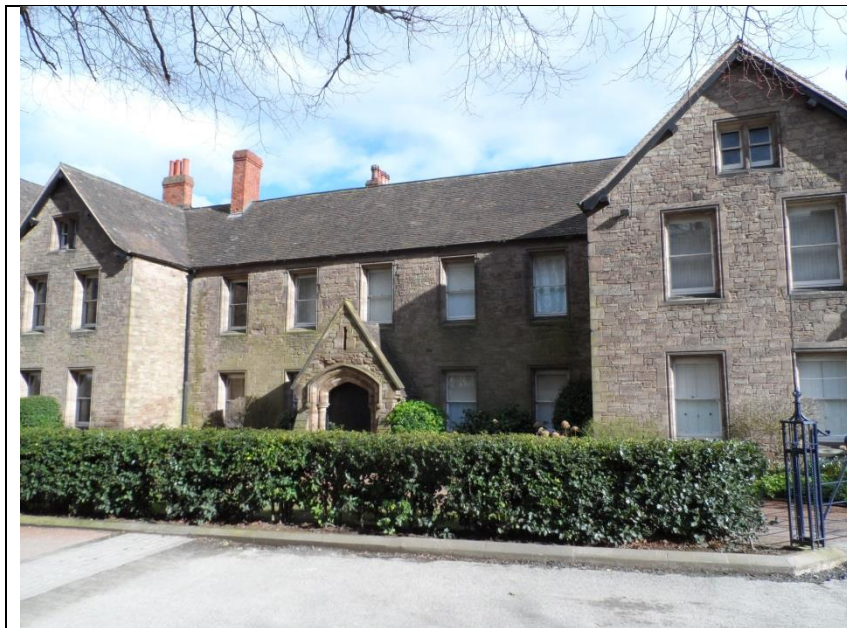
**Ref No:** CC5

**HAR Assessment:** Good condition, however window sills and frames deteriorating.

**Recommendation:** Window frames and sills requiring repair/repainting. Continue to monitor and maintain building.
