# Preventative Conservation & Maintenance Theory; its application to the Hereford City Conservation Area. Part 2 - Appendices

**August 2014**

**JS Conservation Management  
& Town Planning Ltd**  
t: 07741091719  
e: [john@jsconservationplanning.com](mailto:john@jsconservationplanning.com)  
w: [www.jsconservationplanning.com](http://www.jsconservationplanning.com)

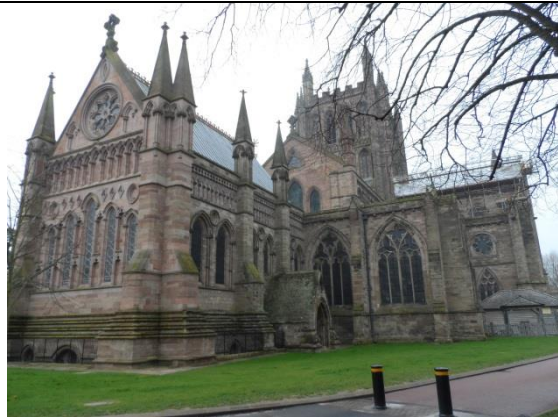
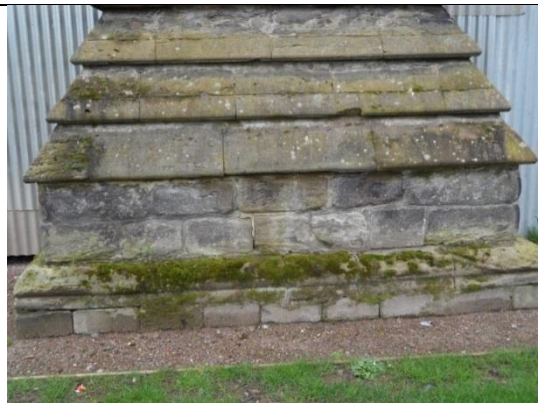
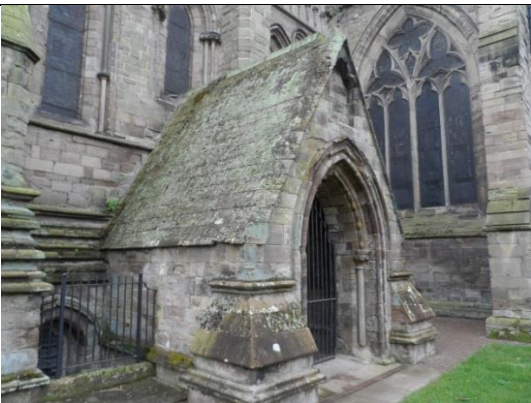
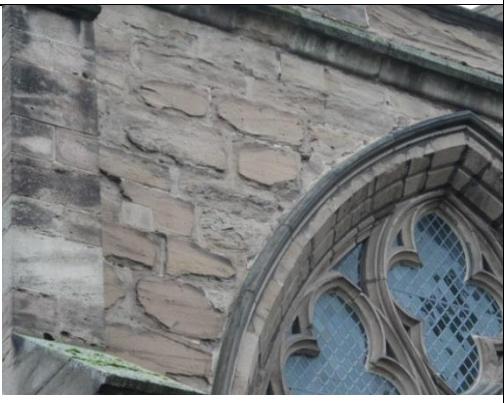
| <b>Ref No:</b> CC6 | | | | | |

| <b>HAR Assessment:</b> Cathedral currently undergoing stone and roof repairs. Lower level stone has moss and lichen growth, some scaling of stone and lack of maintenance to unused northern entrance with roof deteriorating. Structural stability and roof not able to be assessed. | | | | | |

**Recommendation:** Monitor laminating stone, assess roof slates, particularly on northern entrance which appear to be deteriorating quite badly. Continue to monitor and maintain building

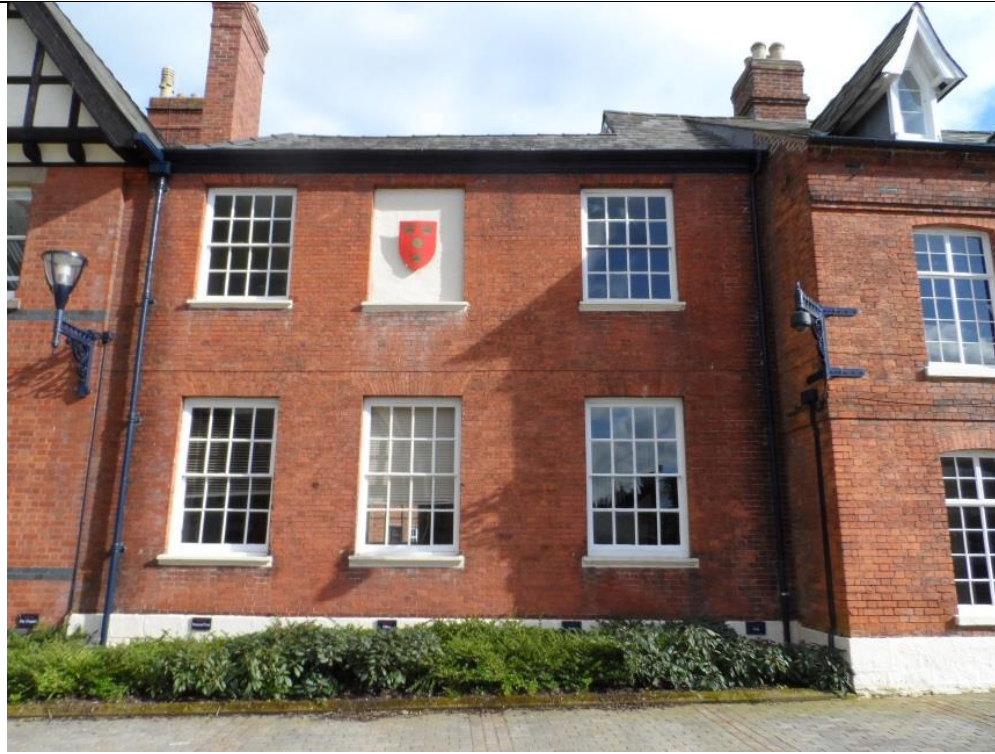
| <b>Ref No:</b> CC7 | <p><b>Description:</b> Late 18<sup>th</sup> Century house with earlier core. Now used as a school. Constructed of brick with hipped Welsh slate roof. 2 storeys; 3-window range (centre now blocked).</p> <p><b>HAR Assessment:</b> Good condition, not at risk</p> <p><b>Recommendation:</b> Continue to monitor and maintain.</p> <h1>NOT AT RISK</h1> |

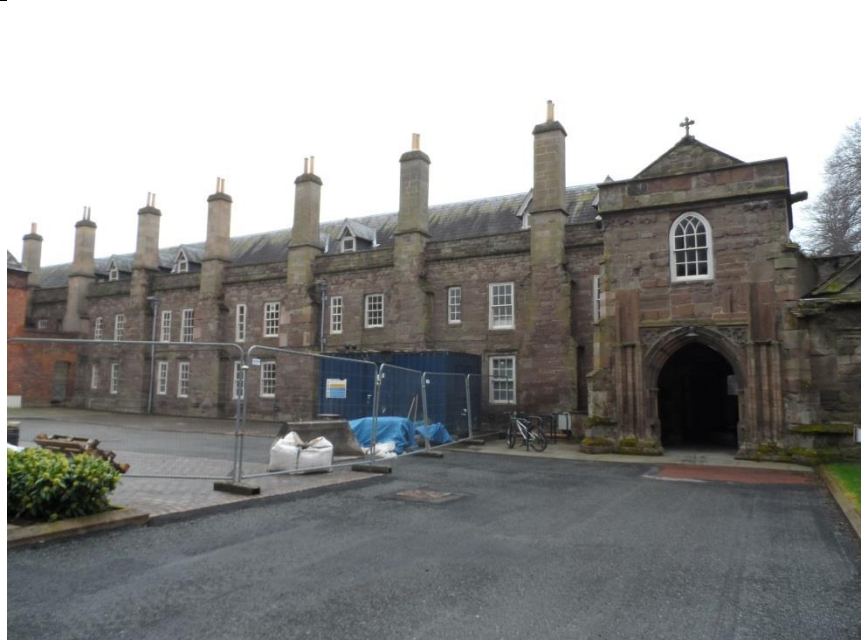
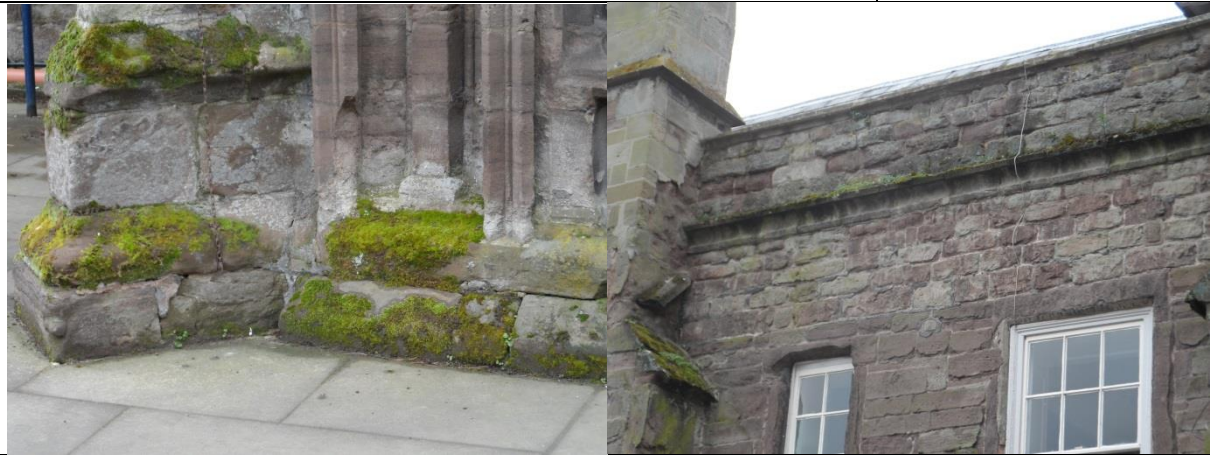
| <b>Ref No:</b> CC8 |

**HAR Assessment:** Showing signs of lack of maintenance, with large moss and lichen growth on lower level stone. Stone string course also showing signs of deterioration.

**Recommendation:** Clean stones of moss and lichen growth and continue to monitor and maintain stone, particularly those which are deteriorating and scaling.

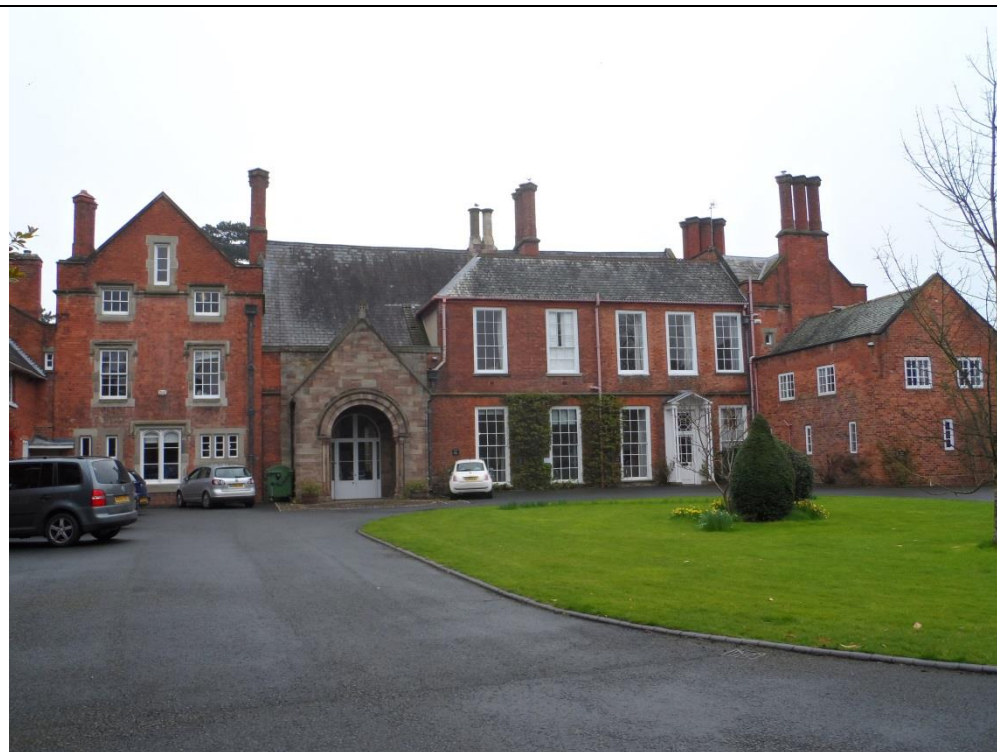
| <b>Ref No:</b> CC9 | <b>Description:</b> Episcopal palace, gatehouse, attached range, former stables, chapel and boundary wall to Gwynne Street. 12 <sup>th</sup> – 17 <sup>th</sup> Century with 18 <sup>th</sup> and 19 <sup>th</sup> Century alterations. Constructed of brick, with ashlar and timber-framing; various slate roofs, and brick and ashlar chimneys.<br><br><b>HAR Assessment:</b> Good condition, not at risk.<br><br><b>Recommendation:</b> Continue to monitor and maintain building.<br><br><h1>NOT AT RISK</h1> |

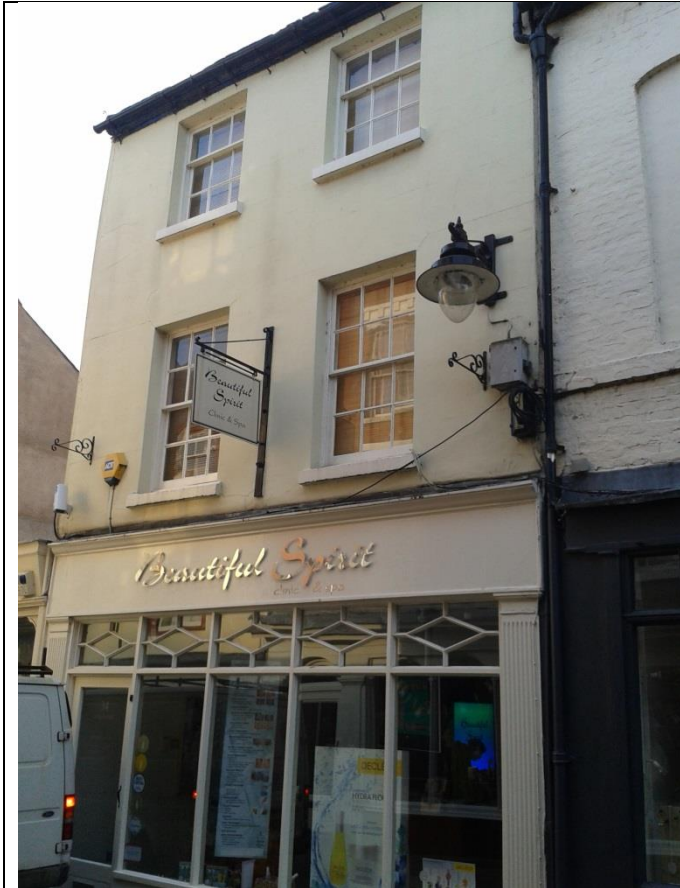
| <b>Ref No:</b> CH3 | <p><b>Description:</b> Late 18<sup>th</sup> Century shop and dwelling. Three storeys, constructed of Brick with Stucco, and hipped plain tiled gable roof. 20<sup>th</sup> Century shop front and Gas street lamp.</p> <p><b>HAR Assessment:</b> Stucco is cracking.</p> <p><b>Recommendations:</b> Undertake survey of façade to determine cause of stucco cracking. Continue to monitor stucco and replace if necessary with a conservation approach. Continue to monitor and maintain building</p> <p><b>NOT AT RISK</b></p> |

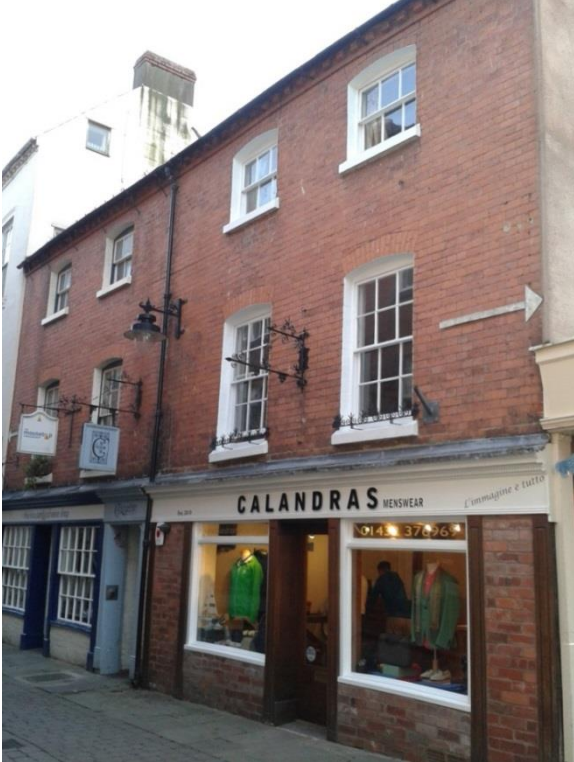
| | <b>Ref No:</b> CH4 | <b>Description:</b> Early 17th Century shops and dwellings with late 18th Century/ early 19th Century front. Three storeys, timber framed with brick facade. Gas street lamp.<br><br><b>HAR Assessment:</b> Weeds growing from gutters.<br><br><b>Recommendations:</b> Clear gutters, continue to monitor and maintain.<br><br><b>NOT AT RISK</b> |

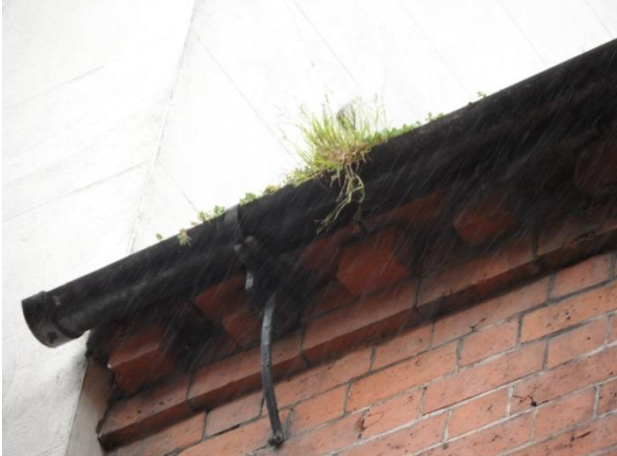
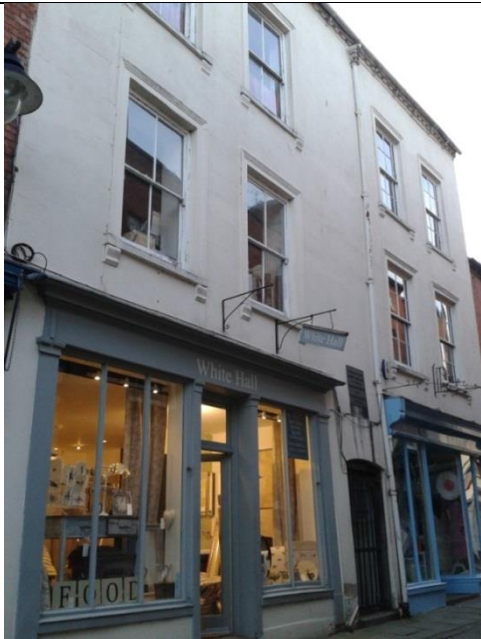
| | <b>Ref No:</b> CH5 | <b>Description:</b> Late 18 <sup>th</sup> Century shops and dwellings. Finished in stucco with slate roof to front, plain tiles to rear; Three storeys, attic and cellar. Two 19 <sup>th</sup> Century shop fronts.<br><br><b>HAR Assessment:</b> Window frames deteriorating, and downpipes and hopper box rusted.<br><br><b>Recommendations:</b> rusted downpipes and hopper box are coming to end of life and require replacement. Window frames also require repair/repainting.<br><br><b>LOW RISK</b> |

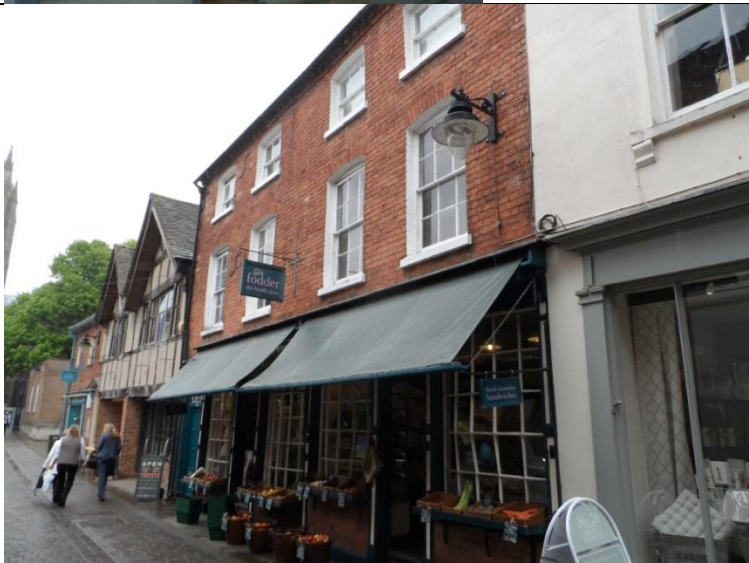
| | <b>Ref No:</b> CH6 | <b>Description:</b> Early 19 <sup>th</sup> Century shops and dwellings. Constructed of brick with a plain tile roof. Left returned side gable displays stick framing. Gas lamp and 20 <sup>th</sup> Century shop front.<br><br><b>HAR Assessment:</b> Good condition, not at risk.<br><br><b>Recommendations:</b> Continue to monitor and maintain building.<br><br><b>NOT AT RISK</b> |

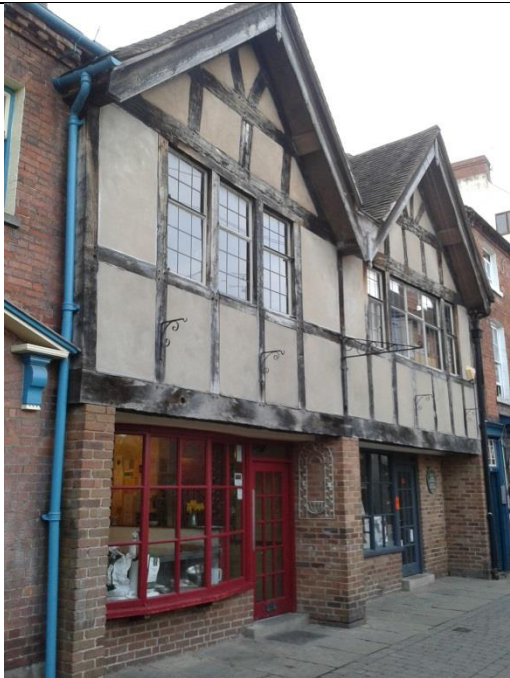
| | <b>Ref No:</b> CH7 | <p><b>Description:</b> Early 17<sup>th</sup> Century shops and dwellings. Timber-frame and render; twin gable and plain tile roof, with higher slate roof to right rear. Two storeys with 20<sup>th</sup> Century shop fronts, restored circa 1970.</p> <p><b>HAR Assessment:</b> Good condition, not at risk.</p> <p><b>Recommendations:</b> Continue to monitor and maintain building.</p> <p><b>NOT AT RISK</b></p> |

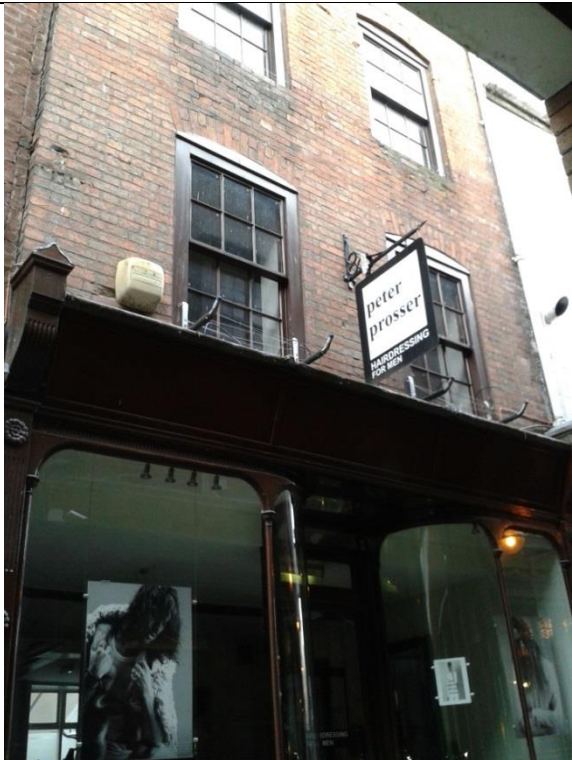
| | <b>Ref No:</b> CH9 | <b>Description:</b> Late 28 <sup>th</sup> Century shop and dwelling with earlier origins. Three storeys and cellar, constructed of brick with a slate roof. Late 19 <sup>th</sup> Century shop front.<br><br><b>HAR Assessment:</b> Brick sills and under brick sills showing signs of damp and water build up and staining with bricks on façade deteriorating.<br><br><b>Recommendations:</b> Façade needs a survey to determine damp remedial measures. Continue to monitor and maintain building<br><br><b>LOW RISK</b> |

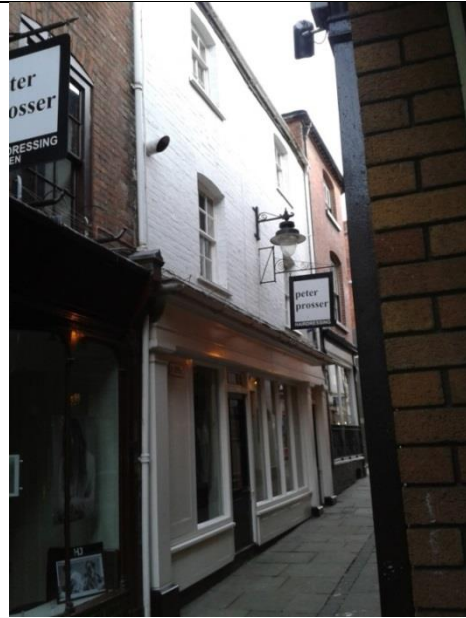
| <b>Ref No:</b> CH10 |

**HAR Assessment:** Downpipes and gutters are rusted and appear to be at end of life.

**Recommendations:** Investigate downpipes and guttering and replace if necessary. Continue to monitor and maintain building.

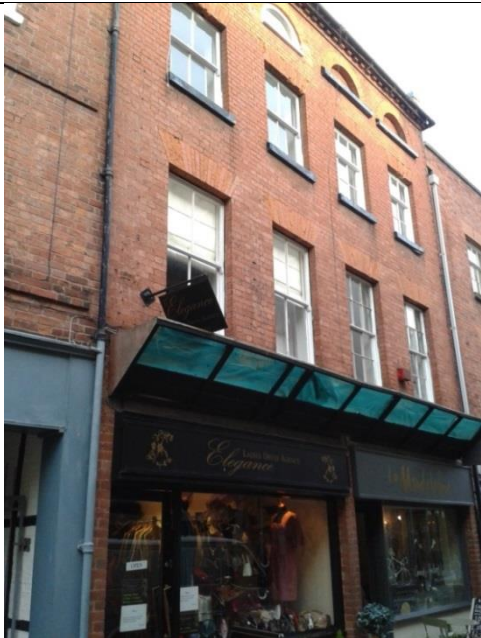
| | <b>Ref No:</b> CH14 | <b>Description:</b> Late 18 <sup>th</sup> Century dwellings and shops, with earlier origins. Three Storeys, constructed of brick with hipped slate roof and 20 <sup>th</sup> Century shop front.<br><br><b>HAR Assessment:</b> Some frost damage to bricks.<br><br><b>Recommendations:</b> Continue to monitor frost damage and repair/replace with a conservation approach if necessary. Monitor and maintain building.<br><br><b>NOT AT RISK</b> |

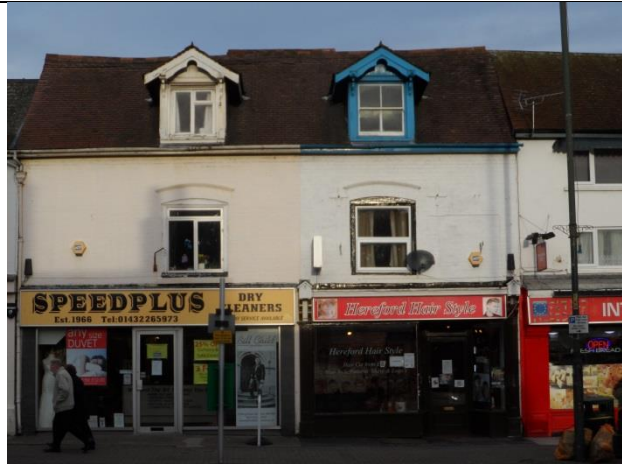
**Ref No:** CR1

**HAR Assessment:** No.8 (left) has blocked guttering with weeds growing. Dormer window paint deteriorating

**Recommendation:** Clear gutters, repair and re-paint exterior dormer with a breathable paint. Continue to monitor and maintain buildings

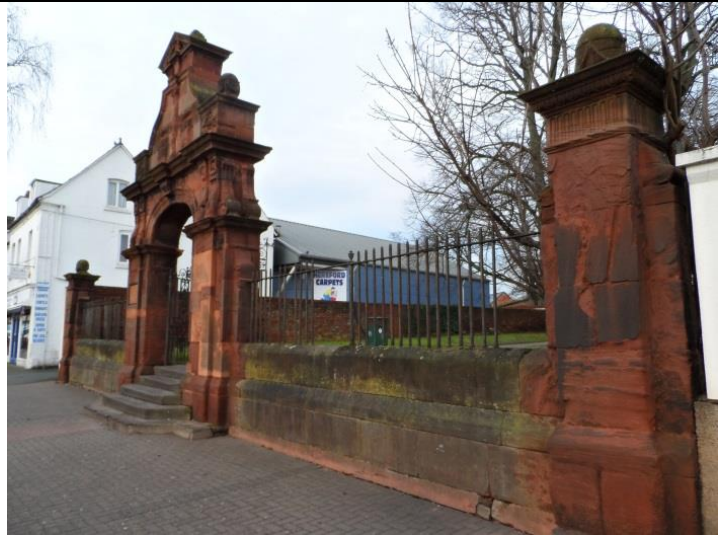
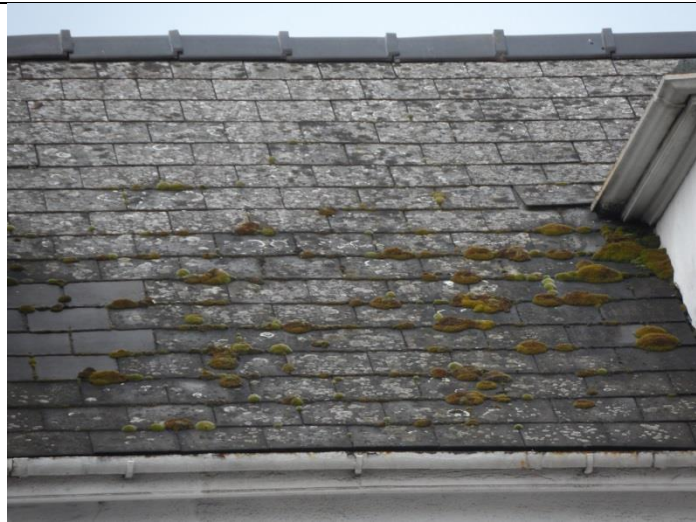
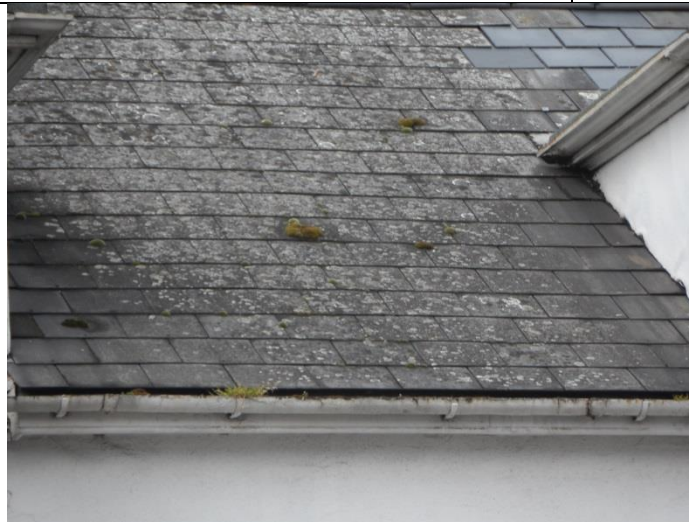
**Ref No:** CR2

**HAR Assessment:** The calcareous sandstone is problematic in that it is experiencing rapid decay, and laminating of the stone. Some railings missing, and 20<sup>th</sup> Century concrete step deteriorating. Options appraisal Report completed on the restoration of the arch and railings, however no funding agreed.

**Recommendations:** Repair concrete step with stone step, remove past poor stone repairs, protect stone and ensure any replacement stone is calcareous sandstone

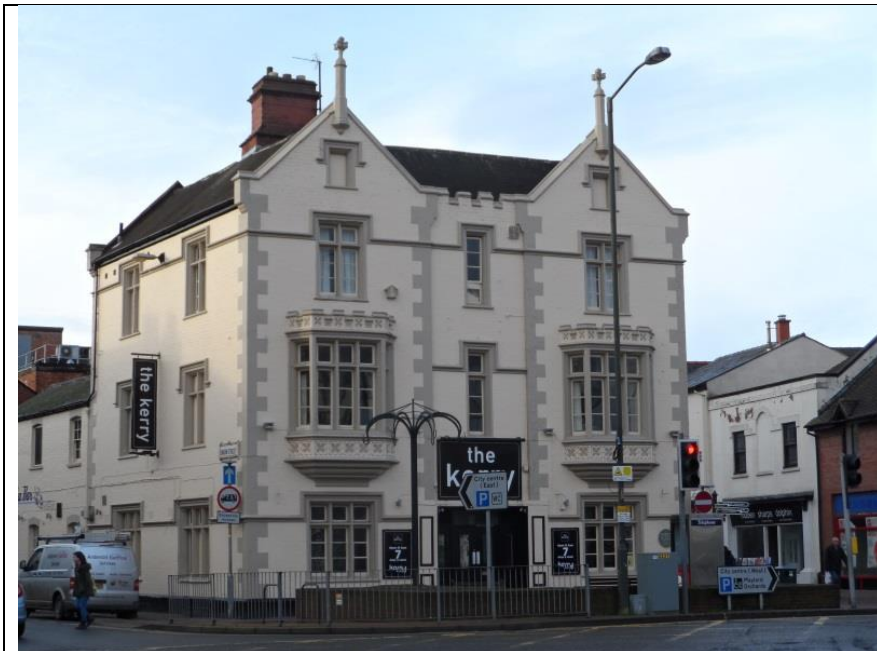
| <b>Ref No:</b> CSQ1 | <b>Description:</b> Late 19 <sup>th</sup> Century Victorian Hotel with 20 <sup>th</sup> Century entrance.<br><br><b>HAR Assessment:</b> The hotel has undergone extensive interior and exterior refurbishment and is in good condition<br><br><b>Recommendations:</b> Continue to monitor and maintain building.<br><br><h1>NOT AT RISK</h1> |

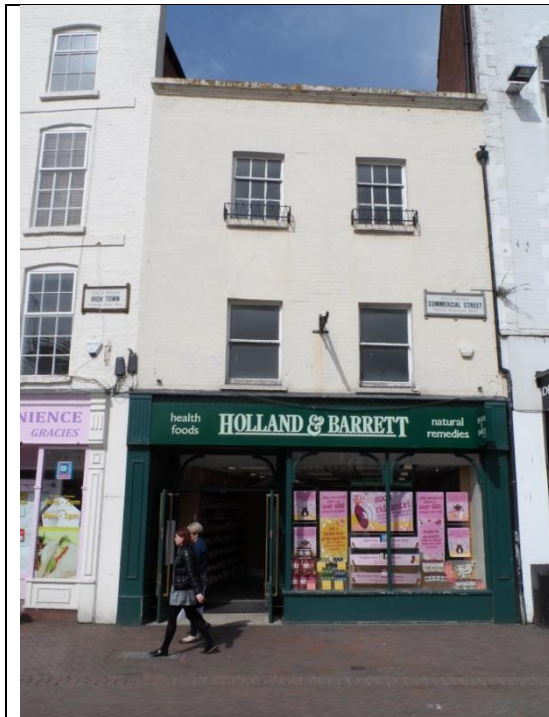
**Ref No:** CM1

**HAR Assessment:** Water build-up and rust staining to façade and window sills, window frames and shop front deteriorating.

**Recommendations:** Repair and re-paint window frames and shopfront and clean rust stains. Continue to monitor and maintain building.

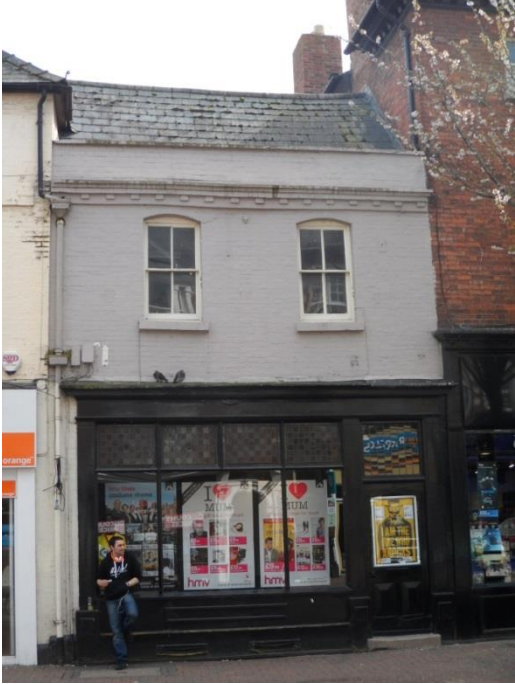
| | <b>Ref No:</b> CM4 | <p><b>Description:</b> Late 18<sup>th</sup> Century shop and dwelling. Two storeys and cellar, painted brick and 20<sup>th</sup> Century composite tile roof. Late 19<sup>th</sup> Century shop front.</p> <p><b>HAR Assessment:</b> Hopper box appears to be blocked, and deteriorating cornice.</p> <p><b>Recommendations:</b> Clear hopper box. Continue to monitor and maintain building.</p> <p><b>LOW RISK</b></p> |

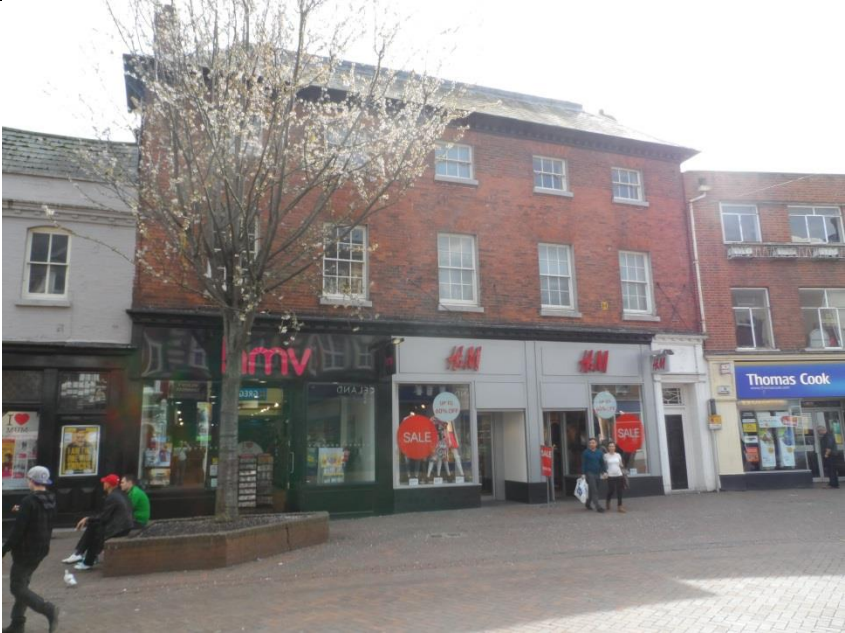
| | <b>Ref No:</b> CM6 | <b>Description:</b> 18 <sup>th</sup> Century shop and dwelling, now shops, dwellings and restaurant. Three storeys, constructed of brick with hipped Welsh slate roof. 20 <sup>th</sup> Century shop fronts.<br><br><b>HAR Assessment:</b> weed growth in guttering.<br><br><b>Recommendations:</b> Clear guttering and continue to monitor and maintain building.<br><br><h1>NOT AT RISK</h1> |

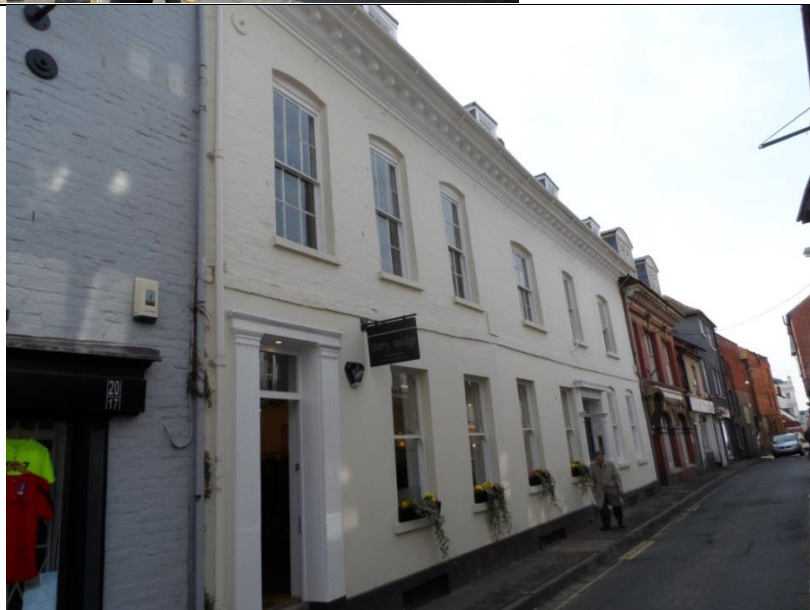
**Ref No:** ES3

**HAR Assessment:** Good condition, not at risk.

**Recommendations:** Continue to monitor and maintain building

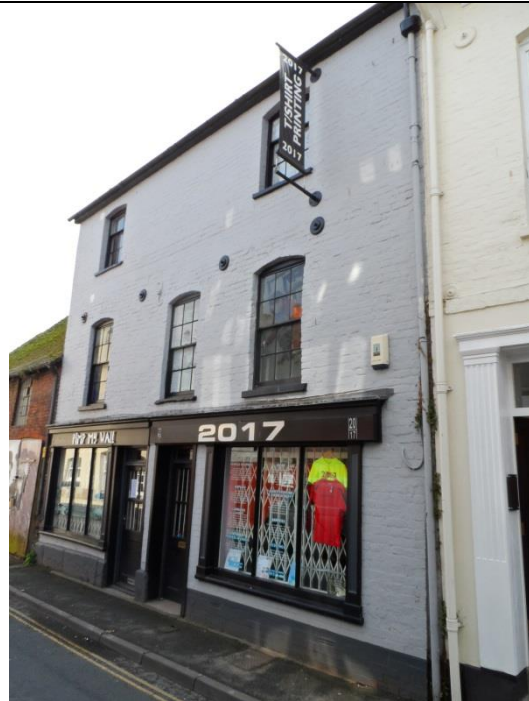
**Ref No:** ES4

**HAR Assessment:** Gutters have weed growth, with cracks evident in downpipes with weeds growing.

**Recommendations:** Clear gutters of weed growth and repair /replace downpipes. Continue to monitor and maintain building.

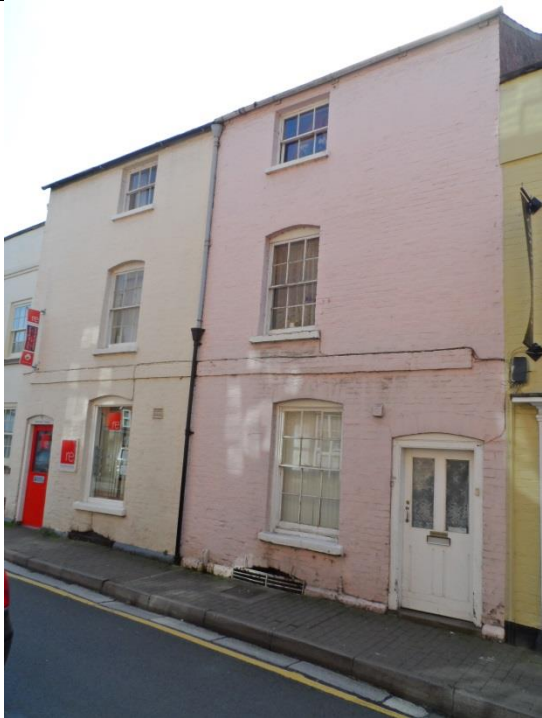
| | <b>Ref No:</b> ES7 | <b>Description:</b> 18 <sup>th</sup> Century dwellings, now offices and accommodation. Constructed of brick which is painted and a slate roof. Three storeys and cellar.<br><br><b>HAR Assessment:</b> Paint staining and flaking. Cellar opening blocked with weed growth.<br><br><b>Recommendations:</b> Repaint and repair front façade with a breathable paint and clear weed growth. Monitor and maintain building. |

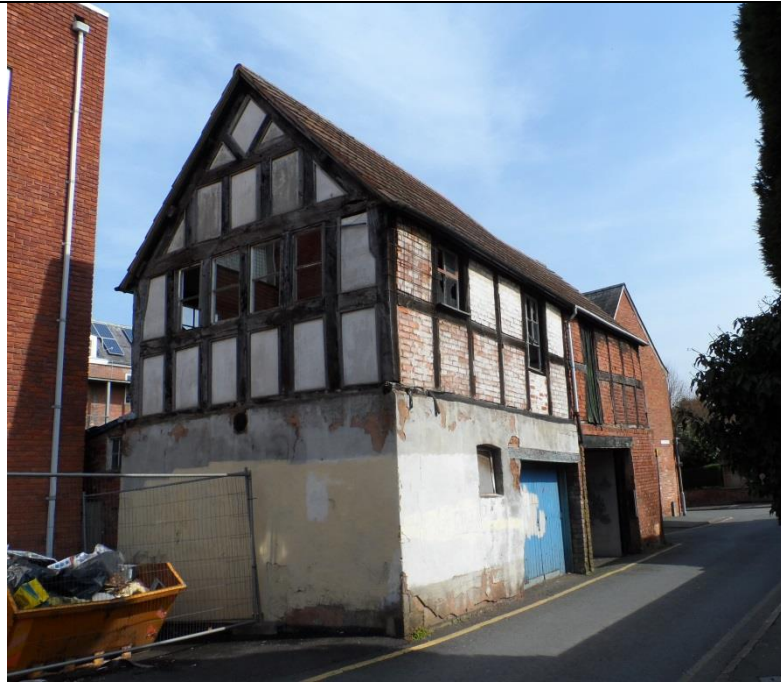
**Ref No:** ES8

**HAR Assessment:** Evidence of previous fire damage, derelict building with broken glass panes, render cracked, pigeons nesting and sections of wall missing and deteriorating plaster and brick infill. No evidence of planning applications or listed building consent to repair building.

**Recommendations:** Find a suitable form of occupation of the building, repair windows, infill and missing walls and make water tight, monitor and maintain building.

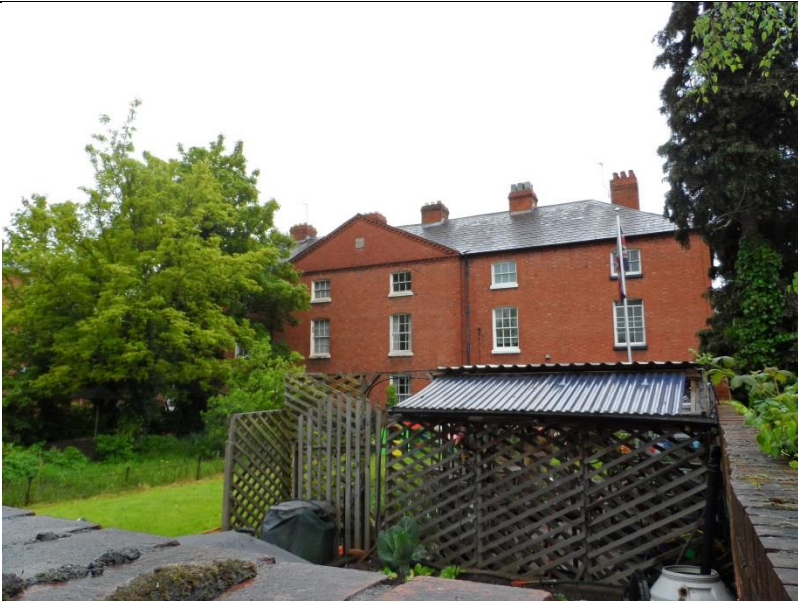
| | <b>Ref No:</b> ER2 | <p><b>Description:</b> Houses circa 1822 according to date tablet. Three storeys and attic, constructed of brick with Welsh slate roof.</p> <p><b>HAR Assessment:</b> Window frames deteriorating and slipped slates on roof.</p> <p><b>Recommendations:</b> Repair and repaint window frames, replace missing/slipped slates, continue to monitor and maintain building.</p> <p><b>NOT AT RISK</b></p> |

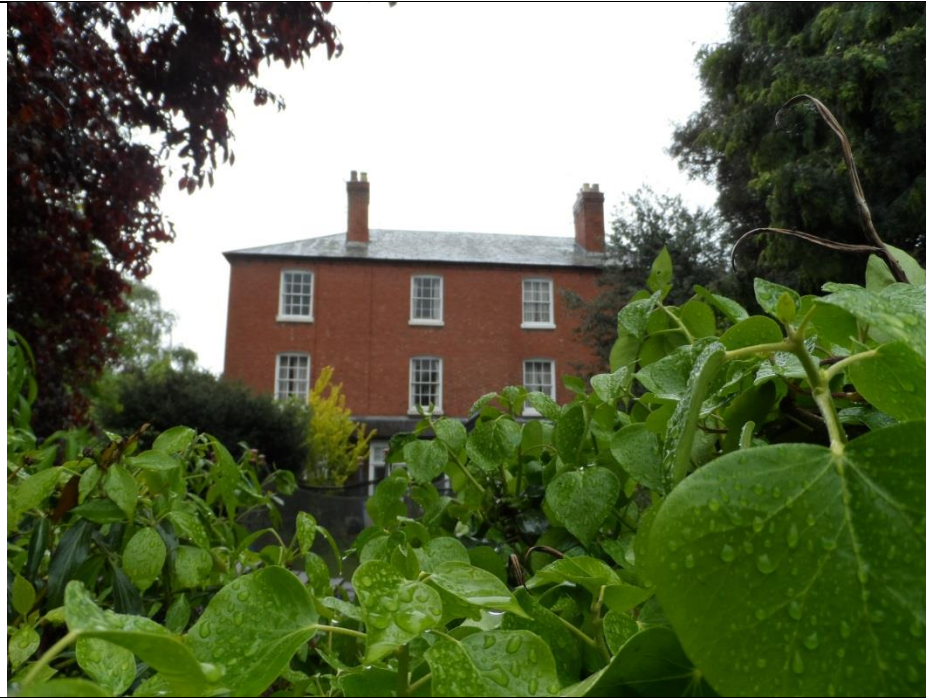
| <b>Ref No:</b> ER4 | <b>Description:</b> Early 19 <sup>th</sup> Century houses, now houses and offices and 20 <sup>th</sup> Century additions. Three storeys and cellar, constructed of brick with stone plinth and hipped slate roof.<br><br><b>HAR Assessment:</b> Good condition, not at risk.<br><br><b>Recommendations:</b> Continue to monitor and maintain building.<br><br><h2>NOT AT RISK</h2> |

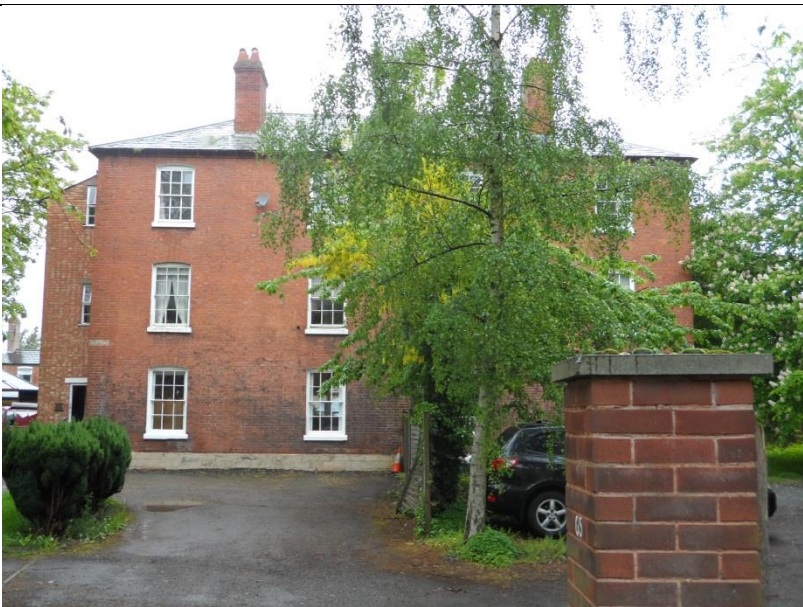
| | <b>Ref No:</b> ER5 | <p><b>Description:</b> Early 19<sup>th</sup> Century houses, now flats. Three storeys and cellar, constructed of brick with a hipped Welsh slate roof.</p> <p><b>HAR Assessment:</b> Blocked guttering which may be causing water build-up on outside of brickwork, with probable damp problems inside (interior not inspected). Slipped slates.</p> <p><b>Recommendations:</b> replace, re-attach slipped slates, clear guttering, continue to monitor and maintain building.</p> <p><b>LOW RISK</b></p> |

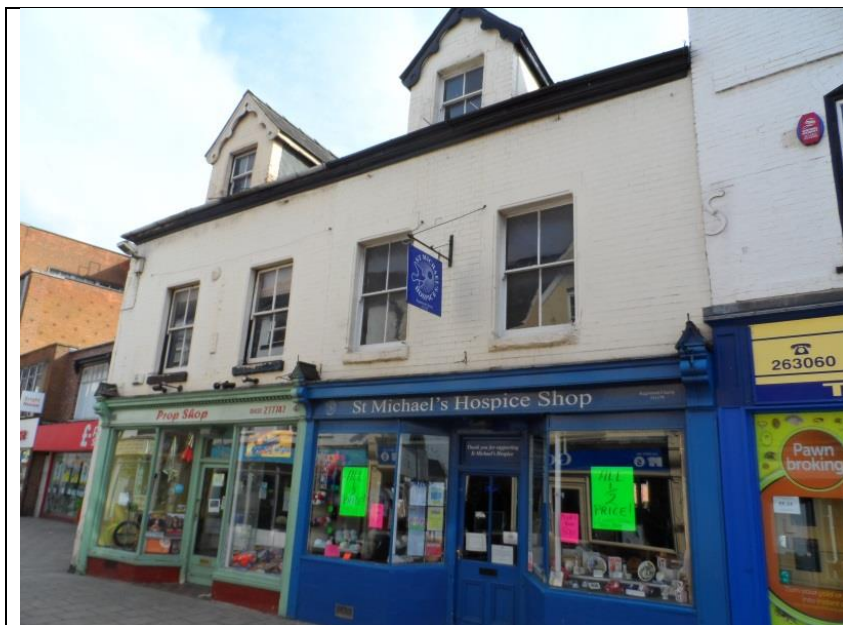
**Ref No:** EG3

**HAR Assessment:** Guttering deteriorating and rusty, window sills deteriorating.

**Recommendations:** Façade and sills require repair/ re-painting, and the installation of new guttering. Continue to monitor and maintain building.

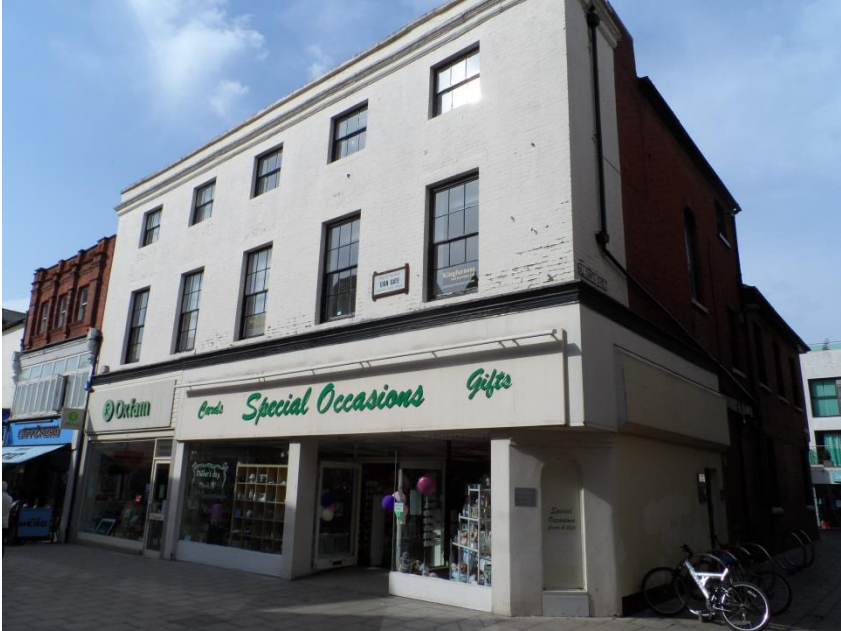
| | <b>Ref No:</b> EG4 | <p><b>Description:</b> 18<sup>th</sup> Century, formerly The Greyhound Inn, now shops and offices. Painted brick with possible slate roof. Three Storeys with 20<sup>th</sup> Century shopfront.</p> <p><b>HAR Assessment:</b> Paint flaking from façade which is most likely due to non-breathable paint being used on façade and water trying to escape as bricks have taken in built-up water from top of shop front.</p> <p><b>Recommendations:</b> Remove non-breathable paint from façade and repaint with a breathable paint. Continue to monitor and maintain building.</p> <p><b>LOW RISK</b></p> |

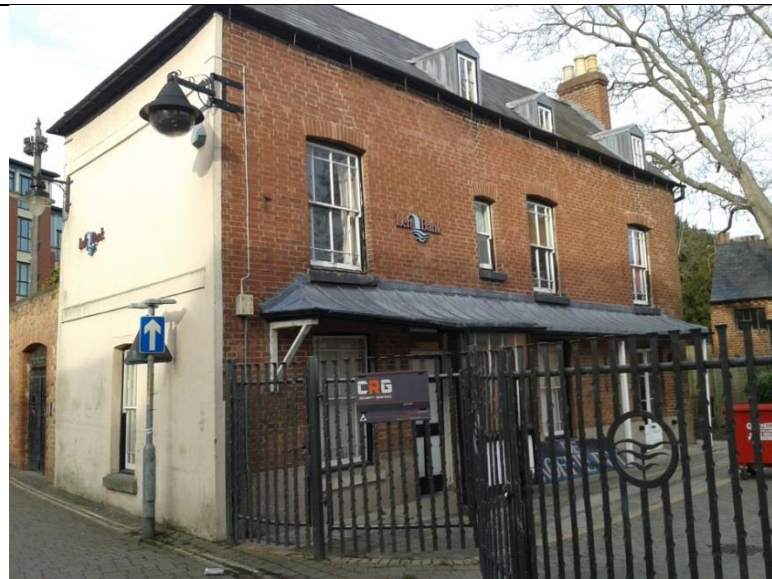
**Ref No:** GW1

**HAR Assessment:** Window frames are deteriorating.

**Recommendations:** repair and re-paint window frames, continue to monitor and maintain building.

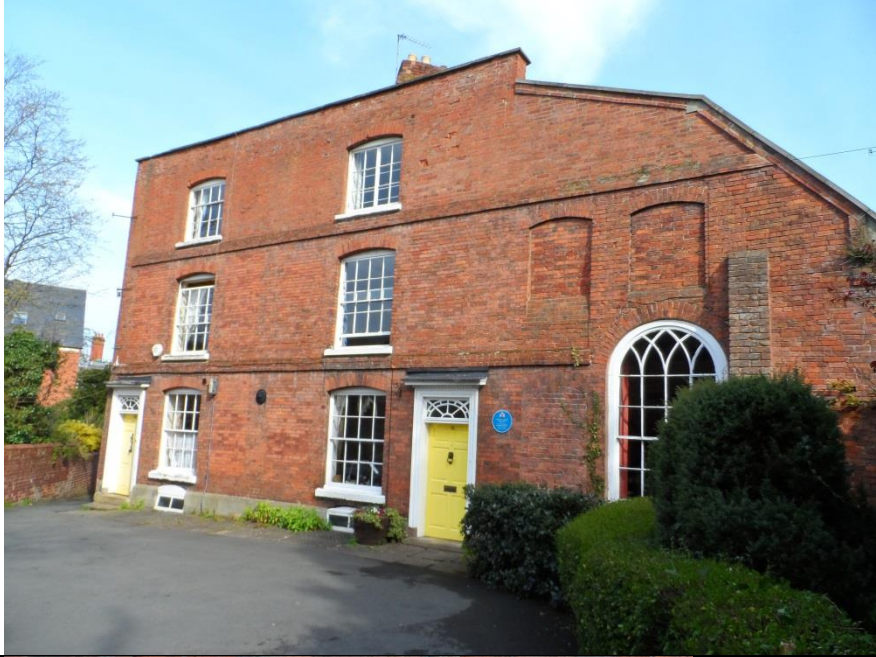
| | <b>Ref No:</b> HC1 | <p><b>Description:</b> 17<sup>th</sup> Century houses with 18<sup>th</sup> Century fronts. Constructed of brick with hipped slate roof. Three storeys and cellar. Wing to right has altered roofline and large 8/8 sash with Gothic glazed head under semicircular arch.</p> <p><b>HAR Assessment:</b> previous poor re-pointing repairs in cement mortar has weakened bricks.</p> <p><b>Recommendations:</b> Continue to monitor brickwork and look to remove past repointing and repair with a breathable mortar. Replace and repair bricks if necessary with a conservation approach. Continue to monitor and maintain.</p> <p><b>NOT AT RISK</b></p> |

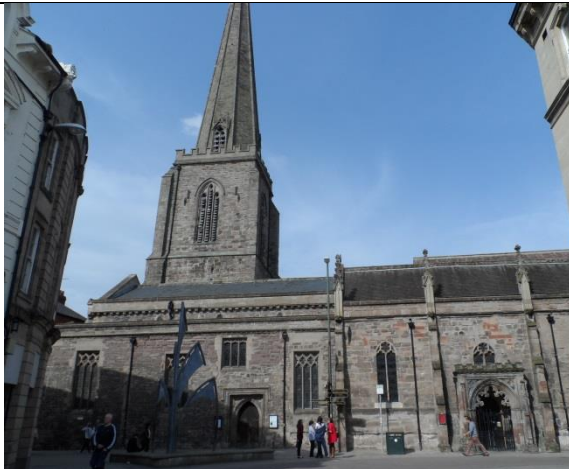
| | Ref No: HS1 | | | | | | <p><b>Description:</b> 13<sup>th</sup> and 14<sup>th</sup> Century Parish Church, now café and church. Coursed rubble; ashlar sandstone; slate and tile roof; ashlar tower and spire. Part of the nave has been converted to a cafe</p> <p><b>HAR Assessment:</b> Moss and lichen growth on stone, particularly above entrance, signs of damp, part of stone laminating, broken cornice. Quinquennial report mentions poor structural condition to bell frame, windows and damp levels as issues.</p> <p><b>Recommendation:</b> Place on at risk register due to poor structural condition. Obtain funding, Continue to monitor and maintain building.</p> <p><b>MEDIUM RISK</b></p> |

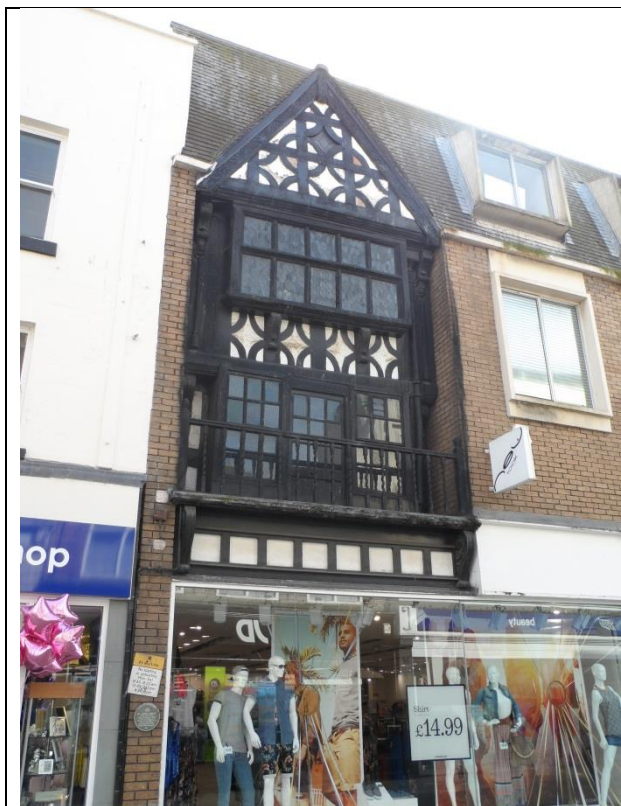
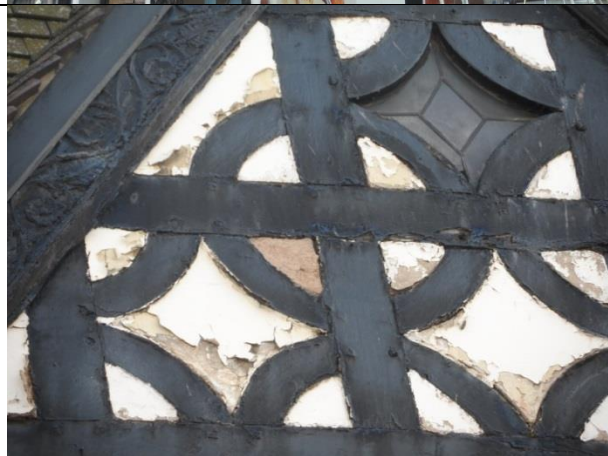
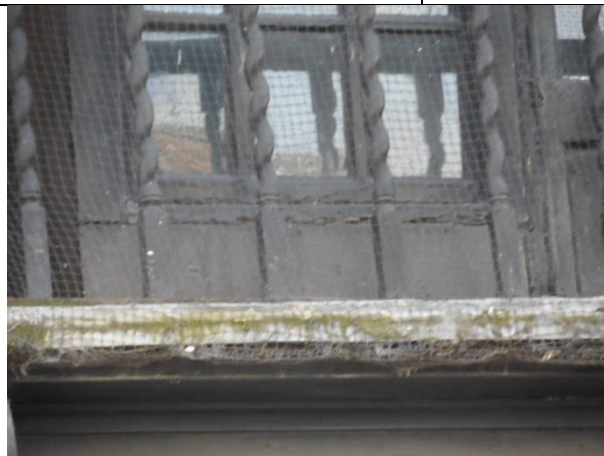
**Ref No:** HS2

**Condition:** Fair

**HAR Assessment:** Deteriorating cornice, weed growth on roof and flaking plaster.

**Recommendations:** Façade requires repair and repainting with breathable paint. Remove weed growth and monitor and maintain façade.

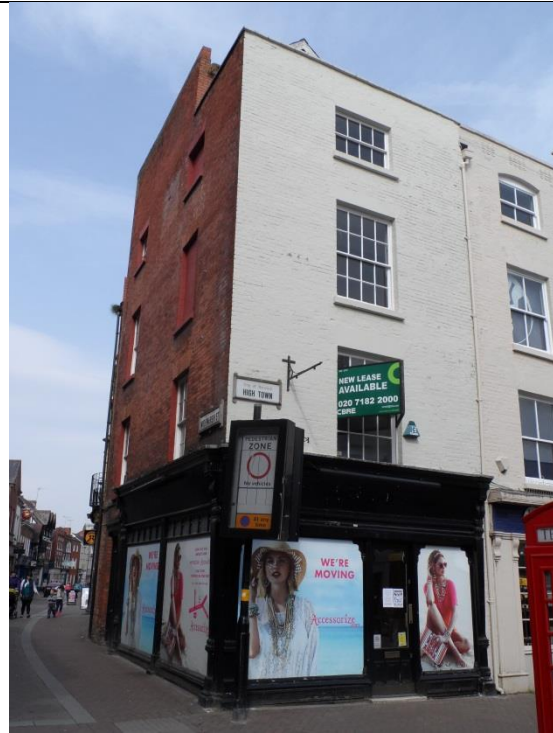
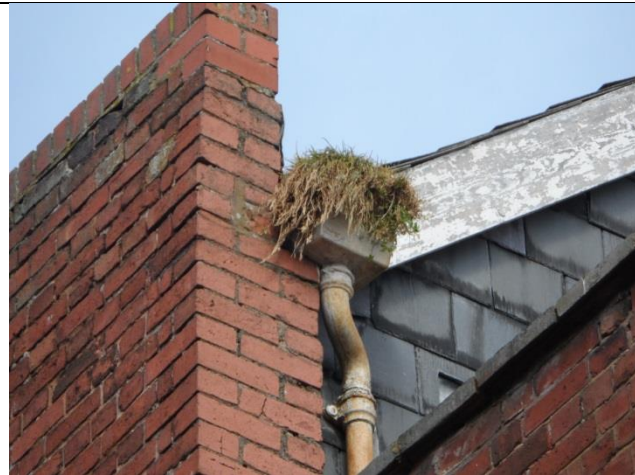
| <b>Ref No:</b> HT1 |

| <b>Condition:</b> Good |

| <p><b>Description:</b> Late 18<sup>th</sup> Century – early 19<sup>th</sup> Century shop and dwelling, including No.2 Widemarsh Street. Four storeys, attic and cellar. Painted brick and hipped slate roof. Late 19<sup>th</sup> Century shop front. No. 2 Widemarsh Street was an early 19<sup>th</sup> Century house and shop, now shop. Three Storeys constructed of brick with slate roof.</p> <p><b>HAR Assessment:</b> Currently vacant which makes the building vulnerable, however tenants are being sought which would make the building 'low risk.' Also a lack of maintenance is evident with hopper box blocked by weed growth.</p> <p><b>Recommendations:</b> Secure a tenant and clear out gutters and hopper box, continue to monitor and maintain building.</p> |

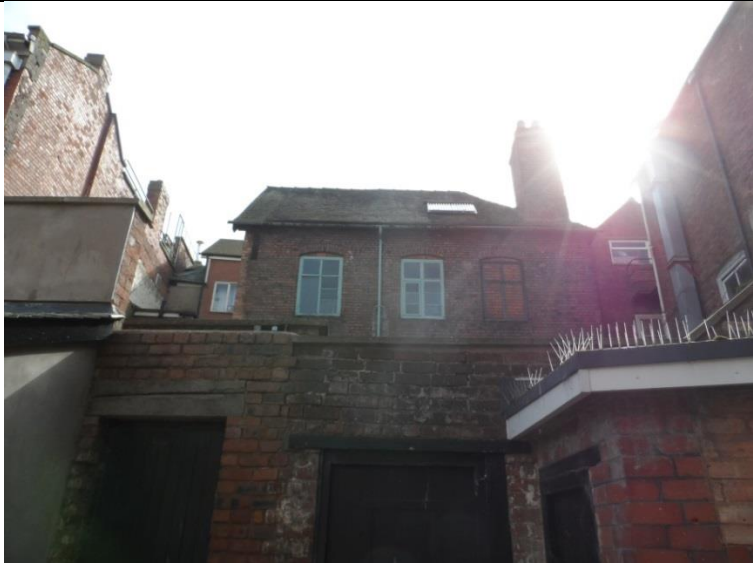
| | <b>Ref No:</b> HT3 | <b>Description:</b> Late 17 <sup>th</sup> Century house. Constructed of brick with plain tile turnerised roof. Three storeys, attic and cellar.<br><br><b>HAR Assessment:</b> Roof slates appear very worn.<br><br><b>Recommendations:</b> Survey of roof slates needed and repair/ or replacement of roof slates needed with a conservation approach, continue to monitor and maintain building.<br><br><h2>NOT AT RISK</h2> |
