# Preventative Conservation & Maintenance Theory; its application to the Hereford City Conservation Area. Part 2 - Appendices

**August 2014**

**JS Conservation Management  
& Town Planning Ltd**  
t: 07741091719  
e: [john@jsconservationplanning.com](mailto:john@jsconservationplanning.com)  
w: [www.jsconservationplanning.com](http://www.jsconservationplanning.com)

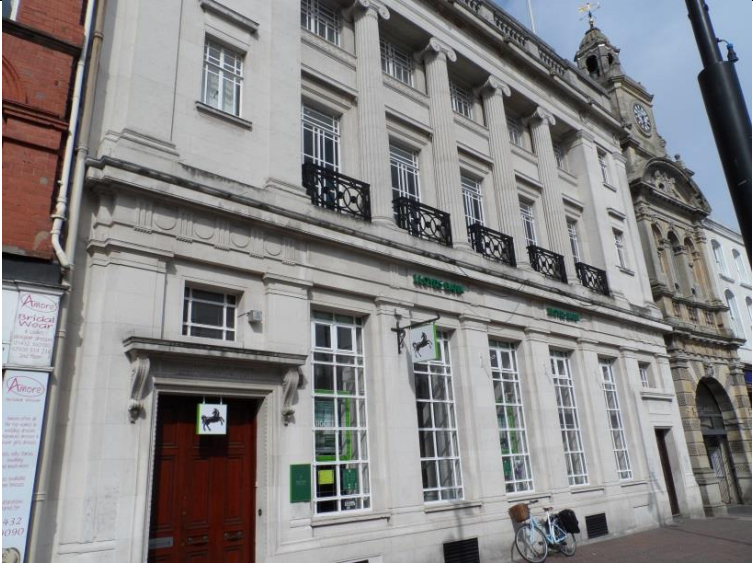
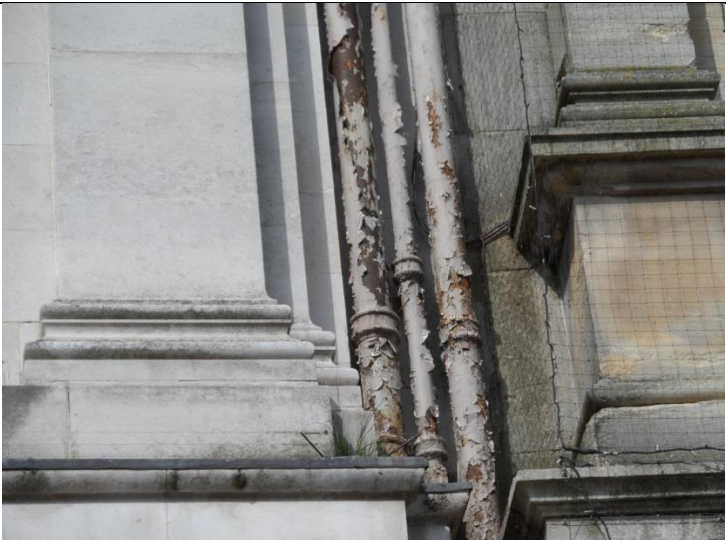
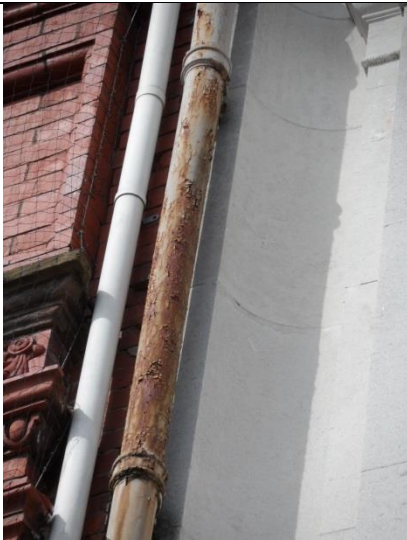
| | <b>Ref No:</b> HT4 | <b>Description:</b> Bank constructed in 1927 and designed by Waller and Son of Gloucester. Three storeys, classical styles with Ashlar with parapeted roof.<br><br><b>HAR Assessment:</b> Downpipes appear at end of life with large amounts of rust, weed growth in cornice possibly due to water build up in façade.<br><br><b>Recommendations:</b> Maintenance of façade required to clear weed growth, and replacement of downpipes. |

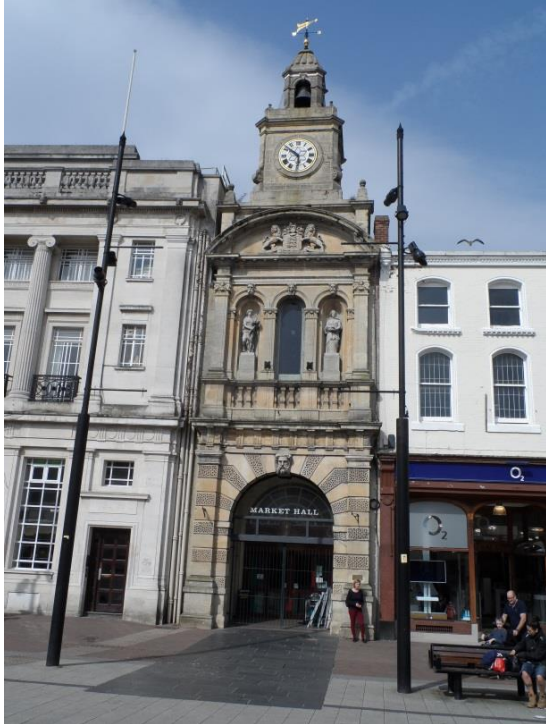
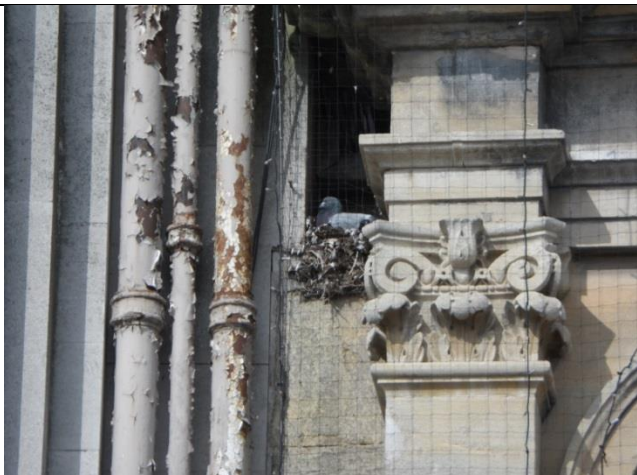
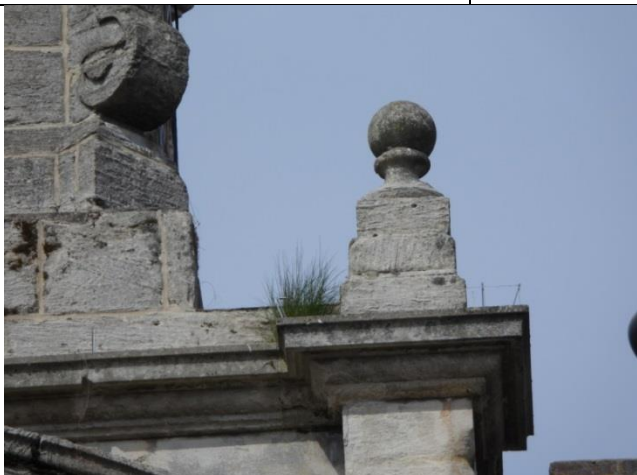
| | <b>Ref No:</b> HT6 | | <p><b>Description:</b> Market Hall entrance circa 1860, by John Clayton. Ashlar Tower with through-passage. Three niches over, with light and flanking figures; armorial tablet under moulded arch. Clock tower with buttresses; bellcote with weather-vane; clock by J Smith &amp; Sons, Midland Steam Clock Works, Derby.</p> <p><b>HAR Assessment:</b> Netting over façade appears to be damaged as allowing pigeons to nest. Cornice has weed growth which is most likely due to water build up on cornice. Is rated 'low risk' as the tower itself is not occupied, but is utilised as part of the market entrance.</p> <p><b>Recommendations:</b> Repair netting to ensure birds cannot nest on the façade, remove weeds on cornice, continue to monitor and maintain building.</p> <p><b>LOW RISK</b></p> |

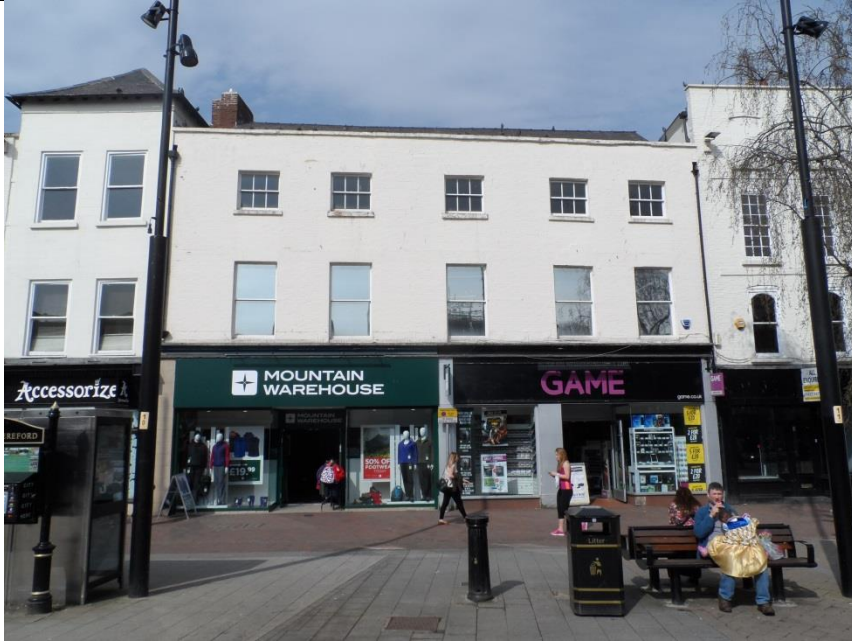
| | <p><b>Ref No:</b> HT8</p> <p><b>Address:</b> 12 &amp; 13 High Town, Hereford</p> <p><b>Designation:</b> Grade II</p> <p><b>List Entry No:</b> 1196840</p> <p><b>Condition:</b> Good</p> <p><b>Occupancy:</b> Occupied</p> <p><b>Owner Type:</b> Commercial Company</p> <p><b>Heritage Crime:</b> N/a</p> <p><b>Priority Category:</b> N/a</p> | <p><b>Description:</b> 18<sup>th</sup> Century shops and dwellings, now shops. Three storeys, painted brick with Welsh slate roof and two 20<sup>th</sup> Century shop fronts.</p> <p><b>HAR Assessment:</b> Fair condition, with window sills deteriorating due to water build up.</p> <p><b>Recommendations:</b> Repair and repaint window sills, continue to monitor and maintain building.</p> <p><b>LOW RISK</b></p> |

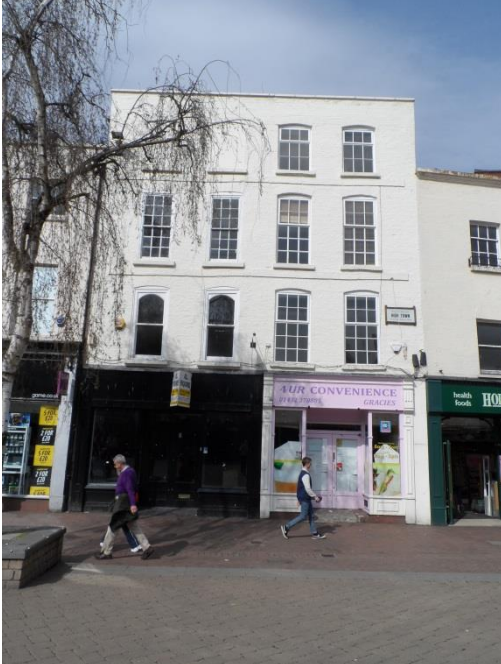
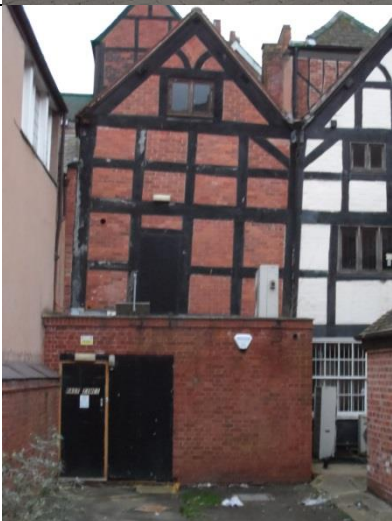
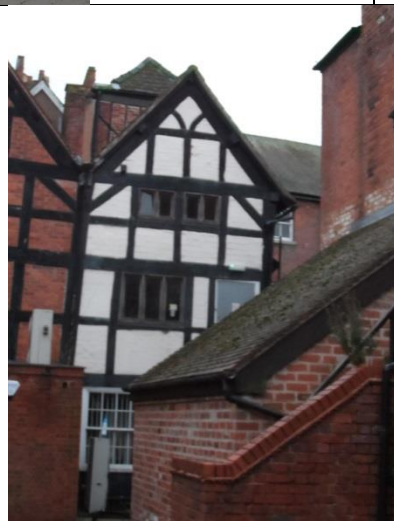
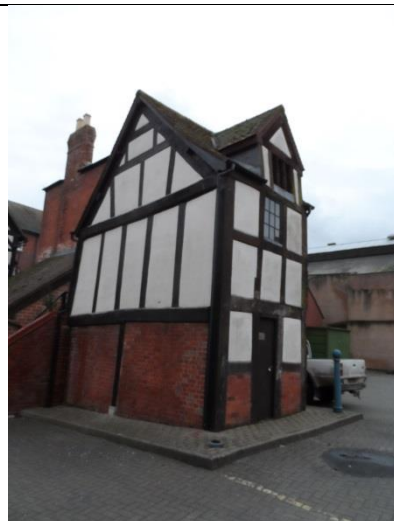
| | Ref No: HT9 | | <p><b>Description:</b> Early 18<sup>th</sup> Century front with 17<sup>th</sup> Century rear wing. Front is painted brick with a Welsh slate roof; rear is 17<sup>th</sup> Century timber framing with brick infill.</p> <p><b>HAR Assessment:</b> Good condition, however shop is vacant which places the building at ‘low risk.’</p> <p><b>Recommendations:</b> Locate tenant for shop. Continue to monitor and maintain building.</p> <h1>LOW RISK</h1> |

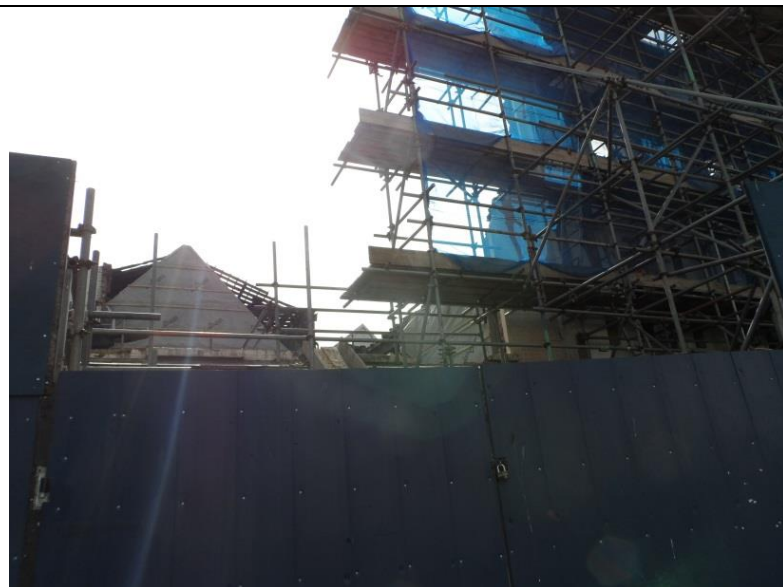
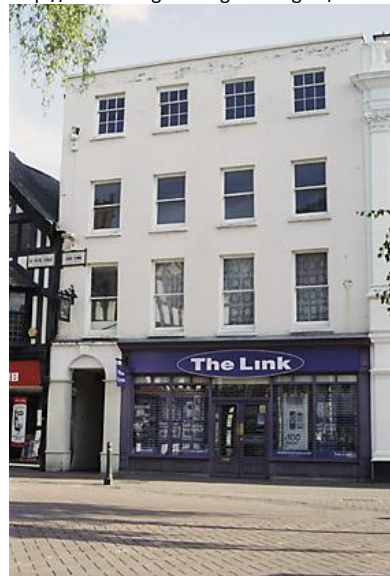
**Ref No:** HT10

**Condition:** Very bad

**HAR Assessment:** Fire to building means that much of the fabric from façade no longer remains, parts of rear wing able to be salvaged. Planning permission and listed building consent granted for repair 2 years ago, however no work has commenced.

**Recommendations:** Work needs to commence to preserve as much historic fabric as possible. A conservation approach needs to be adhered to during these works.

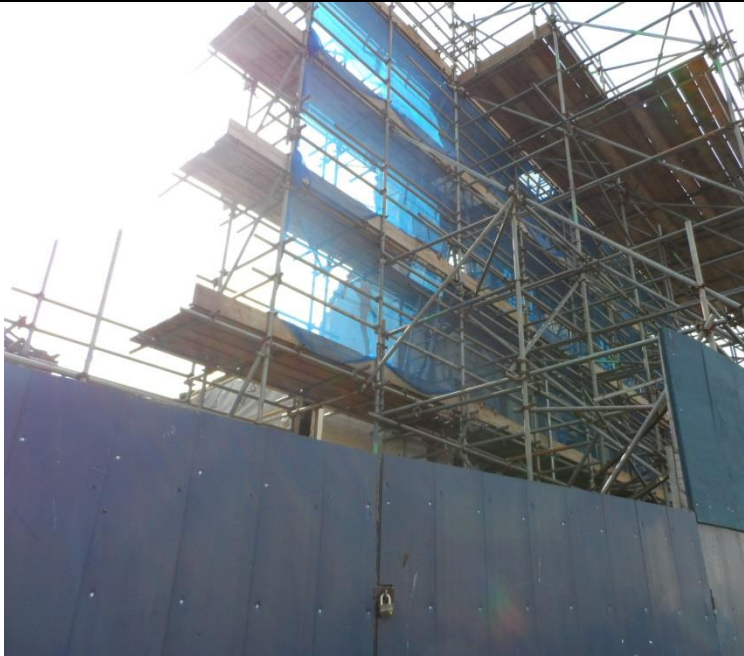
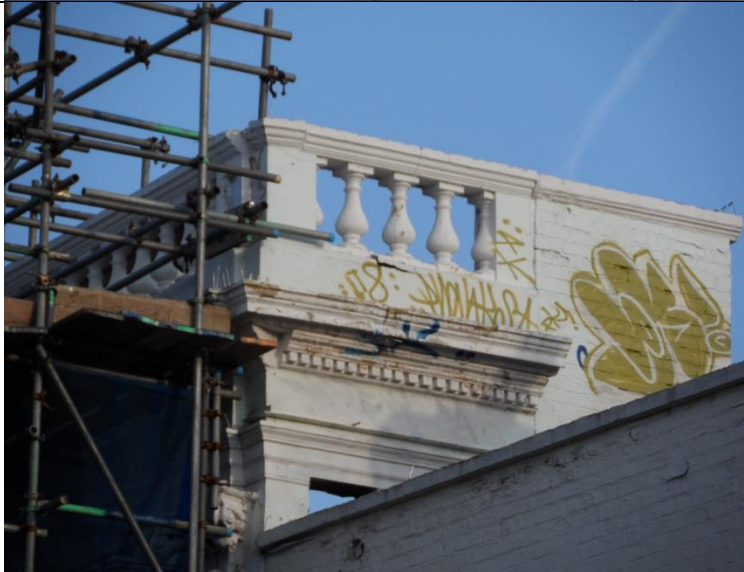
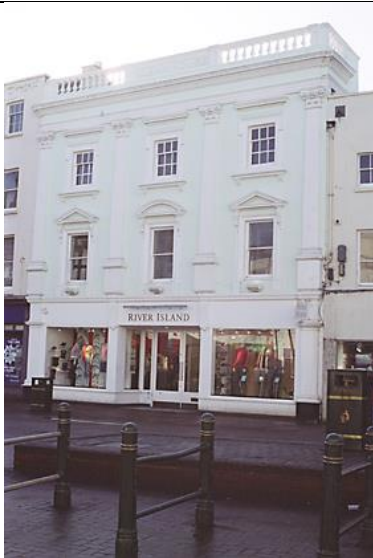
| | <b>Ref No:</b> HT11 | <p><b>Description:</b> Mid 19<sup>th</sup> Century shops with earlier 16<sup>th</sup> Century wing. 18<sup>th</sup> Century front which has been partly demolished as a result of fire. Parts of rear wing remaining.</p> <p><b>HAR Assessment:</b> Fire to building means that much of fabric from façade no longer remains, parts of rear wing able to be salvaged. Planning permission and listed building consent granted for repair 2 years ago, however no work has commenced.</p> <p><b>Recommendations:</b> Work needs to commence to preserve as much historic fabric as possible. A conservation approach needs to be adhered to during these works.</p> |
| | <b>Condition:</b> Very bad | |
| | <p>Photo of building before fire (Source: <a href="http://www.imagesofengland.org.uk/Details/Default.aspx?id=372371&amp;mode=adv">http://www.imagesofengland.org.uk/Details/Default.aspx?id=372371&amp;mode=adv</a>)</p> | |

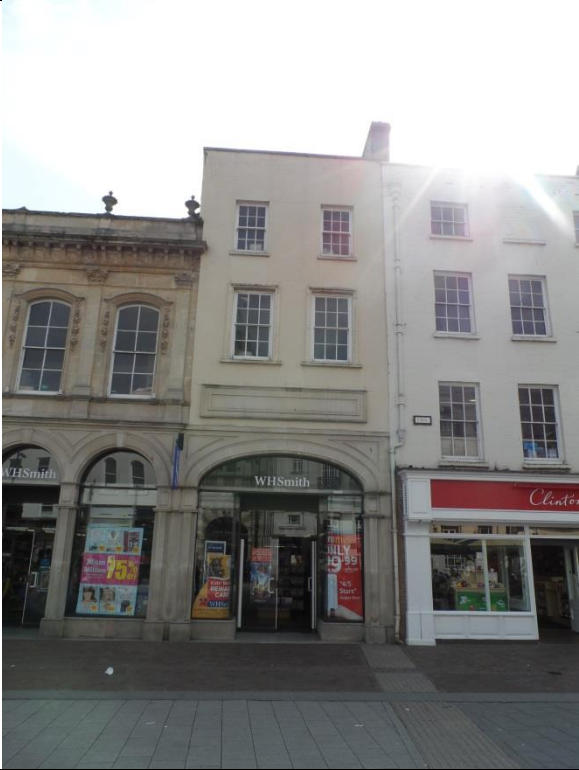
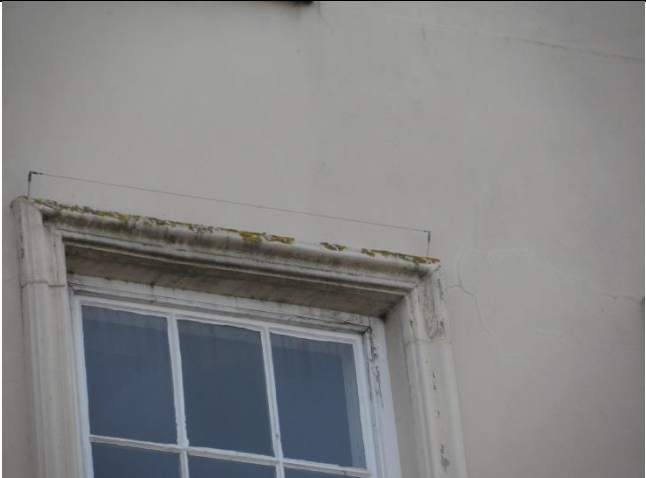
| | <b>Ref No:</b> HT14 | <p><b>Description:</b> 16<sup>th</sup> Century house, now shop. Probably altered in the 17<sup>th</sup> Century, especially internally, and re-fronted in the early 19<sup>th</sup> Century. Timber-framed with facade plastered, probably over brick; parapet hiding roof, probably of slate. Four storeys; and late 20<sup>th</sup> Century shop front.</p> <p><b>HAR Assessment:</b> window frames are deteriorating.</p> <p><b>Recommendations:</b> Repair and repaint window frames, continue to monitor and maintain building.</p> <h2>NOT AT RISK</h2> |

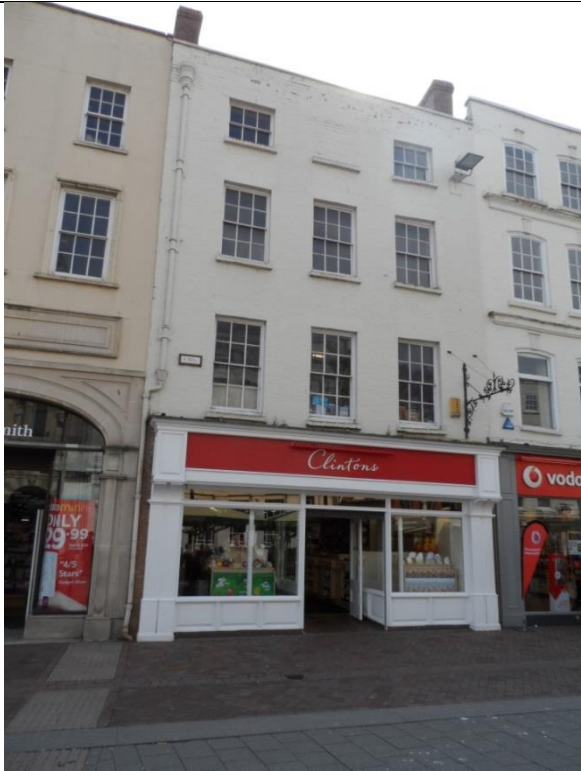
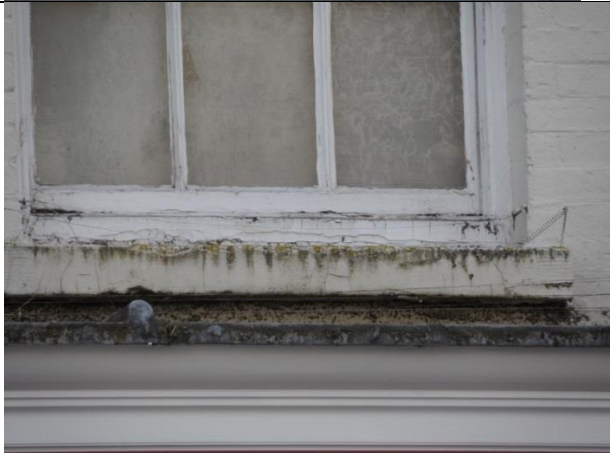
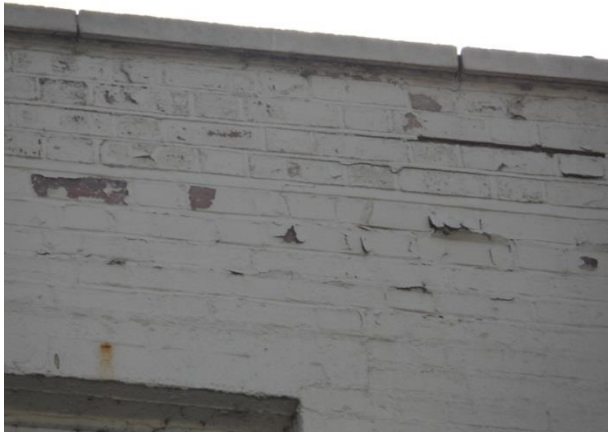
| | <b>Ref No:</b> HT15 | <p><b>Description:</b> Shop and dwelling, now shop. Late 19<sup>th</sup> Century front with Medieval origins. Four storeys, painted brick and plain tile roof and 20<sup>th</sup> Century shop front.</p> <p><b>HAR Assessment:</b> flaking and blistering paint on façade possibly caused by non-breathable paint and water penetrating coping, failed leadwork or parapet gutters blocked. Window frames and sills deteriorating.</p> <p><b>Recommendations:</b> Investigation of roof and guttering need to detect problem behind parapet. Remove paint and repaint façade with breathable paint. Repair/ re-paint window frames/ sills, continue to monitor and maintain building.</p> <p><b>LOW RISK</b></p> |
| | <b>Condition:</b> Fair | |

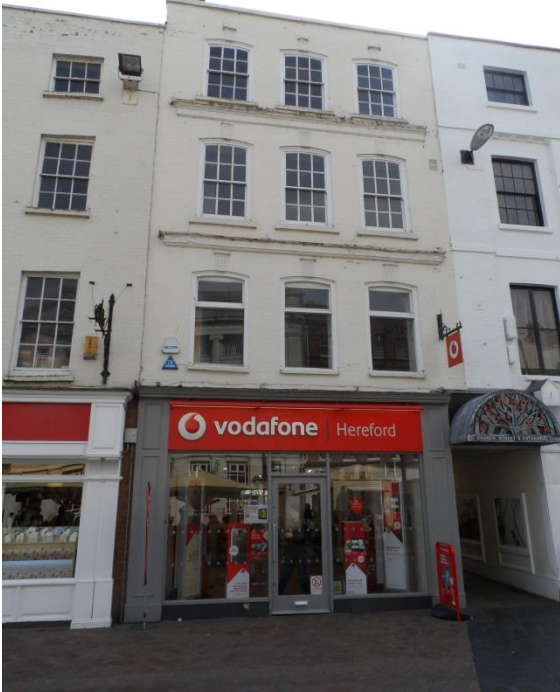
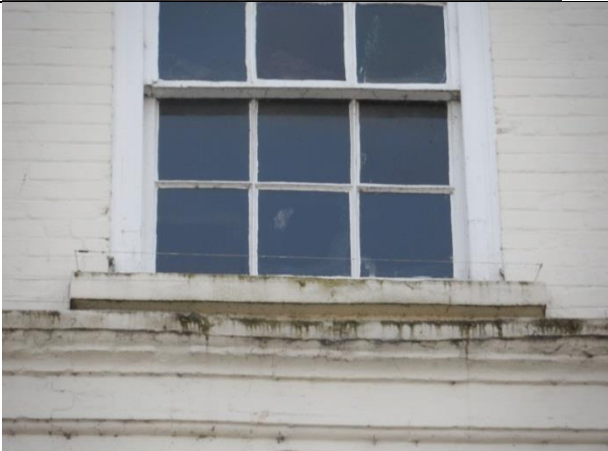
| | <b>Ref No:</b> HT16 | | <b>Description:</b> Early 18 <sup>th</sup> Century shop and dwelling, now shop. Four storeys, painted brick with hipped roof of old plain tiles and 20 <sup>th</sup> Century shop front.<br><br><b>HAR Assessment:</b> Water staining to sills and string course, likely to be caused by water build up on the façade<br><br><b>Recommendations:</b> clean and repaint façade with breathable paint, continue to monitor and maintain building.<br><br><b>NOT AT RISK</b> |

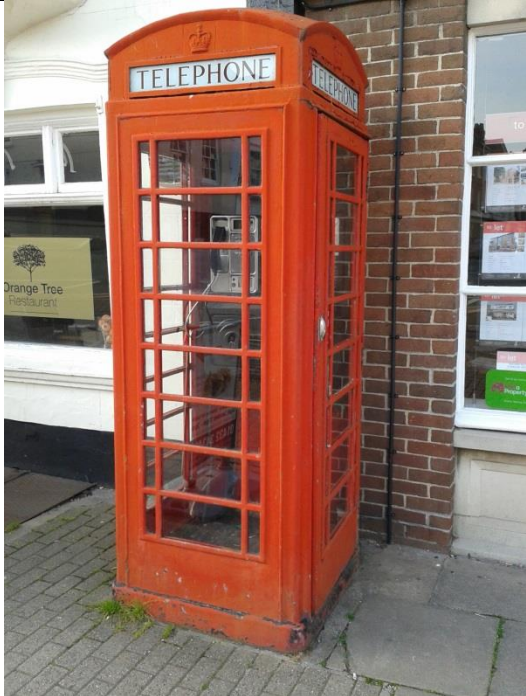
| | <b>Ref No:</b> KS3 | <p><b>Description:</b> Telephone kiosk. Type K6. Designed in 1935 by Sir Giles Gilbert Scott. Made by various contractors. Cast-iron. Square kiosk with domed roof. Unperforated crowns to top panels and margin-glazing to windows and doors.</p> <p><b>HAR Assessment:</b> Some rust and corrosion to roof and base of phone box.</p> <p><b>Recommendations:</b> Repair and repaint phone box and treat roof and base for rust. Continue to monitor and maintain.</p> <p><b>VULNERABLE</b></p> |

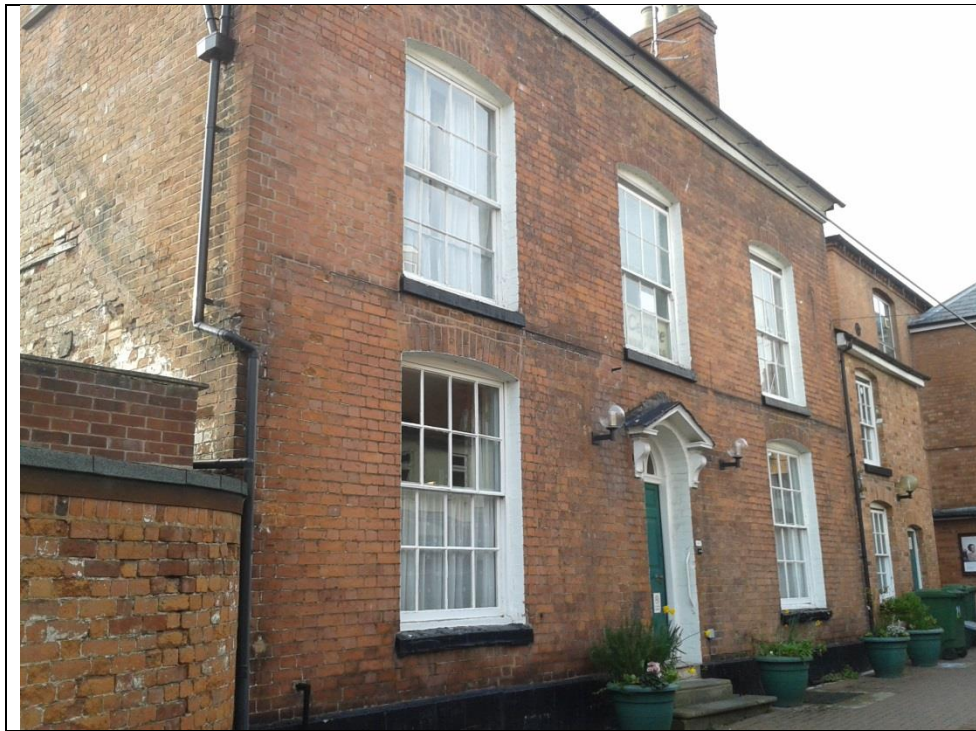
| <b>Ref No:</b> KS4 | <b>Description:</b> Late 18 <sup>th</sup> Century house, restored in 20 <sup>th</sup> Century, now flats. Brick with timber-frame and slate roof. Two storeys, attic and cellar. Rear: timber-framing.<br><br><b>HAR Assessment:</b> Good condition, not at risk<br><br><b>Recommendations:</b> Continue to monitor and maintain building.<br><br><h1>NOT AT RISK</h1> |

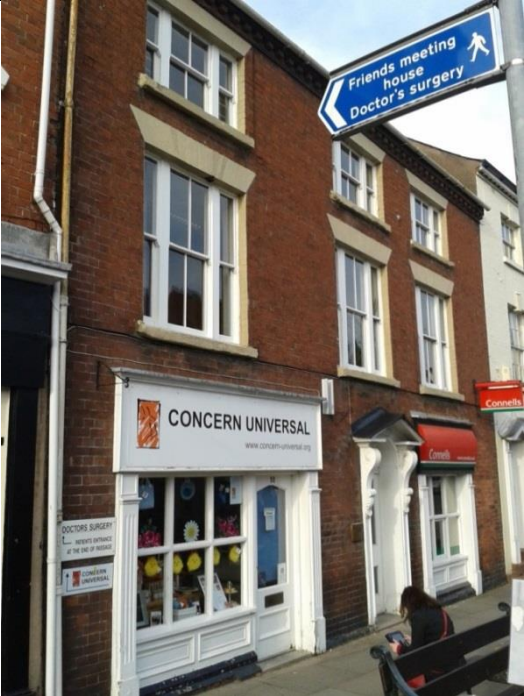
| | <b>Ref No:</b> KS5 | <p><b>Description:</b> 17<sup>th</sup> Century house, with 18<sup>th</sup> Century front, now shops and offices. Constructed of Brick with composite tile roof. Three storeys and cellar.</p> <p><b>HAR Assessment:</b> Guttering and downpipes are rusted and beyond useful life. Cracking to plinth of shopfront and deteriorating key stones.</p> <p><b>Recommendations:</b> Investigate condition of rainwater goods and repair cracks to plinth and key stones and re-paint with breathable paint, continue to monitor and maintain building.</p> <h2>NOT AT RISK</h2> |

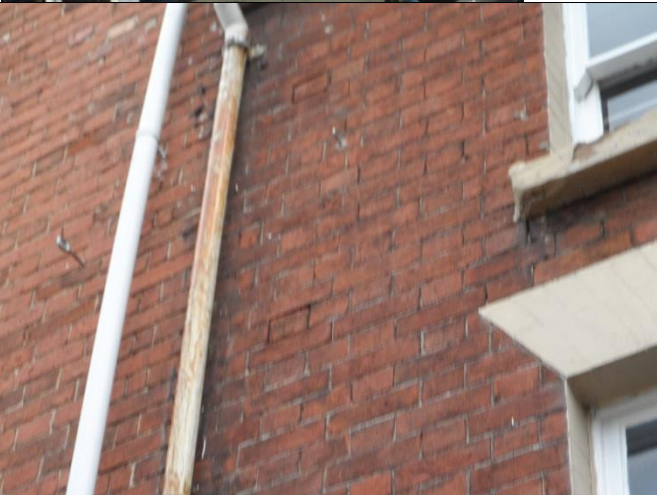
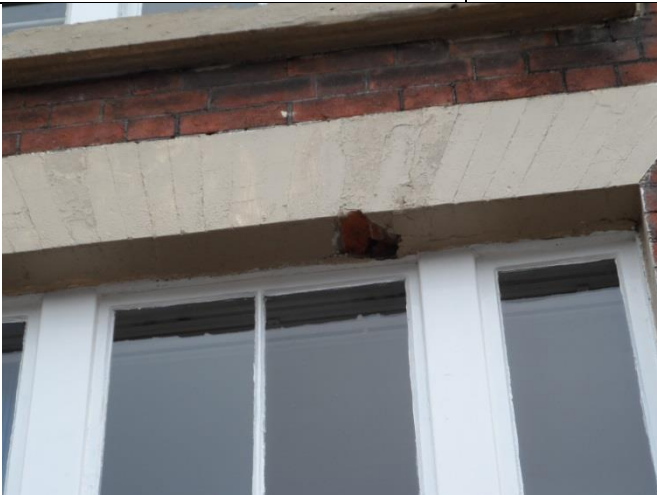
| | <b>Ref No:</b> KS6 | <b>Description:</b> Early 19 <sup>th</sup> Century Shop and dwelling. Three storeys and cellar, Painted brick and plain tile roof.<br><br><b>HAR Assessment:</b> Good condition, not at risk.<br><br><b>Recommendations:</b> Continue to monitor and maintain building.<br><br><h2>NOT AT RISK</h2> |

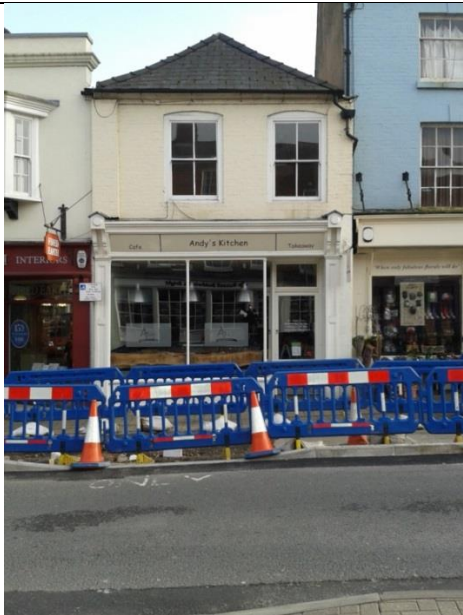
| | <b>Ref No:</b> KS8 | <b>Description:</b> 17 <sup>th</sup> Century house, with 18 <sup>th</sup> Century front, now shop and dwelling. Painted brick with hipped Welsh slate gable roof. Two storeys with attic and cellar. Late 19 <sup>th</sup> Century shop front, with recessed entrance to right.<br><br><b>HAR Assessment:</b> Good condition, not at risk<br><br><b>Recommendations:</b> Continue to monitor and maintain building.<br><br><h2>NOT AT RISK</h2> |

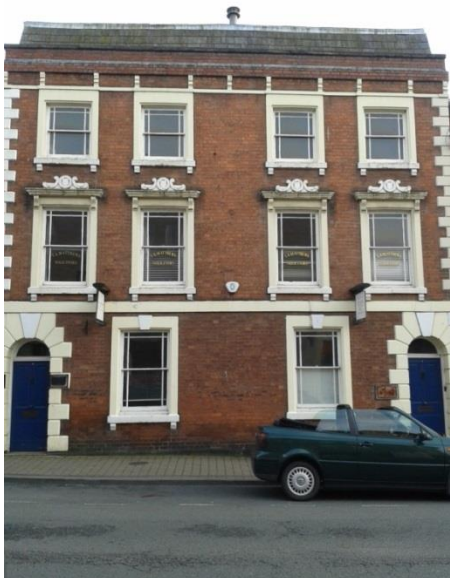
| | <b>Ref No:</b> KS9 | <b>Description:</b> Mid 19 <sup>th</sup> Century houses, now offices. Constructed of brick with a Welsh slate mansard roof. Three storeys.<br><br><b>HAR Assessment:</b> Good condition, not at risk<br><br><b>Recommendations:</b> Continue to monitor and maintain building.<br><br><h2>NOT AT RISK</h2> |

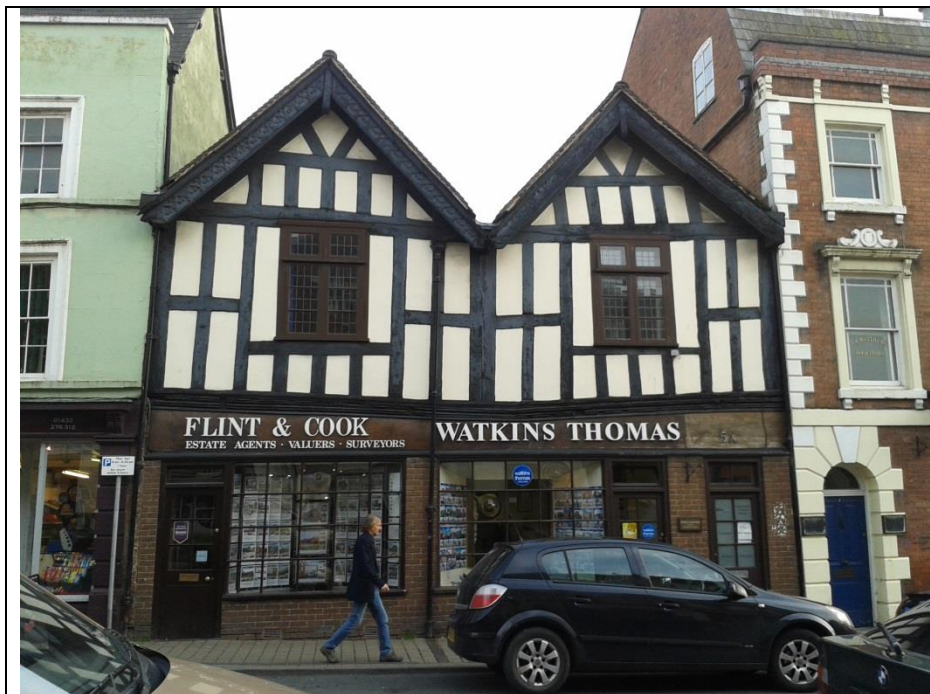
| <b>Ref No:</b> KS10 | <p><b>Description:</b> Late 15<sup>th</sup> Century house, now shop and offices. Timber-frame and plaster; twin gabled plain tile roof. Two storeys with 20<sup>th</sup> Century shop front. The house has the earliest street elevation in the City.</p> <p><b>HAR Assessment:</b> Good condition, not at risk.</p> <p><b>Recommendations:</b> Continue to monitor and maintain building.</p> <p><b>NOT AT RISK</b></p> |

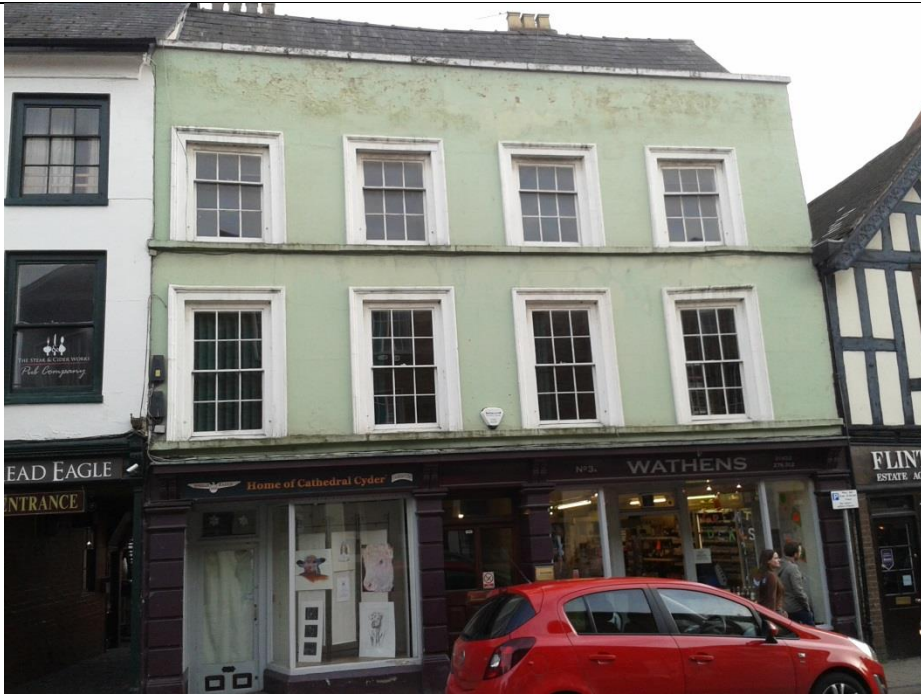
| | <p><b>Ref No:</b> KS11</p> <p><b>Address:</b> Palace Chambers, 3 &amp; 3a King Street, Hereford</p> <p><b>Designation:</b> Grade II*</p> <p><b>List Entry No:</b> 1052295</p> <p><b>Condition:</b> Fair</p> <p><b>Occupancy:</b> Occupied</p> <p><b>Owner Type:</b> Private</p> <p><b>Heritage Crime:</b> N/a</p> <p><b>Priority Category:</b> N/a</p> | <p><b>Description:</b> 17<sup>th</sup> Century houses with 19<sup>th</sup> Century front, now shops and dwelling. Three storeys, walls finished in Stucco with a steep pitched Welsh slate roof.</p> <p><b>HAR Assessment:</b> Appears to be a problem with the parapet gutter with water penetration and flaking and blistering render and paintwork. Possible causes could be blocked guttering, failed copings or leadwork.</p> <p><b>Recommendations:</b> Inspection of parapet guttering required to diagnose problem. Remove paint and re-paint façade with breathable paint. Continue to monitor and maintain building.</p> |

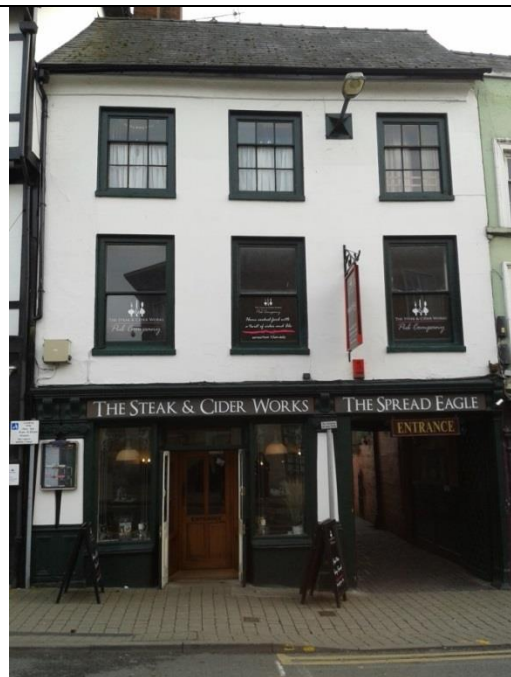
**Ref No:** KS12

**HAR Assessment:** Good condition, not at risk.

**Recommendations:** Continue to monitor and maintain building.

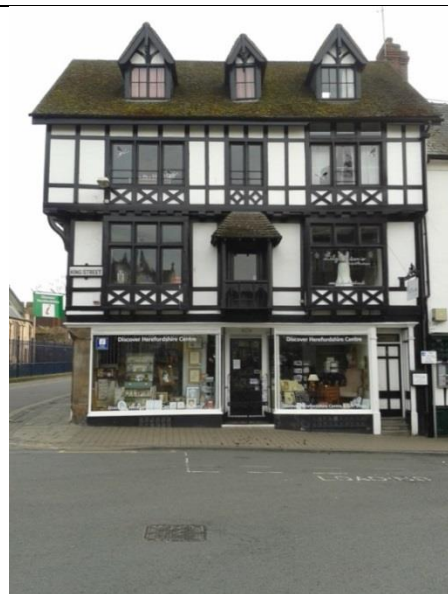
**Ref No:** KS13

**HAR Assessment:** Good condition, not at risk.

**Recommendations:** Continue to monitor and maintain building.

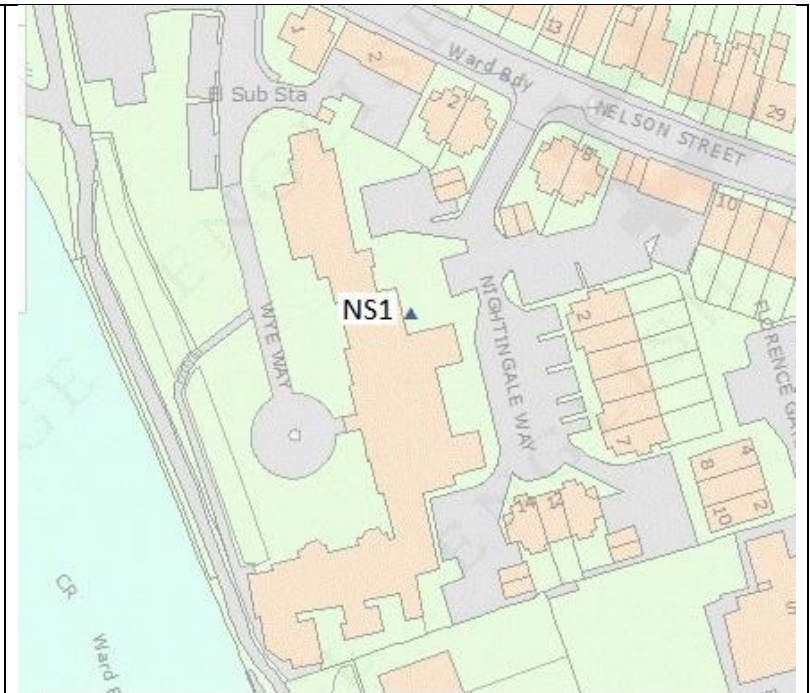
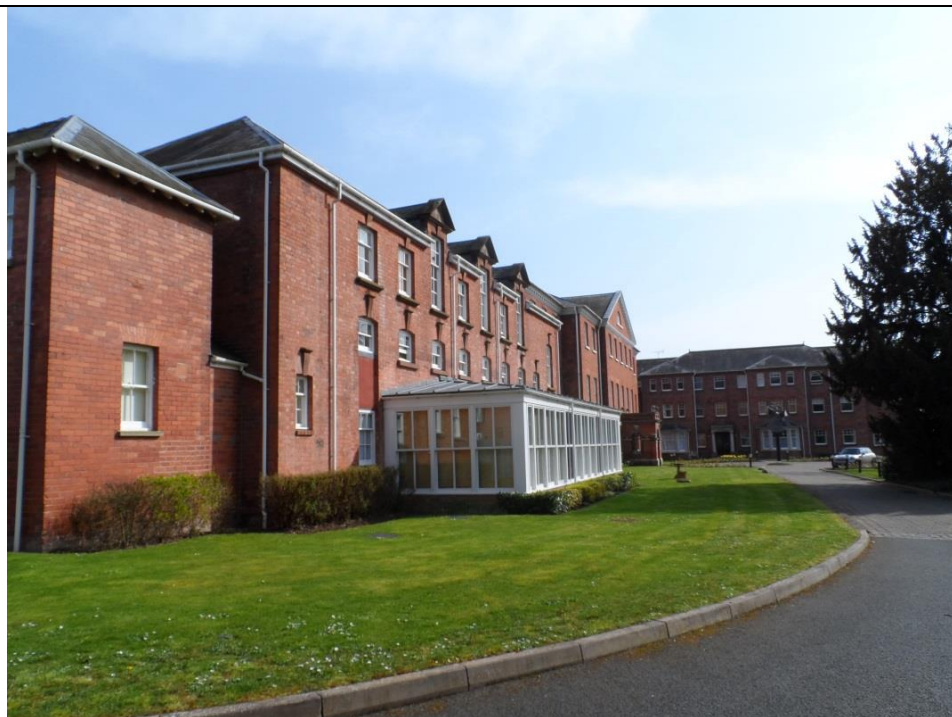
**Ref No:** NS1

**HAR Assessment:** Good condition, not at  
risk

**Recommendations:** Continue to monitor  
building and maintain building.

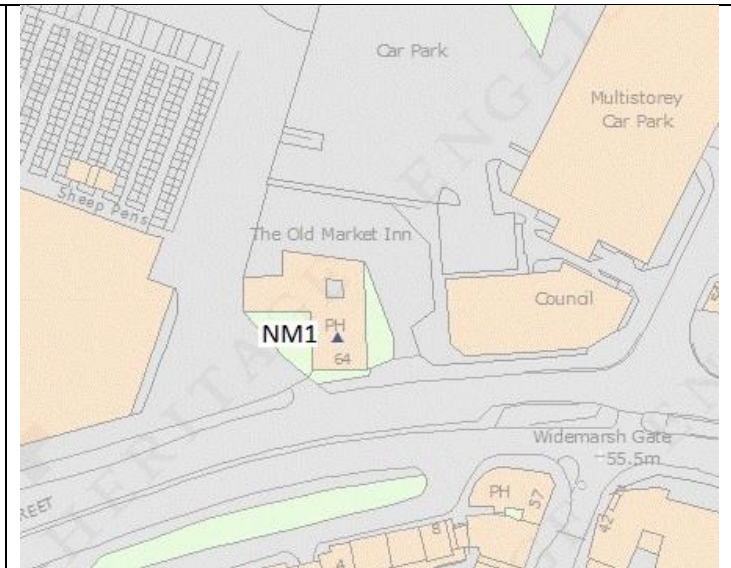
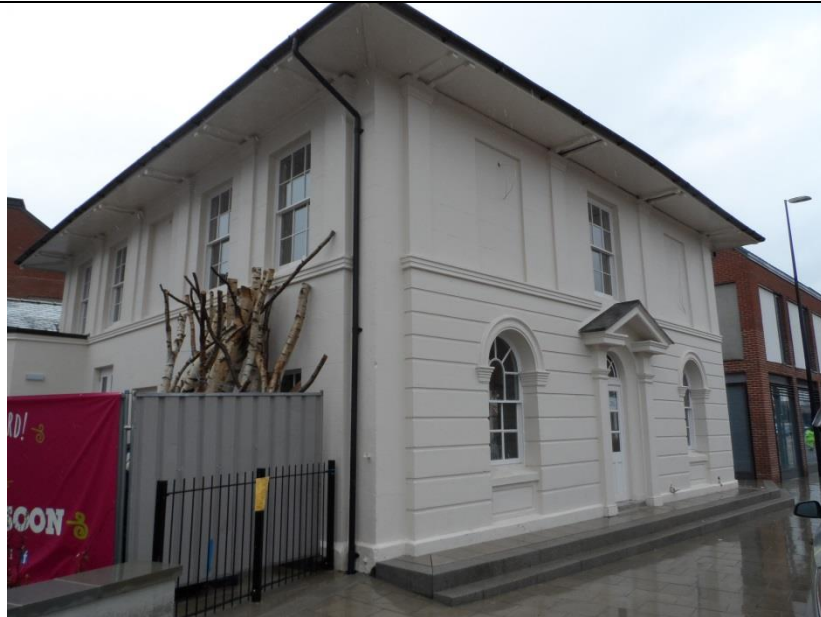
**Ref No:** NM1

**HAR Assessment:** Good Condition, not at risk

**Recommendations:**.. Continue to monitor and maintain building.

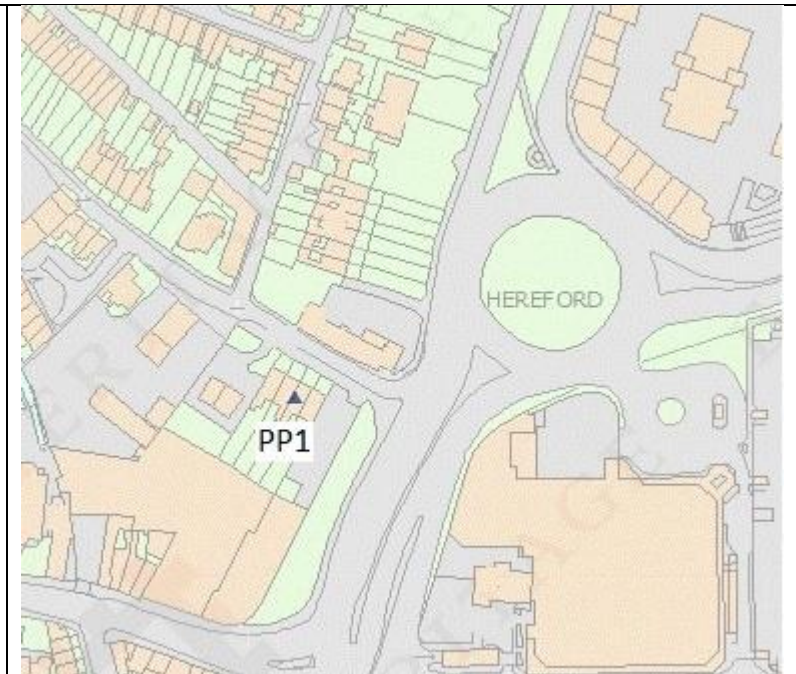
| | <b>Ref No:</b> PP1 | <b>Description:</b> Early 19 <sup>th</sup> Century houses. Constructed of brick with stone plinth and hipped slate roof; painted storeyband.<br><br><b>HAR Assessment:</b> Rear window frames deteriorating.<br><br><b>Recommendations:</b> Repair and repaint window frames, continue to monitor and maintain building.<br><br><h1>NOT AT RISK</h1> |

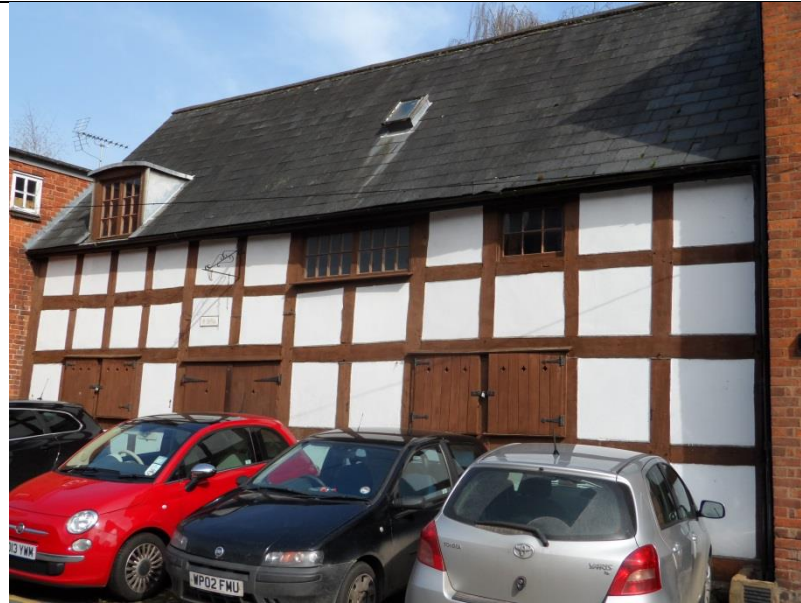
| <b>Ref No:</b> QS2 |

| <p><b>Description:</b> Stable wing to St Ethelbert's, now Cathedral School tuck shop. C17 timber-frame and render; Welsh slate roof. 2 storeys; various 20<sup>th</sup> Century casements; lead roofed box-dormer.</p> <p><b>HAR Assessment:</b> slates slipping from roof.</p> <p><b>Recommendations:</b> Repair/re-attach slates and continue to monitor and maintain building.</p> <p><b>NOT AT RISK</b></p> |

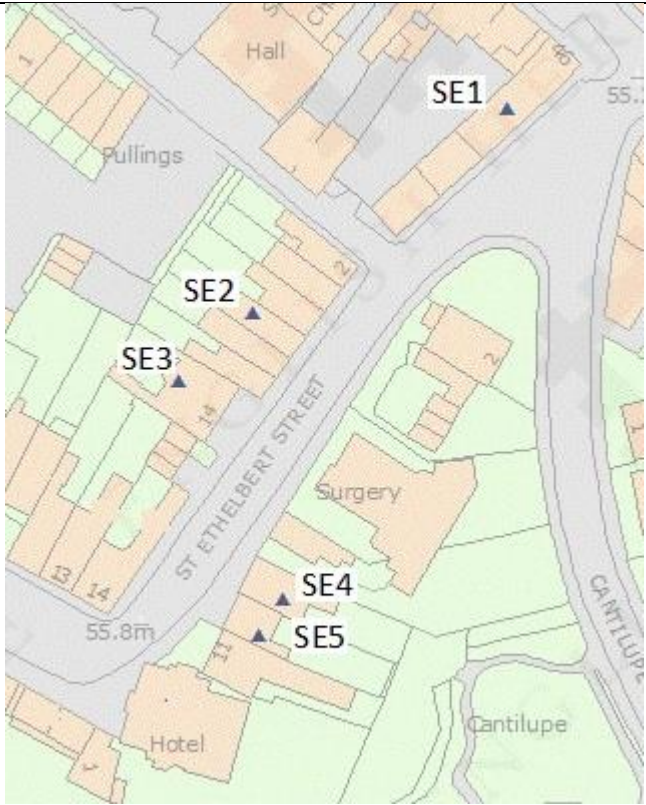
| | <b>Ref No:</b> SE1 | <p><b>Description:</b> Service wing and outbuildings of Chandos House, St Owen Street, now shops and flats. Early 18<sup>th</sup> Century and partly rebuilt in the 20<sup>th</sup> Century. Constructed in Brick with welsh slate roof. Some 20<sup>th</sup> Century elements such as entrances and casements.</p> <p><b>HAR Assessment:</b> Various chipped bricks along main façade, gable end has structural cracks, chipped bricks and areas of damp.</p> <p><b>Recommendations:</b> Investigations into structural soundness of gable end is needed to investigate cracking and damp issues.</p> <p><b>LOW RISK</b></p> |

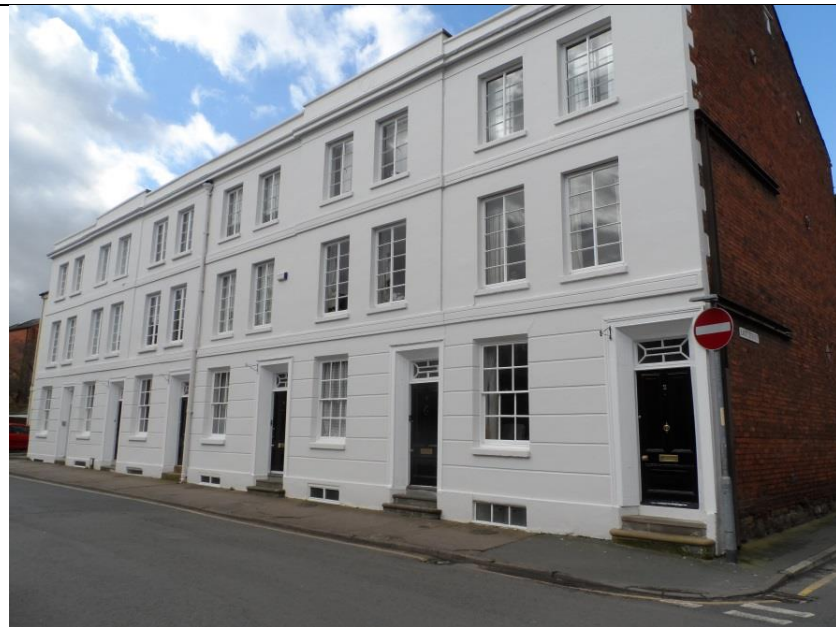
**Ref No:** SE2

**HAR Assessment:** Good condition, not at risk

**Recommendations:** Continue to monitor and maintain building.

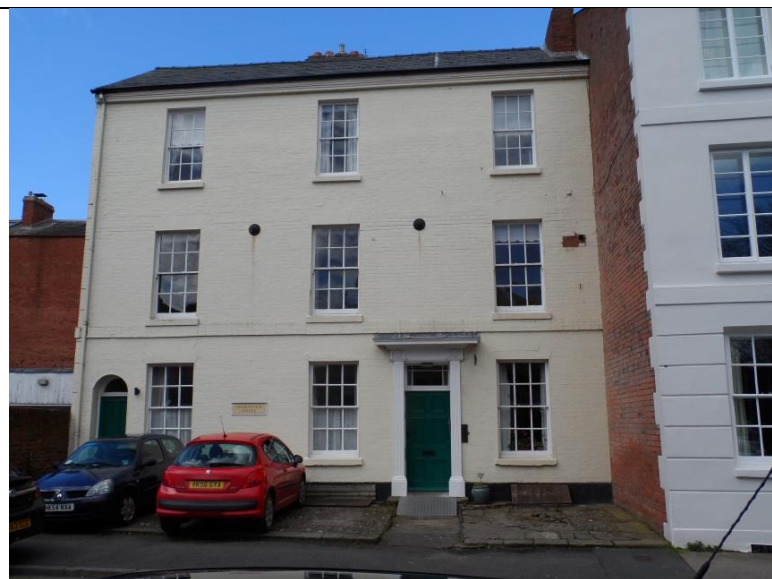
**Ref No:** SE3

**HAR Assessment:** Good condition, not at risk.

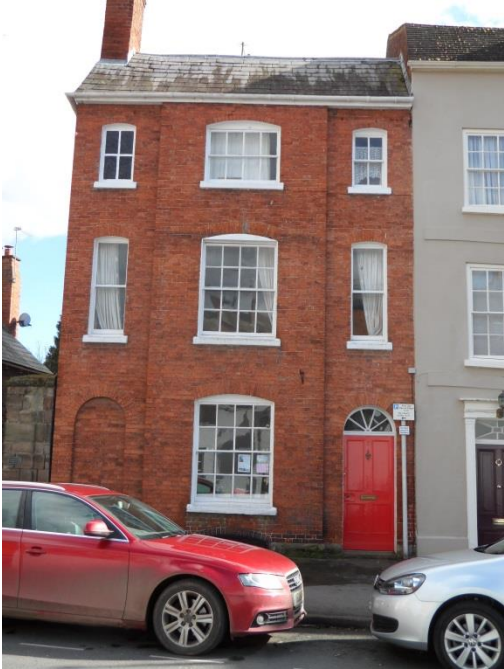
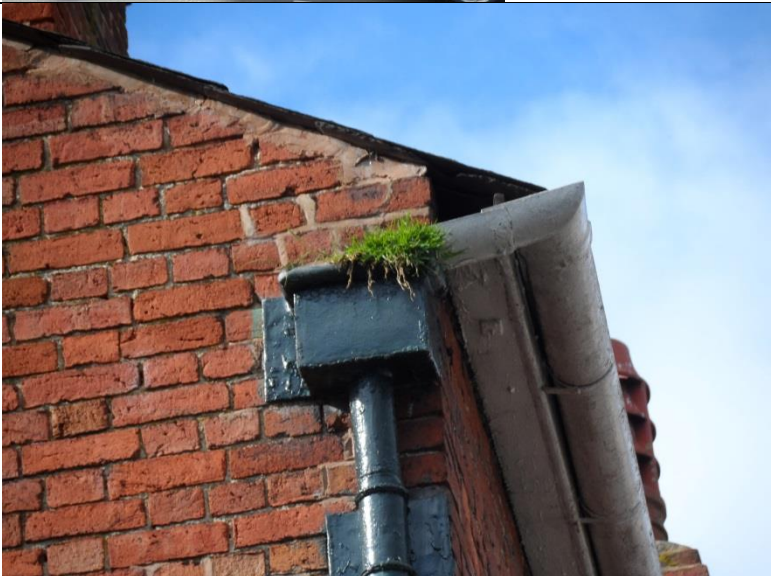
| | <b>Ref No:</b> SE4 | <b>Description:</b> Late 18th Century house, constructed of brick with a Welsh slate roof. Three storeys and cellar. Central bay contains old glass, with end bays of plain 20th century sash windows.<br><br><b>HAR Assessment:</b> There is a blocked hopper box to downpipe which has weed growth.<br><br><b>Recommendations:</b> Unblock hopper box and clear weeds. Continue to monitor and maintain building.<br><br><b>NOT AT RISK</b> |

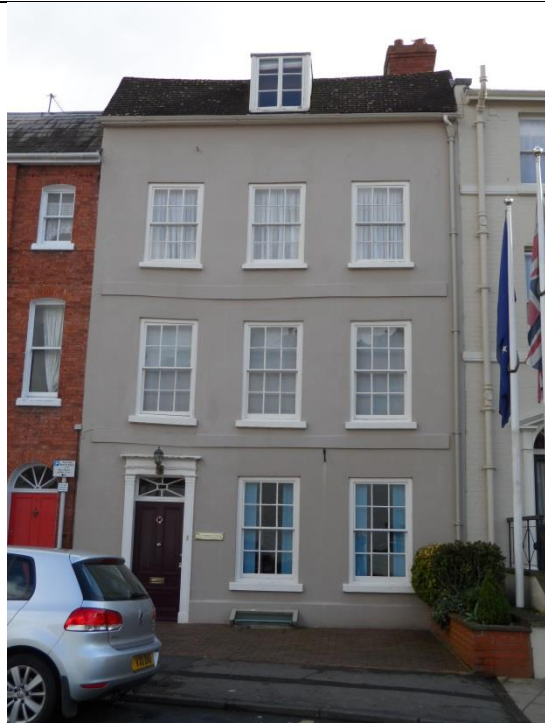
| <b>Ref No:</b> SE5 | <b>Description:</b> Mid 18 <sup>th</sup> Century house constructed of brick with cement render. Three storeys with cellar and 20 <sup>th</sup> Century dormer.<br><br><b>HAR Assessment:</b> Good condition, not at risk.<br><br><b>Recommendations:</b> Continue to monitor and maintain building.<br><br><h2>NOT AT RISK</h2> |

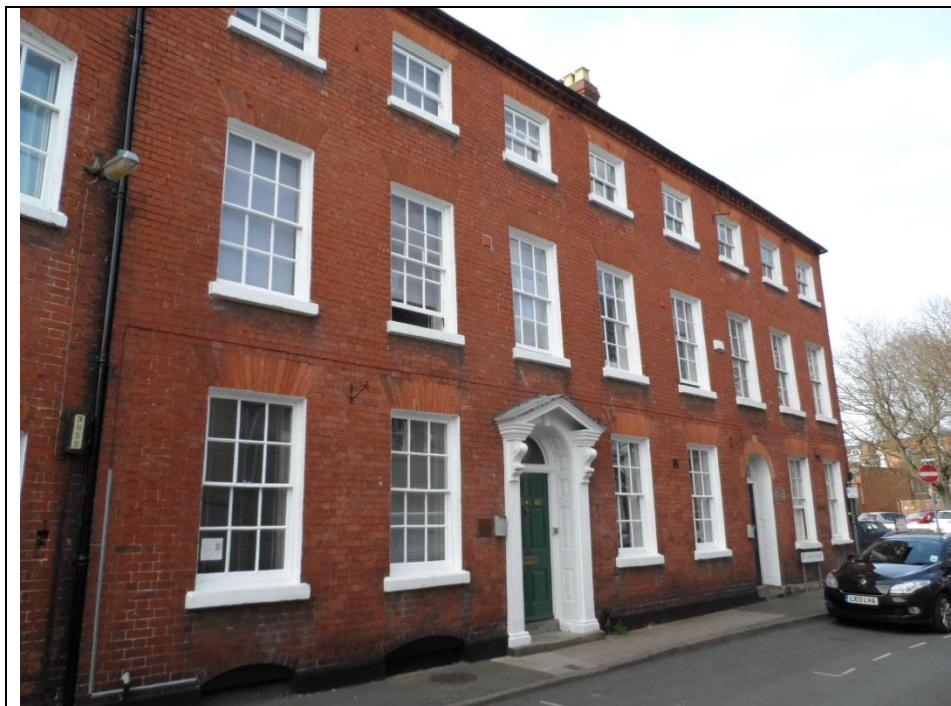
| <b>Ref No:</b> SJ1 | <b>Description:</b> Late 18 <sup>th</sup> Century houses to early 18 <sup>th</sup> Century core. Constructed of brick, with slate roof.<br><br><b>HAR Assessment:</b> Good condition, not at risk<br><br><b>Recommendations:</b> Continue to monitor and maintain building.<br><br><h1>NOT AT RISK</h1> |
