# Preventative Conservation & Maintenance Theory; its application to the Hereford City Conservation Area. Part 2 - Appendices

**August 2014**

**JS Conservation Management  
& Town Planning Ltd**  
t: 07741091719  
e: [john@jsconservationplanning.com](mailto:john@jsconservationplanning.com)  
w: [www.jsconservationplanning.com](http://www.jsconservationplanning.com)

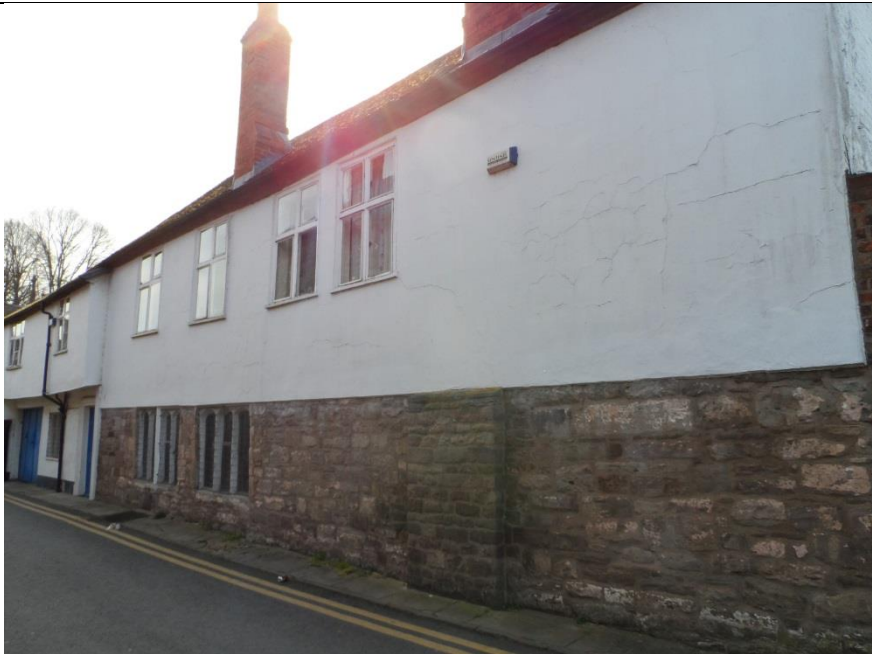
| | <b>Ref No:</b> SJ3 | <b>Description:</b> 17 <sup>th</sup> Century house, including probable former outbuilding, possibly to earlier core. Constructed of stone rubble; with 19 <sup>th</sup> and 20 <sup>th</sup> Century render; plain tile roof with 2 ridge lines.<br><br><b>HAR Assessment:</b> Large amounts of cracking to render.<br><br><b>Recommendations:</b> Render may be cracking as a result of not being breathable and allowing water to escape. Investigate render and repair if necessary with breathable render. Continue to monitor and maintain building.<br><br><b>LOW RISK</b> |

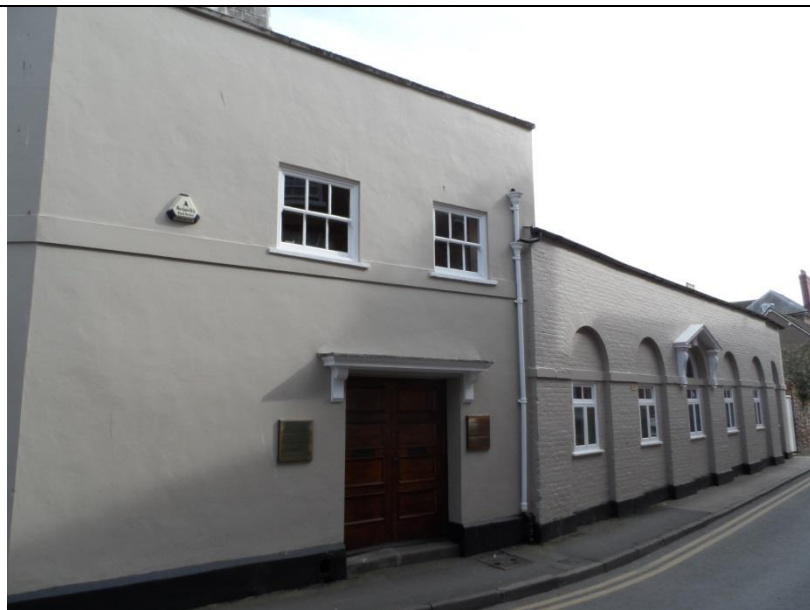
**Ref No:** SJ4

**HAR Assessment:** Good condition, not at risk.

**Recommendations:** Continue to monitor and maintain building.

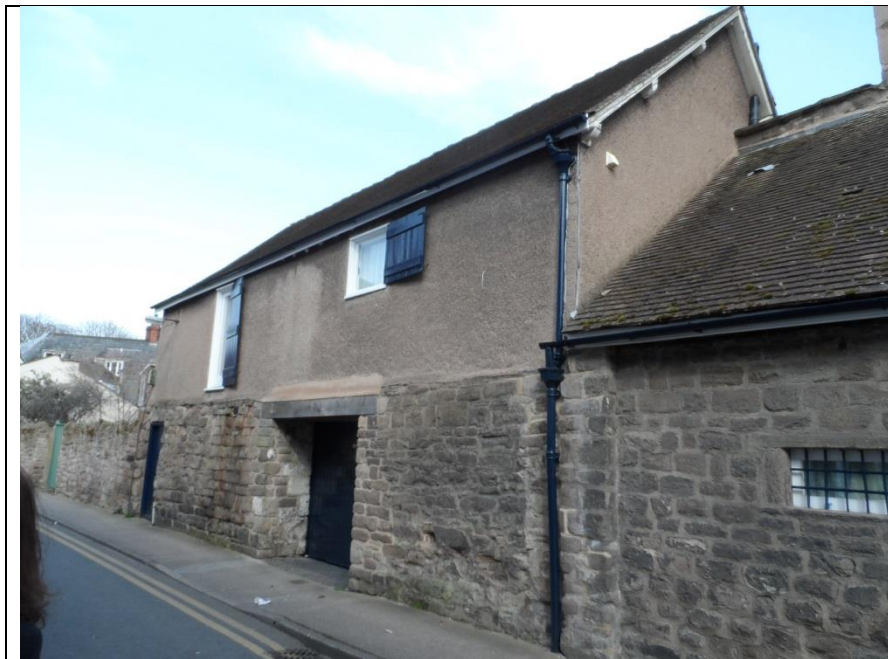
**Ref No:** SJ5

**HAR Assessment:** Exterior showing signs of damp (interior not inspected), poor past pointing repairs to stone.

**Recommendations:** Investigate and Correct damp issues and seek opportunities to correct past repairs with a breathable mortar.

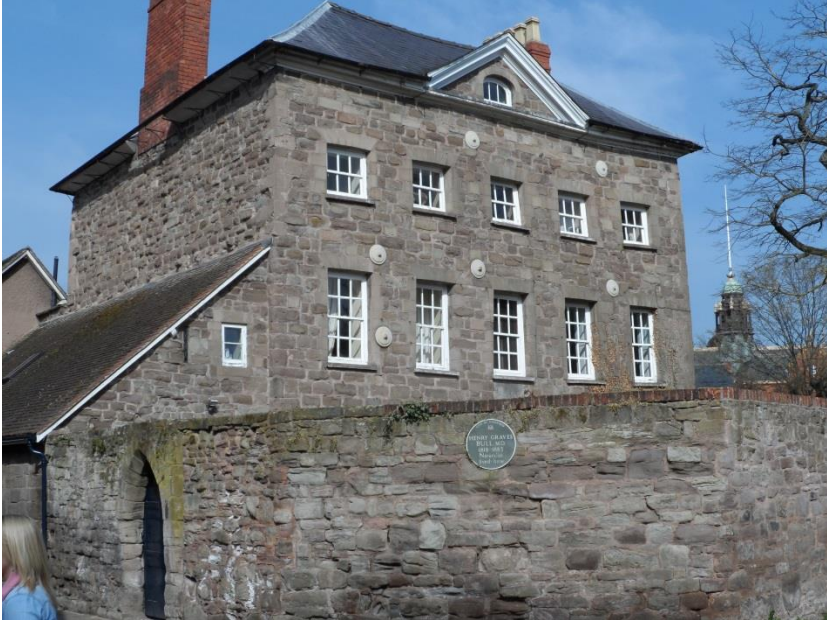
| | <b>Ref No:</b> SJ6 | <b>Description:</b> House circa 1739 front to C16/C17 core. Constructed of coursed sandstone rubble with hipped Welsh slate roof. Three storeys with single storey 19 <sup>th</sup> Century lean-to. This was the home of the naturalist Henry Graves Bull, 1818-85.<br><br><b>HAR Assessment:</b> Good condition, not at risk<br><br><b>Recommendations:</b> Continue to monitor and maintain building.<br><br><h1>NOT AT RISK</h1> |

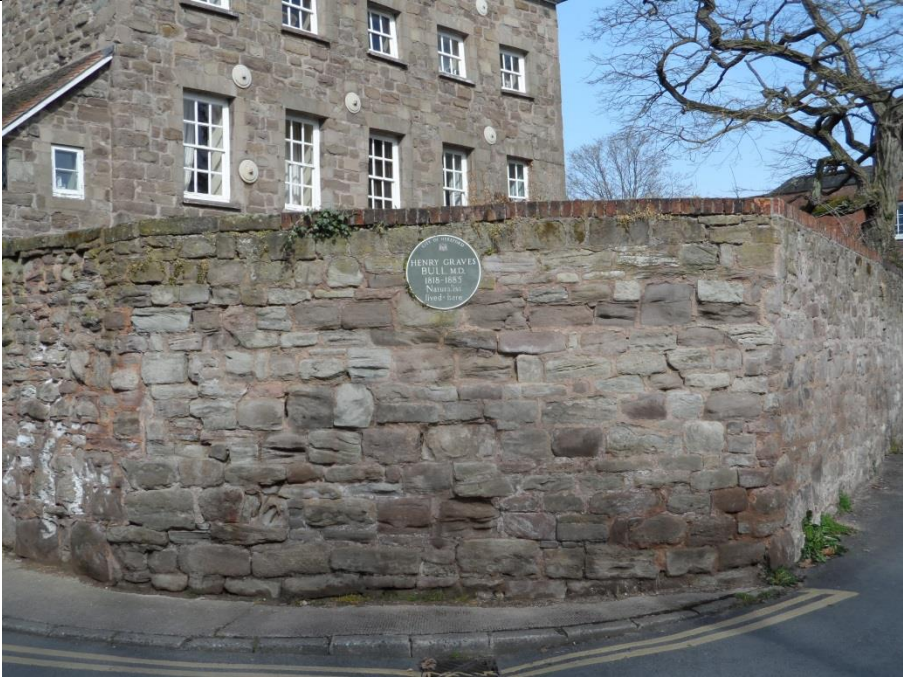
| | <b>Ref No:</b> SJ7 | <b>Description:</b> 18 <sup>th</sup> Century boundary wall constructed of coursed sandstone rubble with brick coping. Wall has 5-panelled door with pointed head in ashlar pointed arch. 2-3m high, extends to south and east for approximately 80m.<br><br><b>HAR Assessment:</b> wall beginning to show signs of lack of maintenance – weed growth in various places.<br><br><b>Recommendations:</b> Treat weeds with herbicide and continue to monitor and maintain.<br><br><h1>NOT AT RISK</h1> |

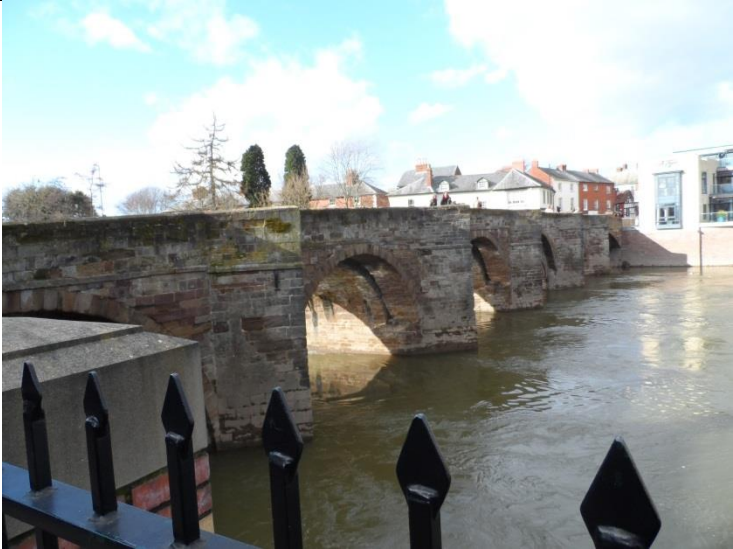
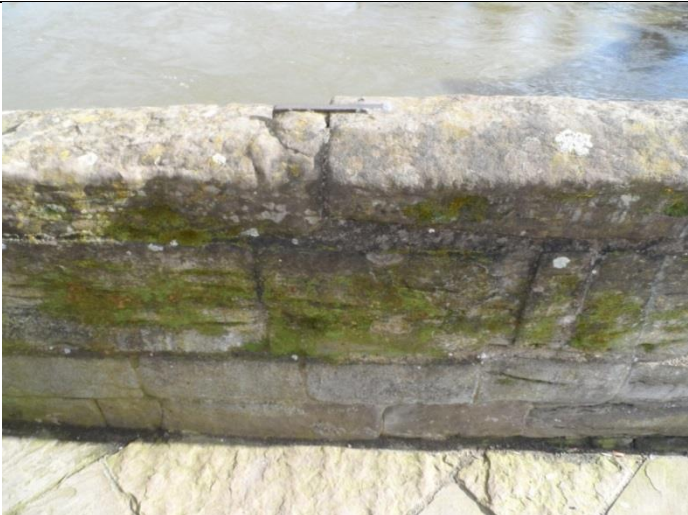
| | <b>Ref No:</b> SM1 | <p><b>Description:</b> Late 15<sup>th</sup> Century bridge, widened in 1826. Constructed of Ashlar sandstone with 6 arches, 1 rebuilt in the 17<sup>th</sup> Century.</p> <p><b>SAM Assessment:</b> As the building/ structure forms a significant component of the site, it is assessed under the 'buildings and structures at risk' criteria.</p> <p><b>HAR Assessment:</b> Some signs of moss growth, however due to the water environment this would be difficult to avoid – evidence of past repairs appear to be still appropriate.</p> <p><b>Recommendations :</b> Continue to monitor and maintain.</p> <p><b>VULNERABLE</b></p> |

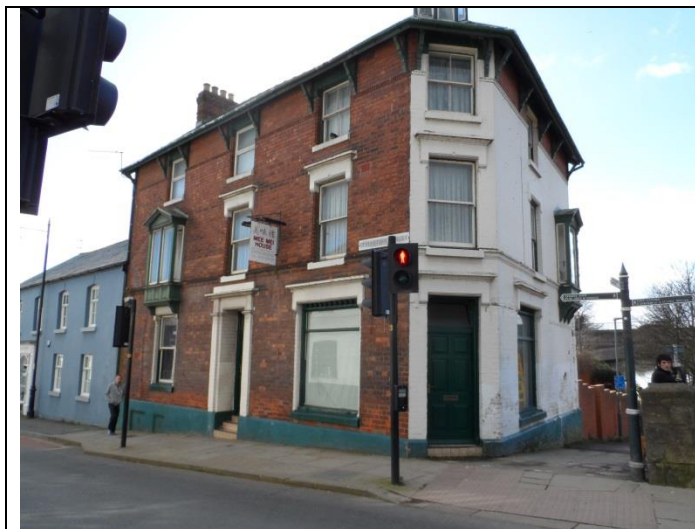
**Ref No:** SM2

**HAR Assessment:** Fair condition with evidence of neglect such as cracks in string course, chipped paint, deteriorating guttering and pigeons nesting under eaves.

**Recommendation:** repair/replace guttering, and repair holes under eaves to prevent birds nesting. Façade requires repainting in a breathable paint.

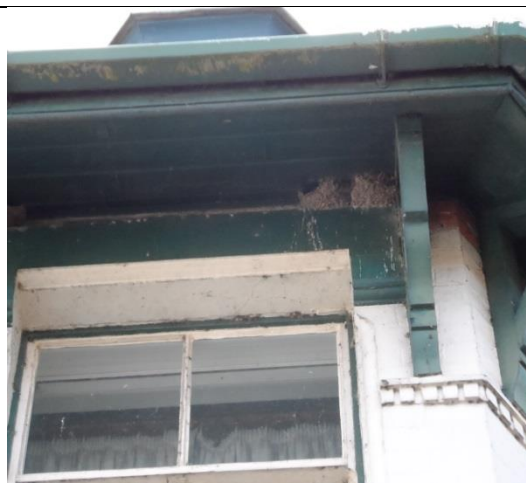
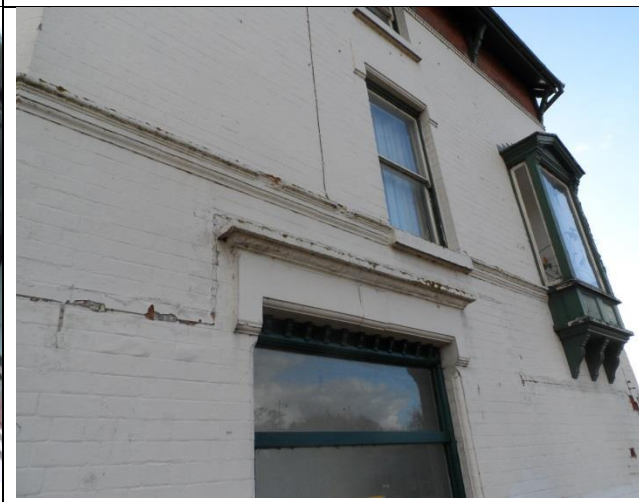
| | <b>Ref No:</b> SM3 | <b>Description:</b> Early 19 <sup>th</sup> Century houses with painted brick, and a Welsh slate roof. Two storeys and cellar.<br><br><b>HAR Assessment:</b> Good condition, not at risk<br><br><b>Recommendation:</b> Continue to monitor and maintain building.<br><br><h2>NOT AT RISK</h2> |

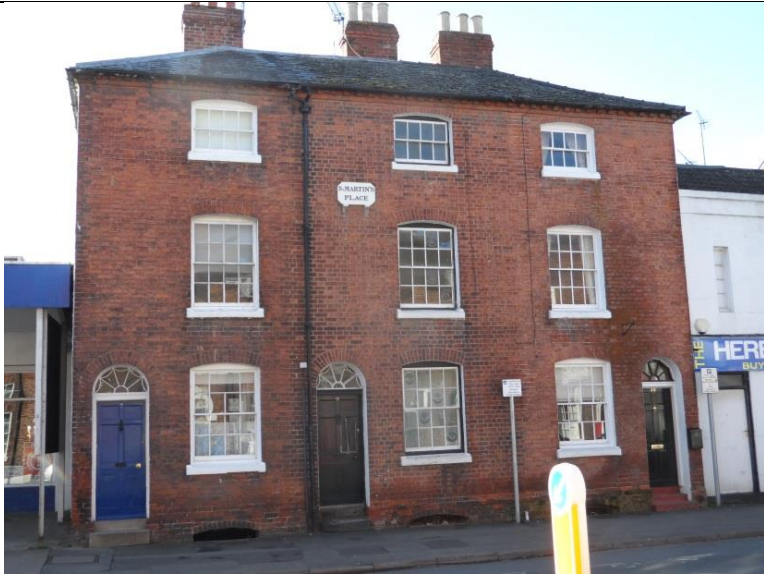
**Ref No:** SM6

**HAR Assessment:** Cracking to door and cellar is missing cover.

**Recommendation:** Repair door and replace cellar cover.

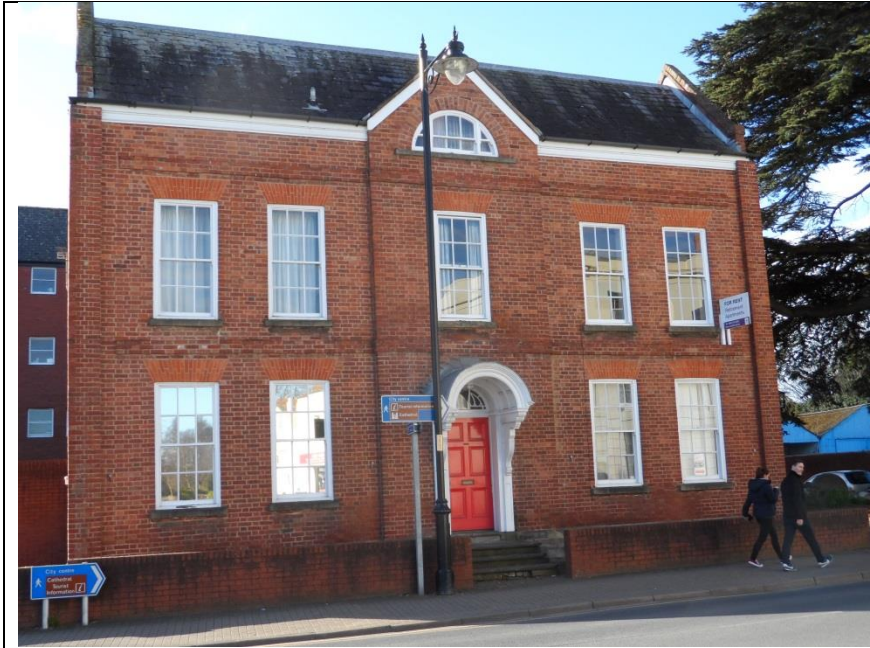
| <b>Ref No:</b> SM7 | <p><b>Description:</b> Mid 18<sup>th</sup> Century House, now day centre and warden's flat. Completely restored circa 1980. Constructed of Brick with stone plinth and graduated Welsh slate roof, Two storeys and attic. Stone tablet: "B &amp; I Bird 1742"; wall, now part of lean-to, continues to right. Similar left returned side.</p> <p><b>HAR Assessment:</b> Good condition, not at risk</p> <p><b>Recommendations:</b> Continue to monitor and maintain building.</p> <p><b>NOT AT RISK</b></p> |

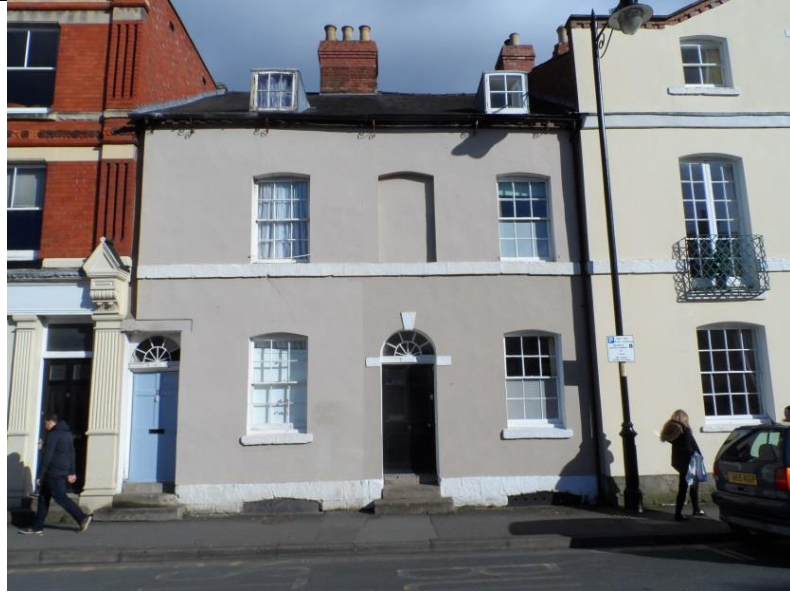
| <b>Ref No:</b> SM8 |

| <b>HAR Assessment:</b> Left dormer window deteriorating. |

| <b>Recommendations:</b> Repair and re-paint dormer window. Continue to monitor and maintain building. |

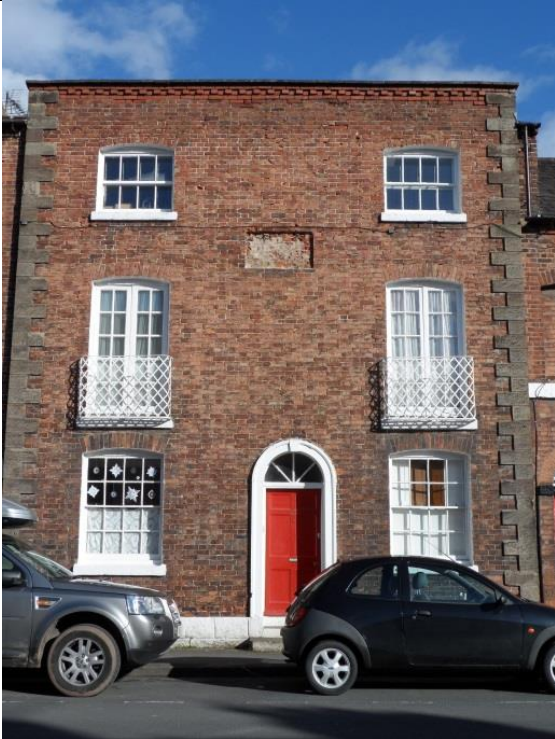
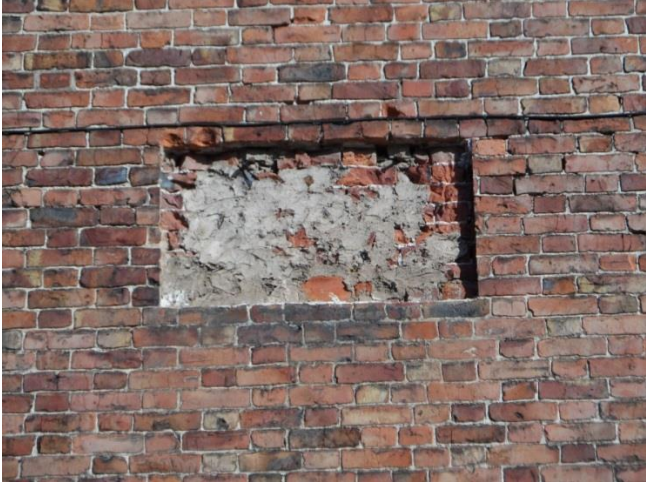
| | | <b>Ref No:</b> SM11 | <p><b>Description:</b> Early 19<sup>th</sup> Century house. Three storeys and cellar, constructed of brick with slate roof. Stone plinth and quoins; weathered sandstone tablet: "Norfolk House".</p> <p><b>HAR Assessment:</b> Stone tablet removed but not repaired and replaced.</p> <p><b>Recommendations:</b> Replace stone tablet, continue to monitor and maintain building.</p> <p><b>NOT AT RISK</b></p> |
| | | <b>Heritage Crime:</b> Stone tablet removed | |

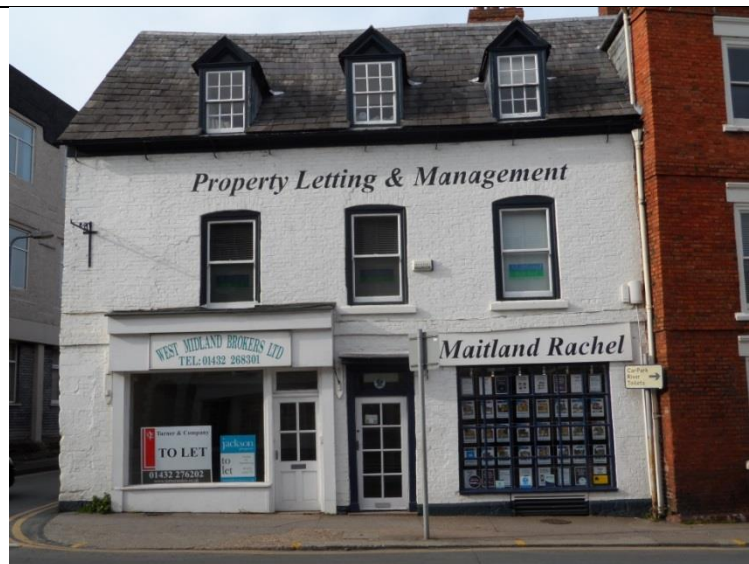
**Ref No:** SN2

**HAR Assessment:** Good condition, shop is vacant which places building up the scale to 'low risk.'

**Recommendations:** Seek tenants, and continue to monitor and maintain building.

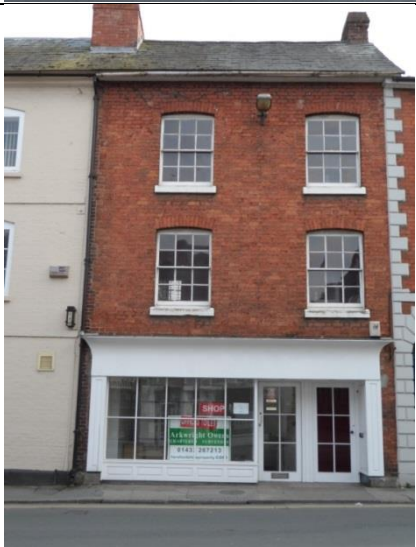
| | <b>Ref No:</b> SN4 | <p><b>Description:</b> Early 19<sup>th</sup> Century house, now offices. Three storeys, constructed of brick with a slate roof. 20<sup>th</sup> Century shopfront with stone plinth.</p> <p><b>HAR Assessment:</b> Guttering is rusted and deteriorating, detached from façade. Shop and upper floors vacant.</p> <p><b>Recommendations:</b> Install new guttering and find tenancy for property. Continue to monitor and maintain building.</p> <p><b>LOW RISK</b></p> |

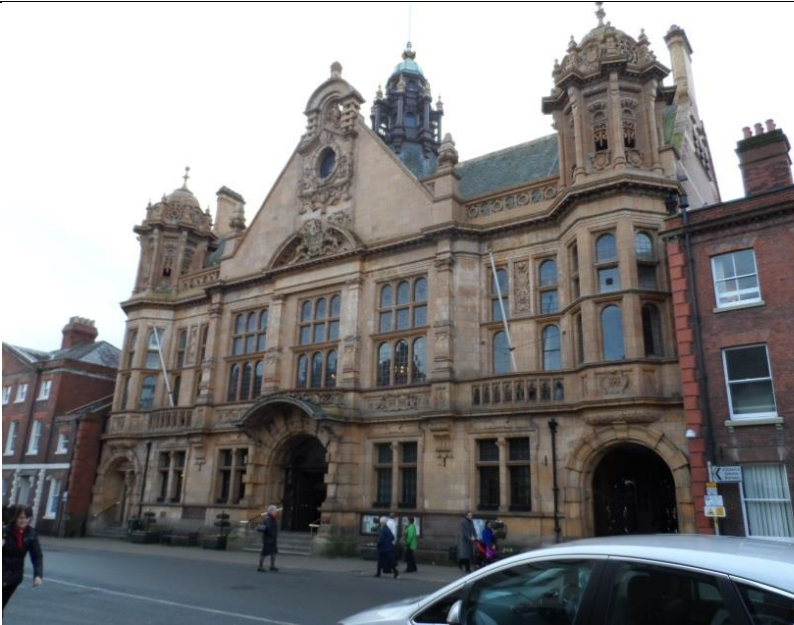
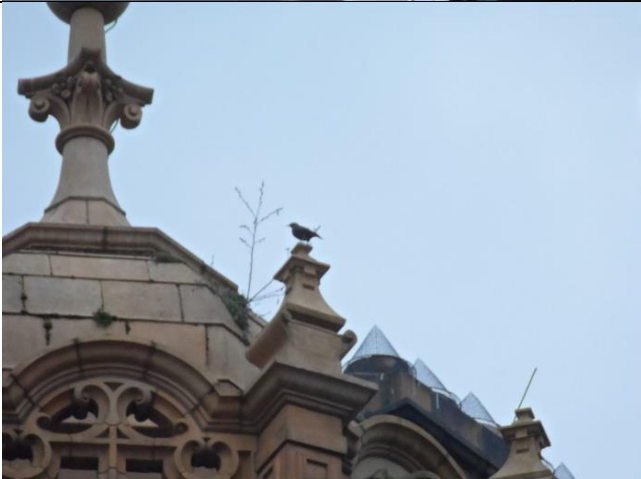
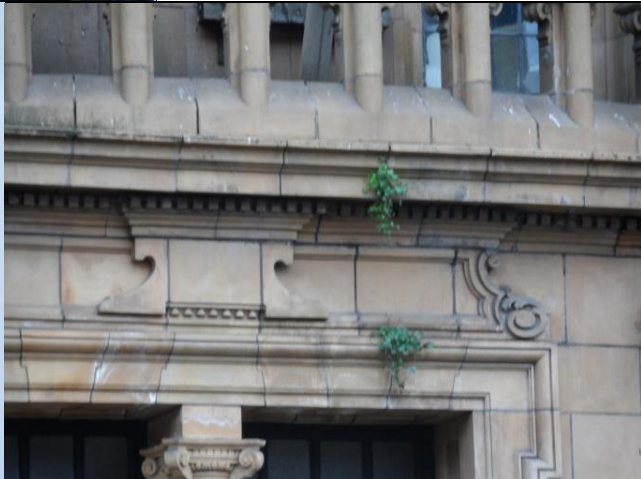
| | <b>Ref No:</b> S02 | <p><b>Description:</b> Town Hall constructed circa 1904 by HA Cheers. Builder WJ Bowers. Terracotta; brick; slate roof. Symmetrical 2 storeys with 7-window range. Central doorway with rusticated pillars and round-headed arch. Large central gable with civic crest and oculus; balustrading. Richly ornamented with banding, pilasters, finials, scrollwork, figures. Elaborate wooden lantern with columns, dome and flagpole. Ornamental iron gates with balcony and railings.</p> <p><b>HAR Assessment:</b> fair condition however experiencing problems due to pigeons nesting. Lack of general maintenance to façade with lanterns having weed growth. <b>Recommendations:</b> removal of weed and moss growth to front façade and application of herbicide, control pigeon nesting with netting or other means</p> <p><b>LOW RISK</b></p> |
| | <b>Heritage Crime:</b> Pigeon nesting in lanterns and crevices, weed growth on lanterns | |

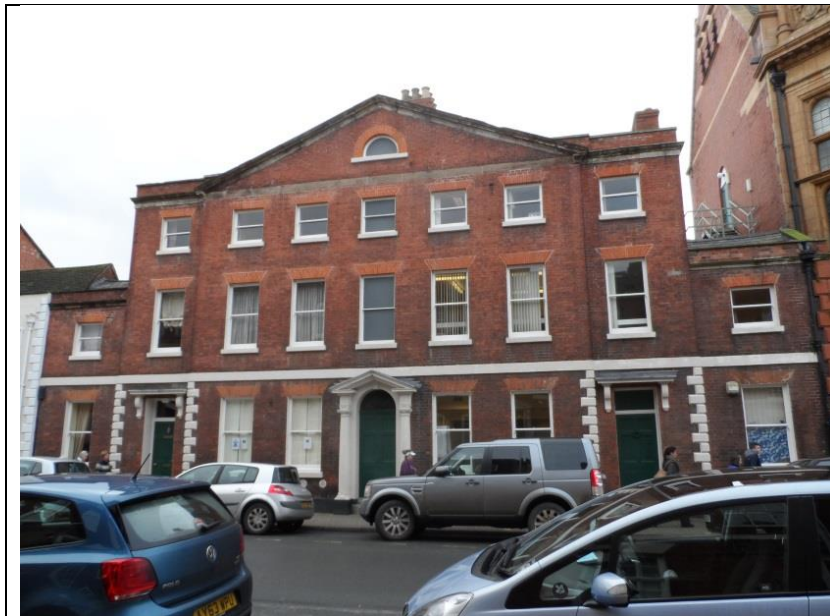
**Ref No:** S03

**HAR Assessment:** Building in fair condition, however edges of pediment and cornices to façade showing signs of deterioration

**Recommendation:** Pediment and cornice require a survey to assess structural stability and repair if necessary. In need of minor maintenance, continue to monitor and maintain building.

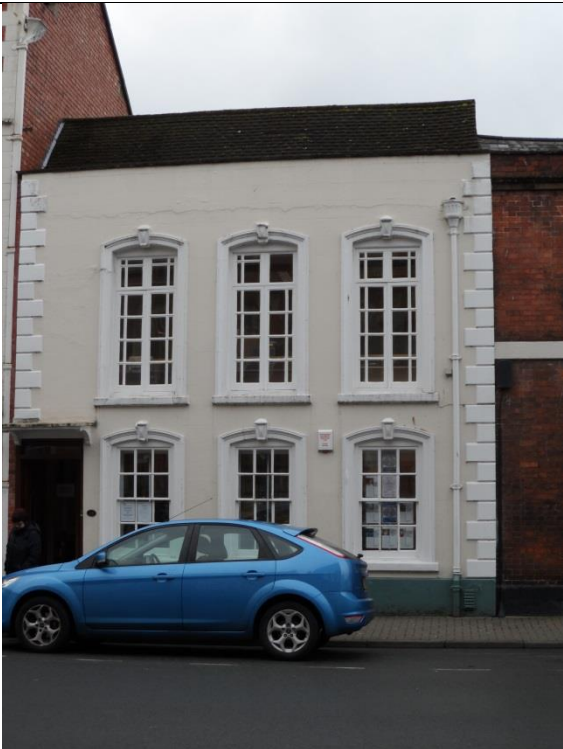
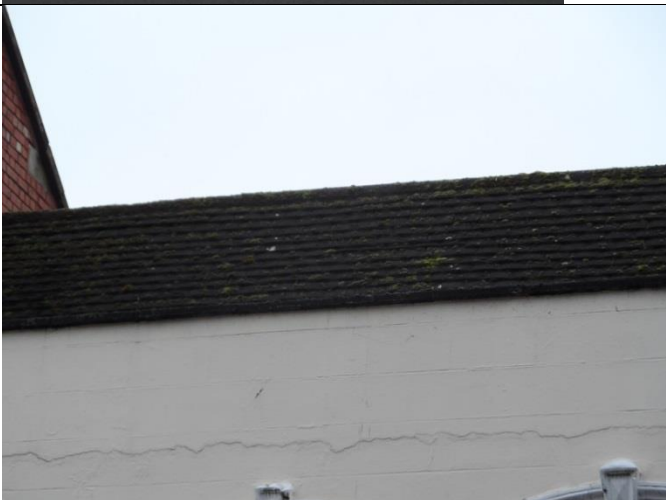
| | | <b>Ref No:</b> SO4 | <p><b>Description:</b> House, now offices. Early 17<sup>TH</sup> Century with 19<sup>th</sup> Century alterations. Timber-frame with stucco, tile roof and a brick stack. Two storeys with 3-window range.</p> <p><b>HAR Assessment:</b> large crack in stucco which stretches across the entire parapet which is probably caused by water penetration from parapet. Possible causes are blocked parapet gutter, failed copings or leadwork behind parapet.</p> <p><b>Recommendation:</b> Undertake a roof survey to detect problem. Remove stucco and replace with breathable material. Continue to monitor and maintain building.</p> <p><b>LOW RISK</b></p> |

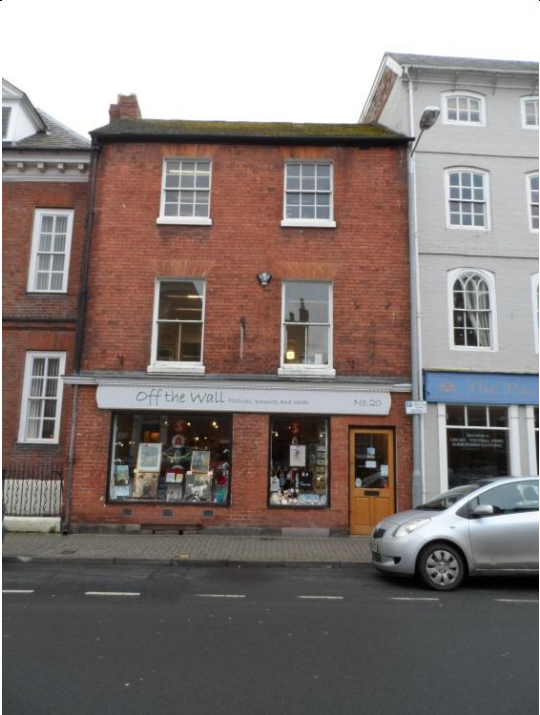
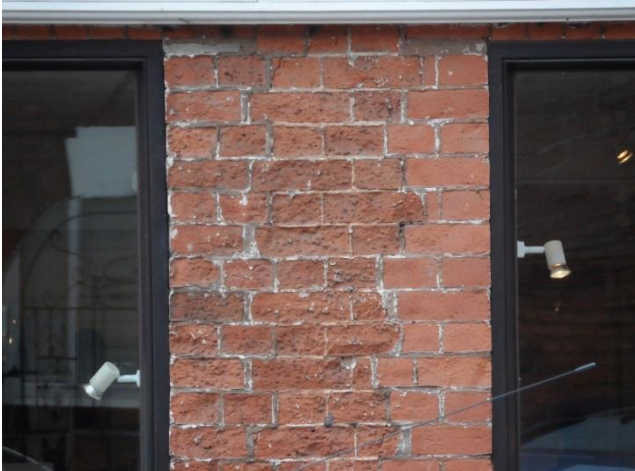
| | <b>Ref No:</b> S06 | <b>Description:</b> House, now shop and offices. Late 18 <sup>th</sup> Century. Brick with plain tile roof and brick end stack. Three storeys and cellar; 2-window range: plain sashes under gauged brick flat arches; 6/6 sashes over. 20 <sup>th</sup> Century shop windows, door and fascia-board and hood over.<br><br><b>HAR Assessment:</b> The brick on ground floor is scaling with fireskin removed.<br><br><b>Recommendation:</b> Monitor brickwork and repair/replace if necessary.<br><br><b>NOT AT RISK</b> |

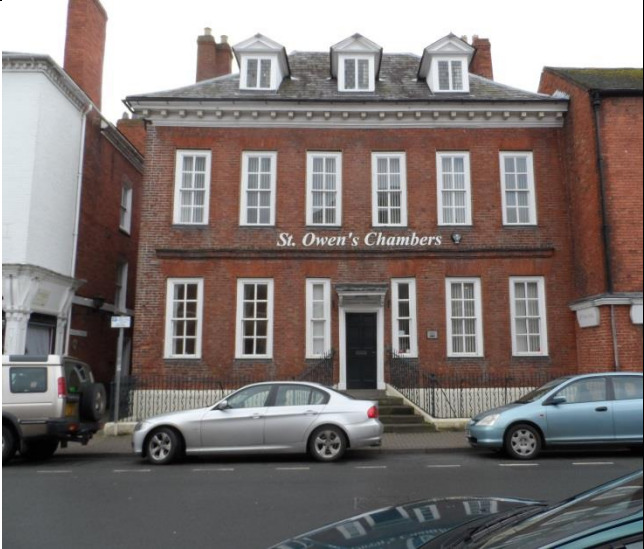
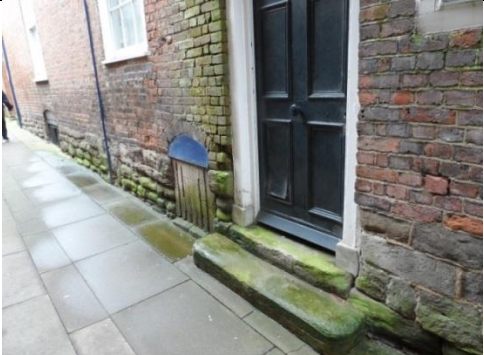
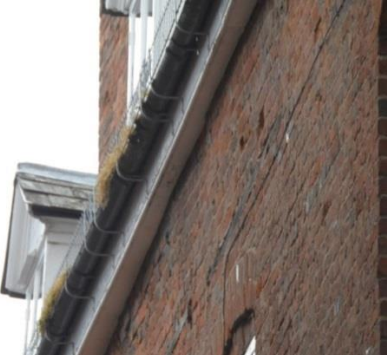
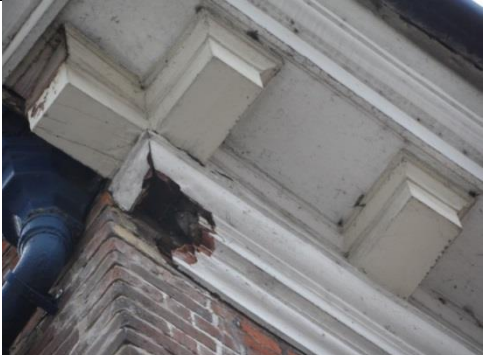
| | <b>Ref No:</b> S07 | <p><b>Description:</b> Former House, now printing works. Early 18th Century. Brick construction with hipped Welsh slate roof; brick end stacks. Central staircase plan. Two storeys, attic and cellar; symmetrical 6-window range: 4/4 sashes in moulded cases with beaded reveals, under gauged brick flat arches; moulded and modillioned wood eaves. Attached railings with tendril motif, flank steps to entrance.</p> <p><b>HAR Assessment:</b> Only exterior inspected. Showing advanced signs of lack of maintenance. Weeds growing in guttering which is likely to be causing damp issues in laneway. Roof badly deteriorating with holes from slipped slates and nesting birds, large levels of moss and lichen growth on laneway brickwork. Brickwork on front façade has water staining possibly due to water running down façade from blocked gutters.</p> <p><b>Recommendation:</b> Building requires investigation and rectification of damp issues, particularly along laneway. Immediate maintenance to fix water penetration issues to avoid further deterioration. Repair hole in eave to stop nesting birds.</p> <p><b>VULNERABLE</b></p> |

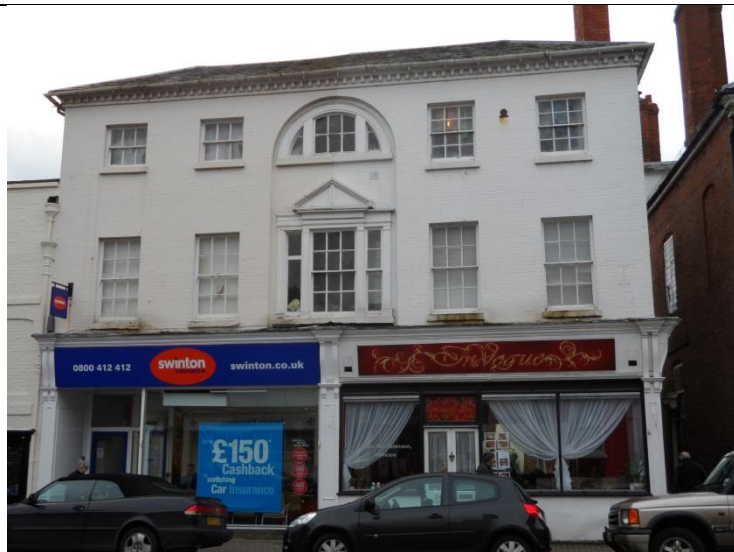
**Ref No:** SO8

**HAR Assessment:** Showing signs of lack of general maintenance. Water staining to window sills, and deteriorating brickwork (see below).

**Recommendation:** Window sills and frames require repair/ repainting with breathable paint.

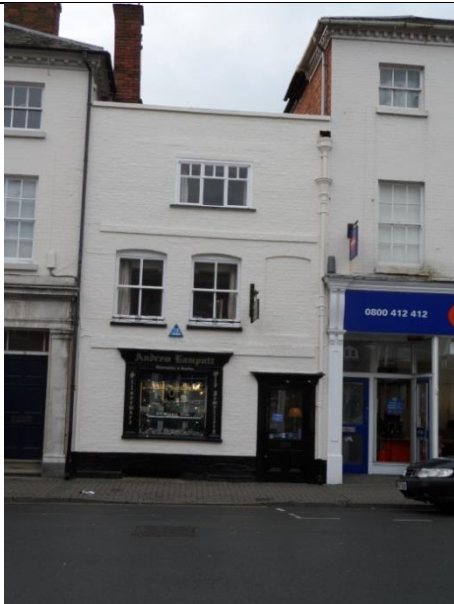
| | <b>Ref No:</b> SO9 | <p><b>Description:</b> 18th Century Shop and dwelling, most likely a 17<sup>th</sup> Century core. Painted brick with a C20 pantile roof and brick end stack. Three storeys and cellar; 2-window range with 20<sup>th</sup> Century sashes. 20<sup>th</sup> Century re-built parapet. 19<sup>th</sup> Century shop window with panelled architrave under moulded fascia-board and hood.</p> <p><b>HAR Assessment:</b> Good condition, not at risk.</p> <p><b>Recommendation:</b> Continue to monitor and maintain building.</p> <p><b>NOT AT RISK</b></p> |

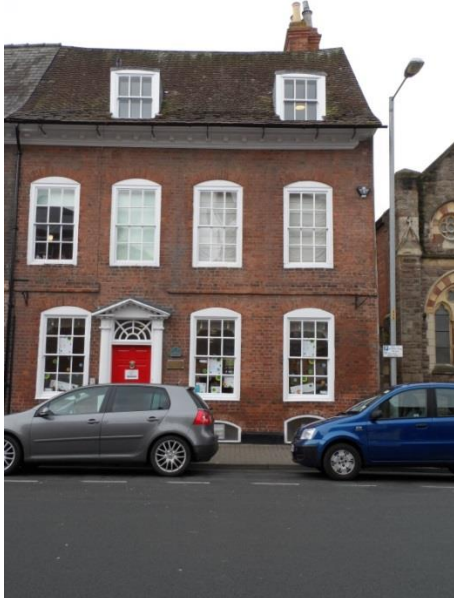
| | <b>Ref No:</b> SO10 | <p><b>Description:</b> Former house, now shops and offices. Early 18<sup>th</sup> Century with 19<sup>th</sup> Century wing to rear. Brick; stucco plinth; plain tile roof; brick end stack to right. Two storeys and attic with a 4-window range. 19<sup>th</sup> Century roof dormers with 3/3 sashes.</p> <p><b>HAR Assessment:</b> Good condition, not at risk.</p> <p><b>Recommendation:</b> Continue to monitor and maintain building.</p> <p><b>NOT AT RISK</b></p> |

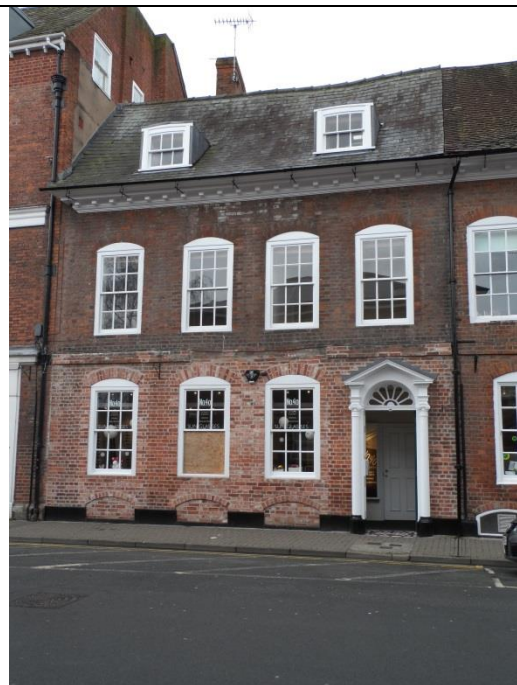
**Ref No:** SO11

**HAR Assessment:** Ground floor was previously painted, which has been removed, however has been poorly re-pointed. Roof showing signs of age but appears to be in good condition.

**Recommendation:** Continue to monitor and maintain building.

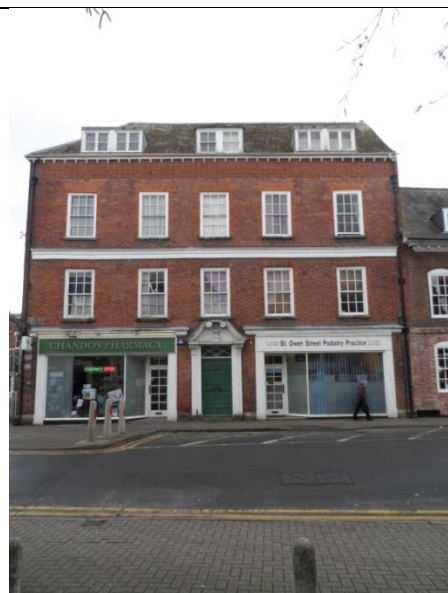
**Ref No:** SO12

**HAR Assessment:** Visually in good condition, not at risk

**Recommendation:** Continue to monitor and maintain building.

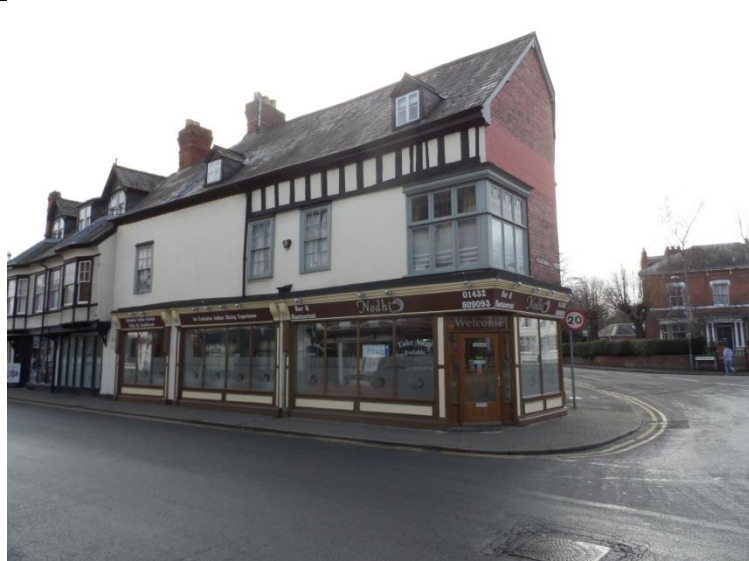
**Ref No:** SO13

**HAR Assessment:** Good condition not at risk.

**Recommendation:** Continue to monitor and maintain building.

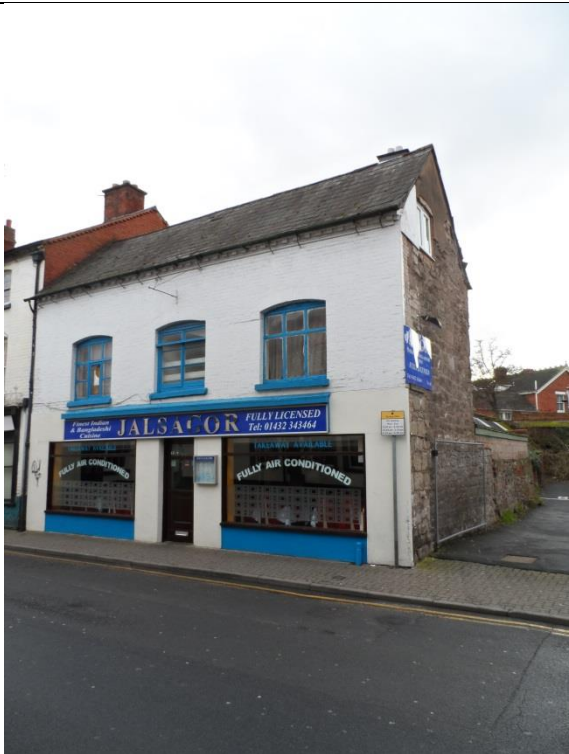
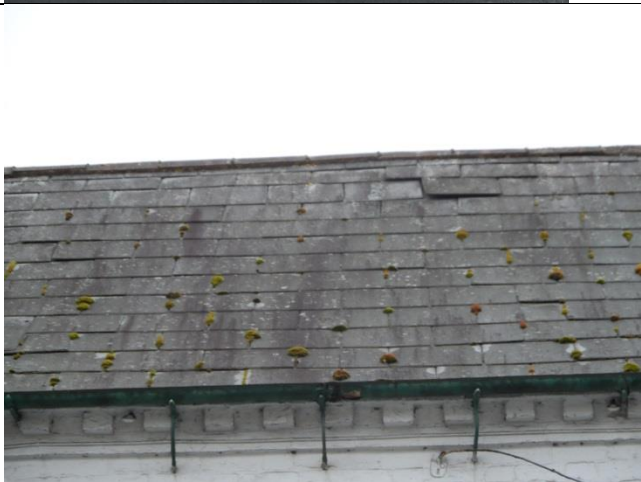
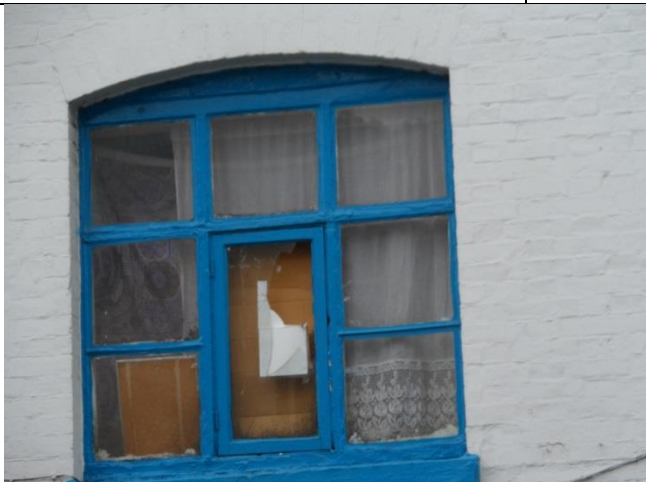
| | <b>Ref No:</b> SO15 | <p><b>Description:</b> Former 18<sup>th</sup> Century house, now shop. Incorporates 13<sup>th</sup> Century elements of the City Wall. Two storeys, painted brick with slate roof. 20<sup>th</sup> Century shop front with central door.</p> <p><b>SAM ASSESSMENT:</b> As the building/structure forms a significant component of the site, it is assessed under the 'buildings and structures at risk' criteria.</p> <p><b>HAR Assessment:</b> Broken glass on left window (see below). City Wall in good condition.</p> <p><b>Recommendation:</b> Repair window. Continue to monitor and maintain building and wall.</p> <p><b>LOW RISK</b></p> |

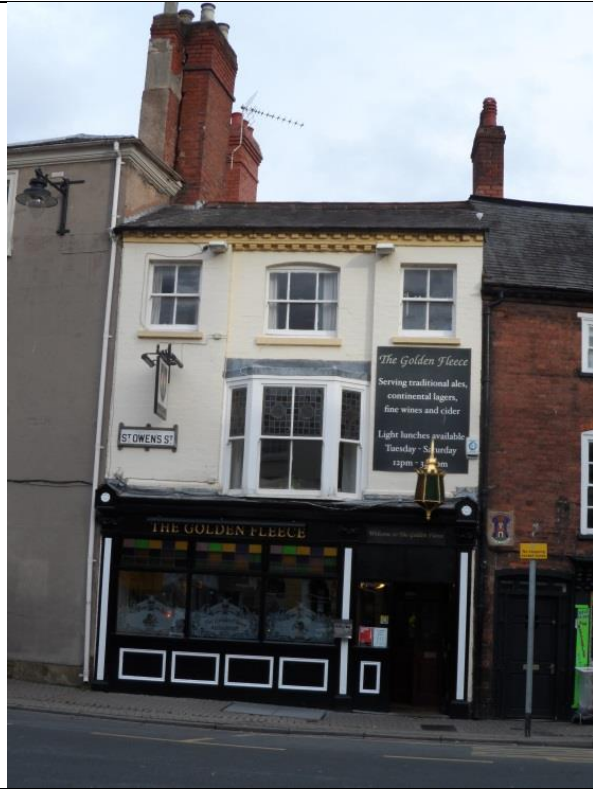
| <b>Ref No:</b> SO16 |

| <p><b>Description:</b> Early 19<sup>th</sup> Century House, now offices. Constructed of brick and finished in stucco with slate roof. Three storeys.</p> <p><b>HAR Assessment:</b> Good condition, not at risk</p> <p><b>Recommendation:</b> Continue to monitor and maintain</p> <p><b>NOT AT RISK</b></p> |

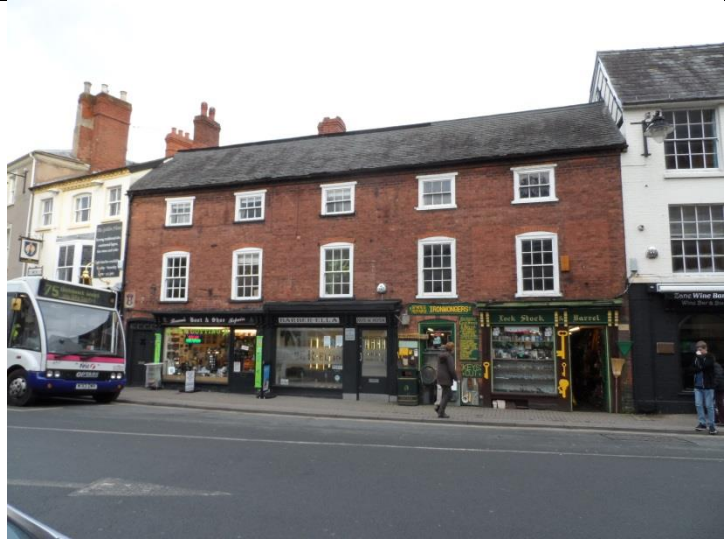
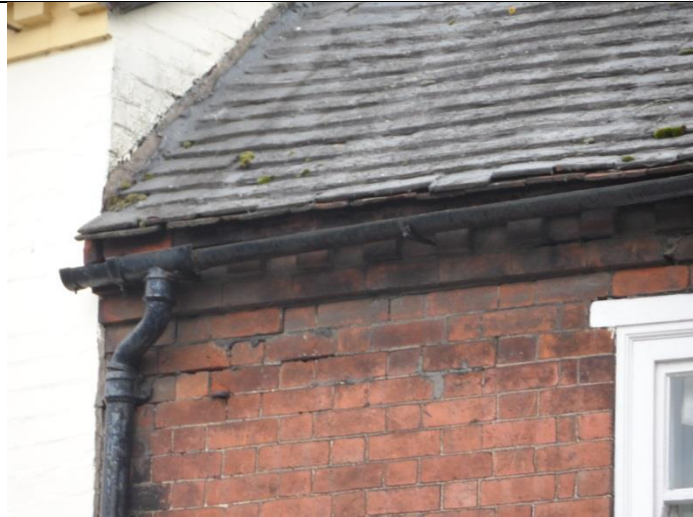
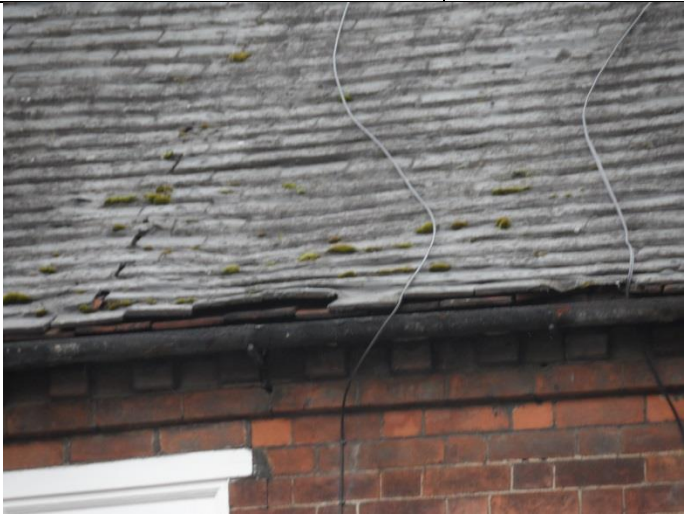
| <b>Ref No:</b> SO17 |

| <p><b>Description:</b> Houses, now shops and flats. 19<sup>th</sup> Century façade to 17<sup>th</sup> Century core. Three storeys, constructed of brick with plain tiled roof. 20<sup>th</sup> Century shopfronts and 19<sup>th</sup> Century door in moulded case to the left.</p> <p><b>HAR Assessment:</b> Some roof slates missing and guttering is detached from façade.</p> <p><b>Recommendation:</b> Replace missing roof slates and affix/replace guttering.</p> |

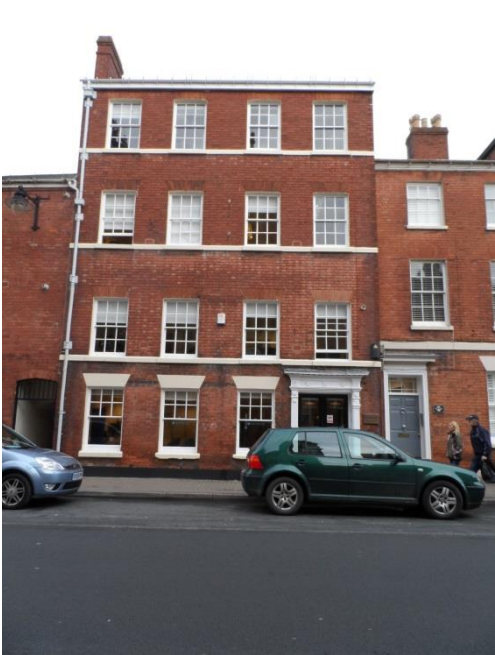
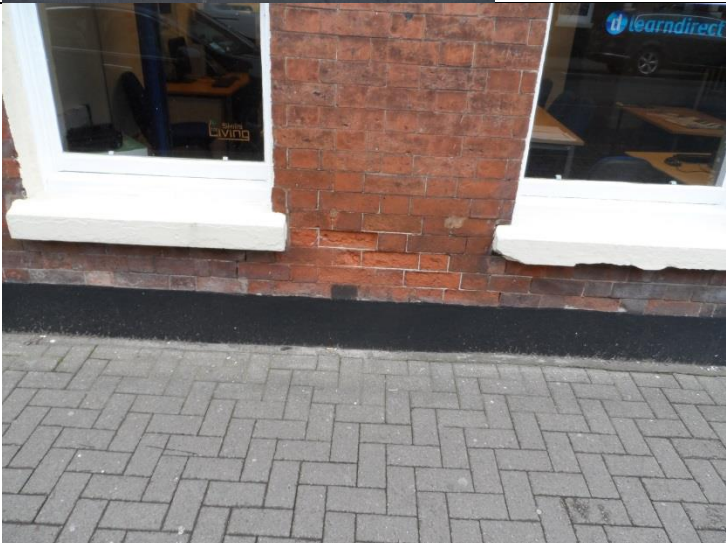
| | <b>Ref No:</b> S019 | <p><b>Description:</b> Former late 18<sup>th</sup> Century house, now offices. Four storeys and cellar constructed of Brick with slate roof; brick stack to rear. 20<sup>th</sup> Century double doors to the right under an 18<sup>th</sup> Century doorcase.</p> <p><b>HAR Assessment:</b> Probable frost damage to bricks which has removed fireskin.</p> <p><b>Recommendation:</b> Monitor brickwork and repair frost damage with a conservation approach where appropriate.</p> <p><b>NOT AT RISK</b></p> |

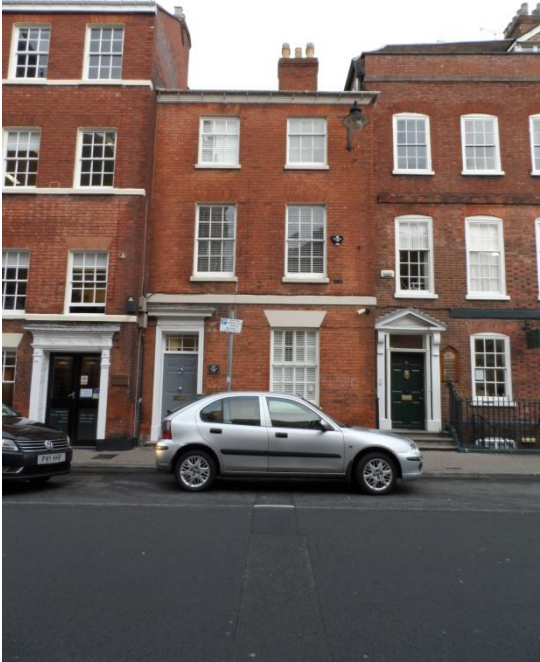
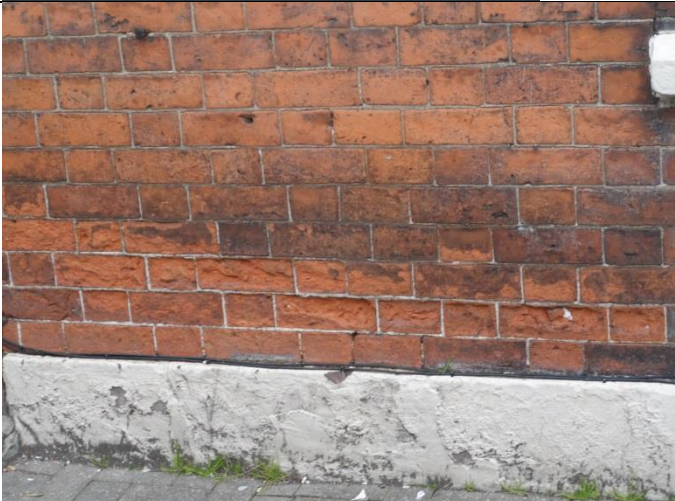
| | | <b>Ref No:</b> SO20 | <p><b>Description:</b> Late 18<sup>th</sup> Century House, now offices. Facade is 18<sup>th</sup> Century to a 17<sup>th</sup> Century core. Constructed of brick to shallow pitched slate roof.</p> <p><b>HAR Assessment:</b> Bricks are suffering from probable frost damage which has removed fireskin.</p> <p><b>Recommendation:</b> Monitor brickwork and repair frost damage where appropriate.</p> <p><b>NOT AT RISK</b></p> |

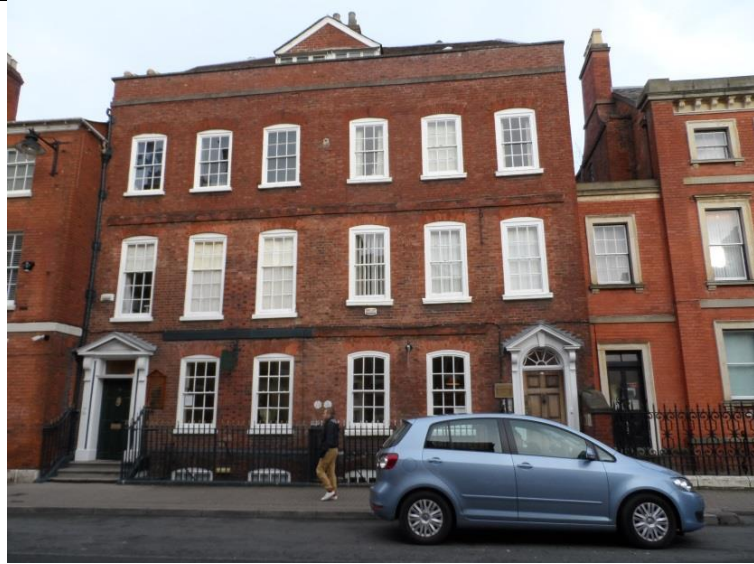
| <b>Ref No:</b> SO21 | <p><b>Description:</b> Mid 18<sup>th</sup> Century houses, now hotel and offices. Constructed of brick with hipped Welsh slate and (to right) plain tile roof. Engraved bricks: SPP and SOP. Attached 18<sup>th</sup> Century railings with spearhead finials.</p> <p><b>HAR Assessment:</b> Building in good condition, however some spearhead finials to railings are missing.</p> <p><b>Recommendation:</b> Continue to monitor and maintain building.</p> <p><b>NOT AT RISK</b></p> |

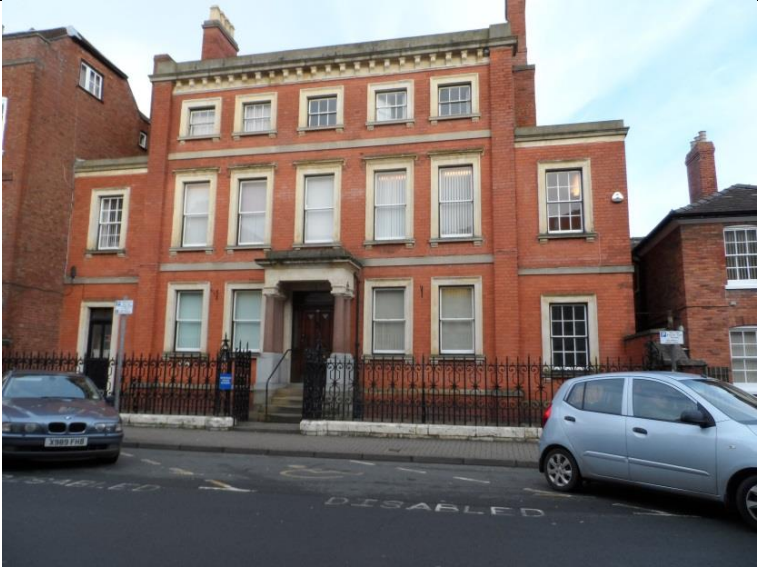
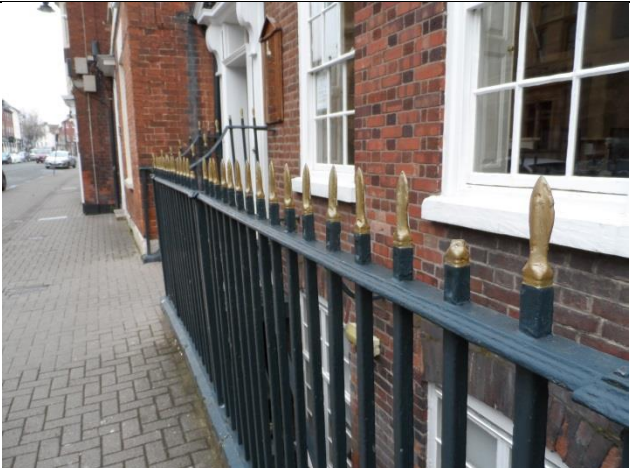
| | <b>Ref No:</b> SO22 | <p><b>Description:</b> Former house, now surgery and offices. 18<sup>th</sup> Century core with 19<sup>th</sup> Century façade. Rear has Dutch gables and attached Orangery (not inspected). Three storeys and cellar, constructed of brick with a Welsh slate roof. Two 2-storey wings to side with ornate iron railings with pillars, gate piers and double gates.</p> <p><b>HAR Assessment:</b> some railing finials missing</p> <p><b>Recommendation:</b> Continue to monitor and maintain.</p> <p><b>NOT AT RISK</b></p> |
