# Preventative Conservation & Maintenance Theory; its application to the Hereford City Conservation Area. Part 2 - Appendices

**August 2014**

**JS Conservation Management  
& Town Planning Ltd**  
t: 07741091719  
e: [john@jsconservationplanning.com](mailto:john@jsconservationplanning.com)  
w: [www.jsconservationplanning.com](http://www.jsconservationplanning.com)

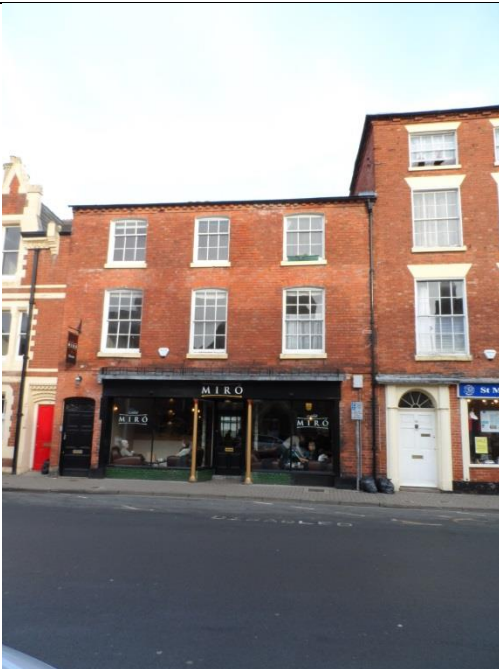
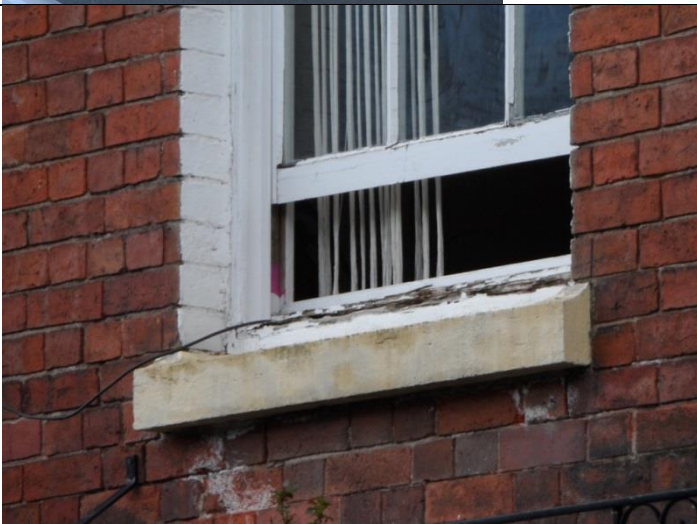
| | <b>Ref No:</b> SO26 | | <b>Description:</b> Early 19 <sup>th</sup> Century Shop and dwelling. Three Storeys, constructed of brick with Welsh slate roof.<br><br><b>HAR Assessment:</b> Window frames deteriorating.<br><br><b>Recommendation:</b> Window frames require repair and re-painting. Continue to monitor and maintain building.<br><br><b>NOT AT RISK</b> |

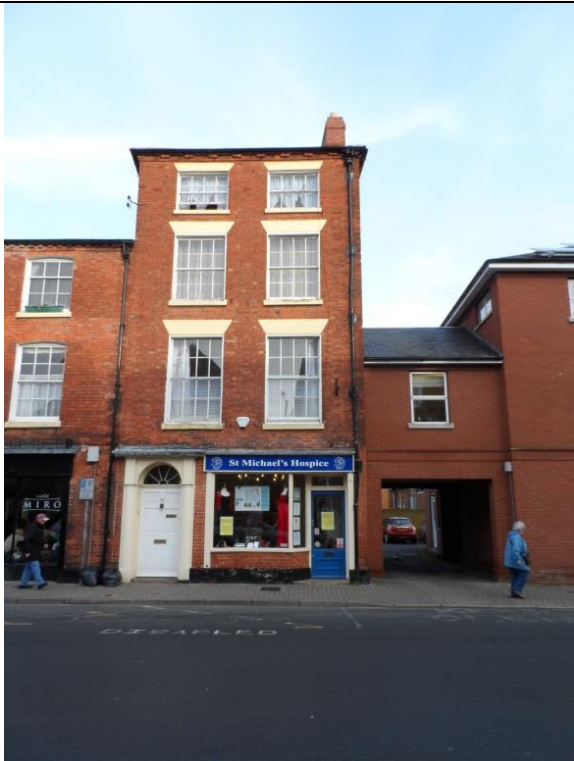
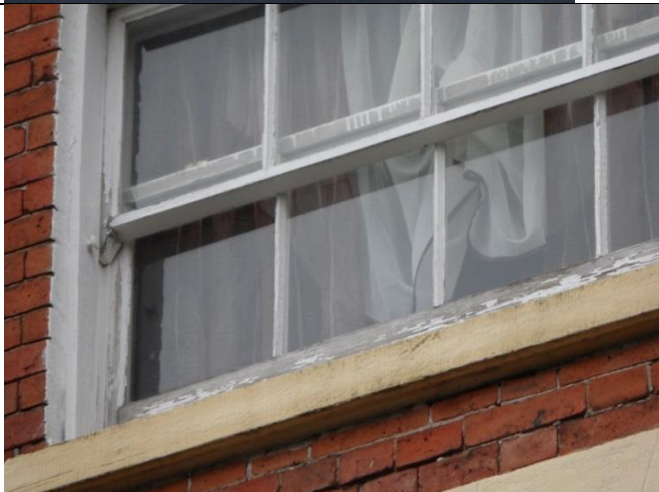
| | <b>Ref No:</b> S027 | <p><b>Description:</b> Late 18<sup>th</sup> Century house, now shop and dwelling. Four storeys, constructed of brick with hipped Welsh slate roof. Late 19<sup>th</sup> Century shop front to right, with recessed part-glazed door.</p> <p><b>HAR Assessment:</b> Window frames are deteriorating.</p> <p><b>Recommendation:</b> Window frames require repair and repainting. Continue to monitor and maintain building.</p> <h2>NOT AT RISK</h2> |

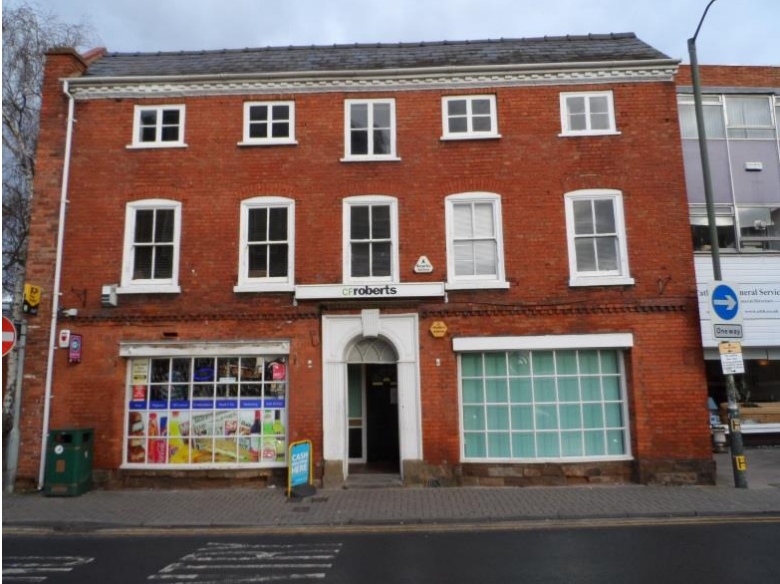
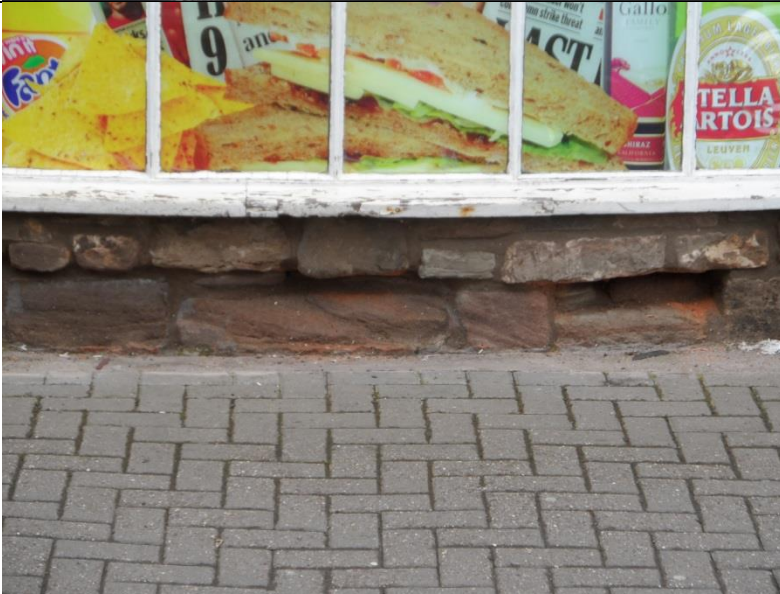
| | <b>Ref No:</b> S028 | <b>Description:</b> House, now shops. Late 18 <sup>th</sup> Century façade to 17 <sup>th</sup> Century core.<br>Three storeys, constructed of brick with 20 <sup>th</sup> century sash windows.<br><br><b>HAR Assessment:</b> stones from plinth missing and cracked.<br><br><b>Recommendation:</b> Repair and replace stones along plinth, continue to monitor and maintain building.<br><br><h1>NOT AT RISK</h1> |

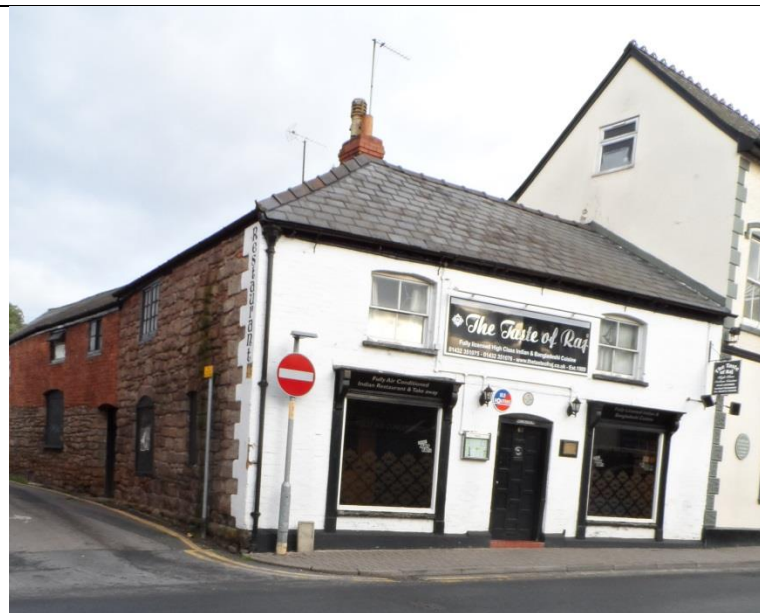
**Ref No:** SO30

**HAR Assessment:** City wall in good condition.

**Recommendation:** Continue to monitor and maintain building.

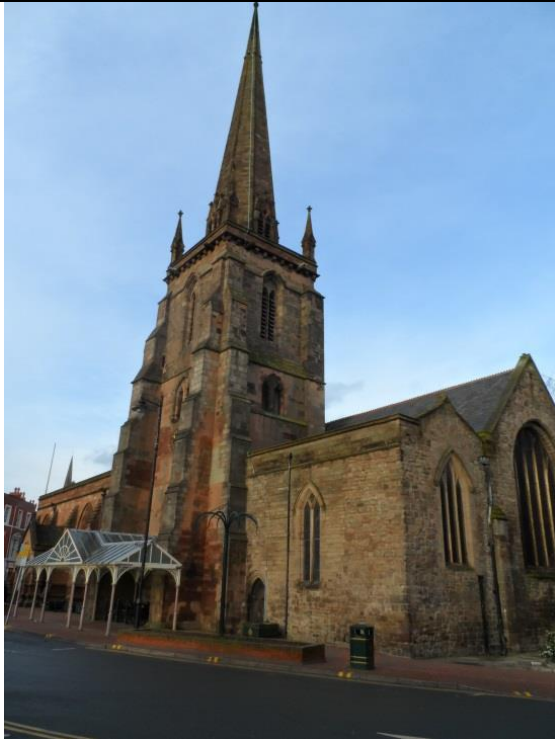
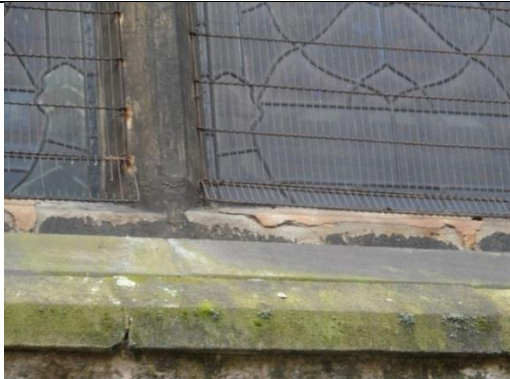
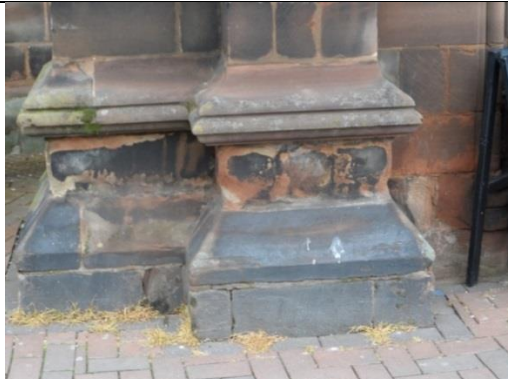
| | <b>Ref No:</b> SP1 | | | | | | <p><b>Description:</b> Late 13<sup>th</sup> Century – early 14<sup>th</sup> Century Parish Church, restored circa 1885 by Nicholson. Ashlar sandstone, and rubble; slate roof. PLAN: nave, chancel, south aisle, and tower with spire.</p> <p><b>HAR Assessment:</b> Overall fair condition, some stone interior and exterior replaced recently, however showing signs of wear and tear as a result of age. Roof of north aisle and Chancel in poor condition and requires urgent replacement. Some scaling of higher level stone, gypsum present on exterior walls. Window tracery on eastern face cracking, past poor roman cement repairs.</p> <p><b>Recommendation:</b> Place on ‘at risk’ register due to roof condition. Continue to monitor and maintain building, take opportunity to repair past poor repairs.</p> <p><b>MEDIUM RISK</b></p> |
| | <b>Overall Condition:</b> Fair | | | | | | |
| <b>High Level Stone</b><br>Fair | <b>Roof</b><br>Poor | <b>Rainwater goods</b><br>Good | <b>Structural stability</b><br>Fair | <b>Interior</b><br>Good | <b>Windows, tracery</b><br>Fair | | |

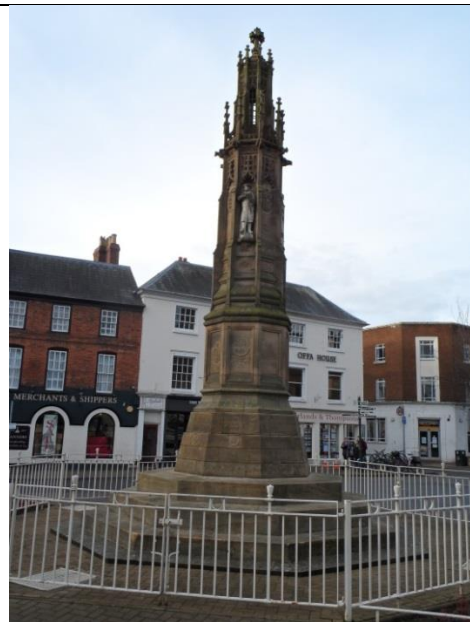
**Ref No:** SP2

**HAR Assessment:** War memorial in good condition, however is listed as vulnerable as it is not possible to be occupied.

**Recommendation:** Continue to monitor and maintain monument

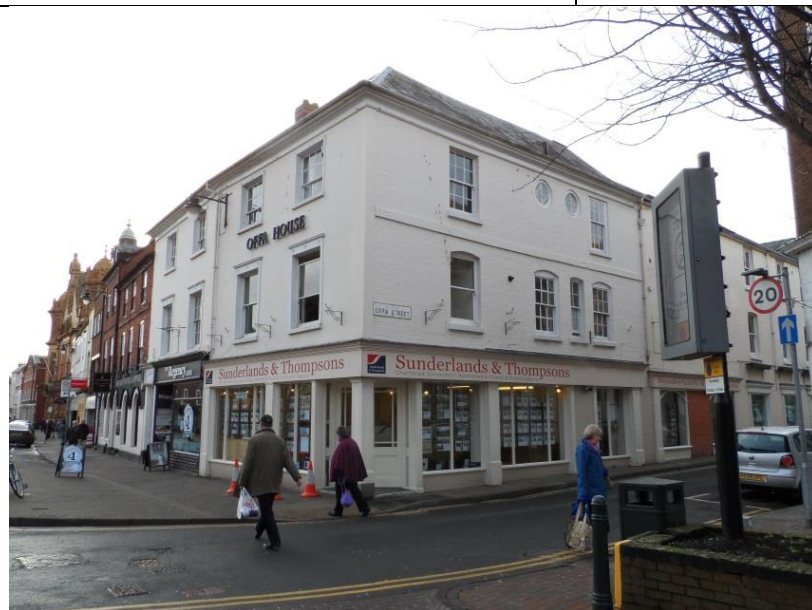
**Ref No:** SP3

**HAR Assessment:** First floor of Offa house undergoing refurbishment 8/8 sashes along St Peter's Square have been replaced.

**Recommendation:** Find tenancy and Continue to monitor and maintain building.

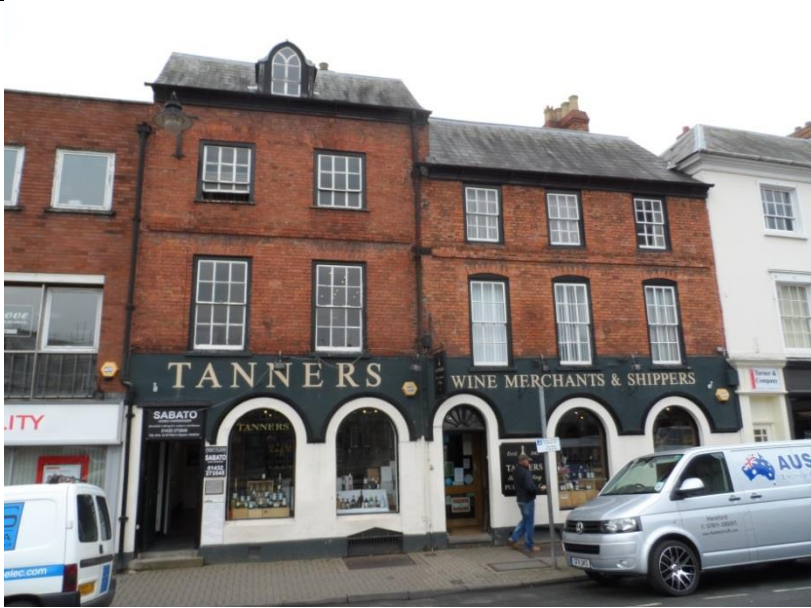
| | <b>Ref No:</b> SP4 | <b>Description:</b> Mid 18 <sup>th</sup> Century shops and dwellings. Three Storeys and basement.<br><br><b>HAR Assessment:</b> Good condition, not at risk<br><br><b>Recommendation:</b> Continue to monitor and maintain building.<br><br><h2>NOT AT RISK</h2> |

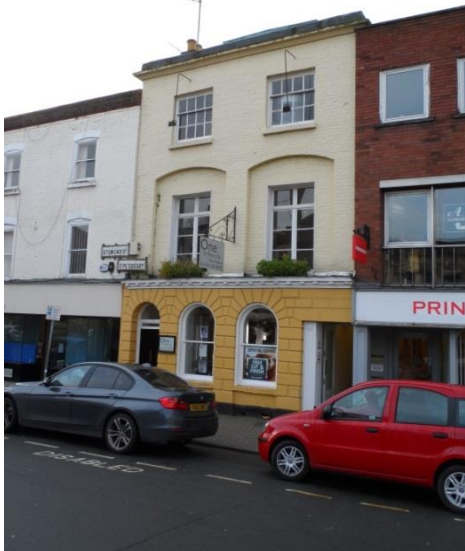
| | <b>Ref No:</b> SP5 | <b>Description:</b> Early 18 <sup>th</sup> Century Shop and dwellings. Painted brick; lead roof; brick lateral stack. 3 storeys and cellar; 2-window range; 19 <sup>th</sup> Century cross windows under flat arches. Recessed 20 <sup>th</sup> Century entrance (to Putta's Close); rusticated stucco; modillioned stone cornice.<br><br><b>HAR Assessment:</b> Good condition, not at risk<br><br><b>Recommendation:</b> Continue to monitor and maintain building.<br><br><h2>NOT AT RISK</h2> |

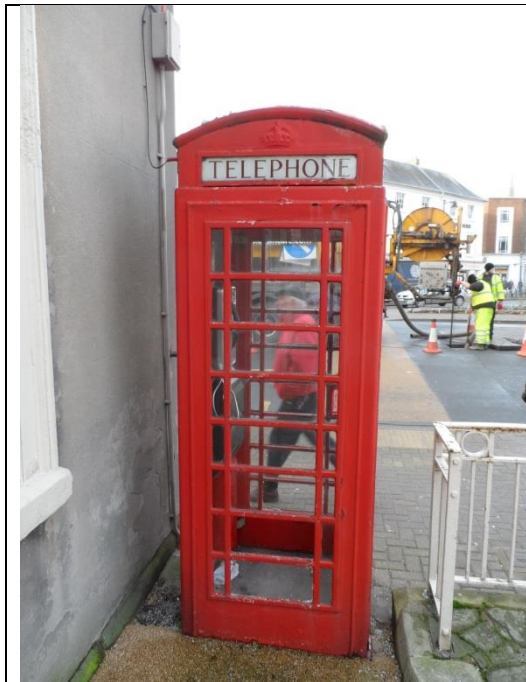
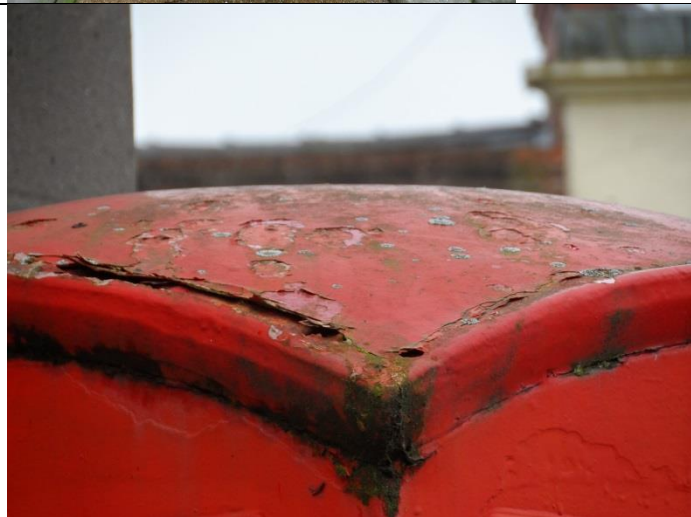
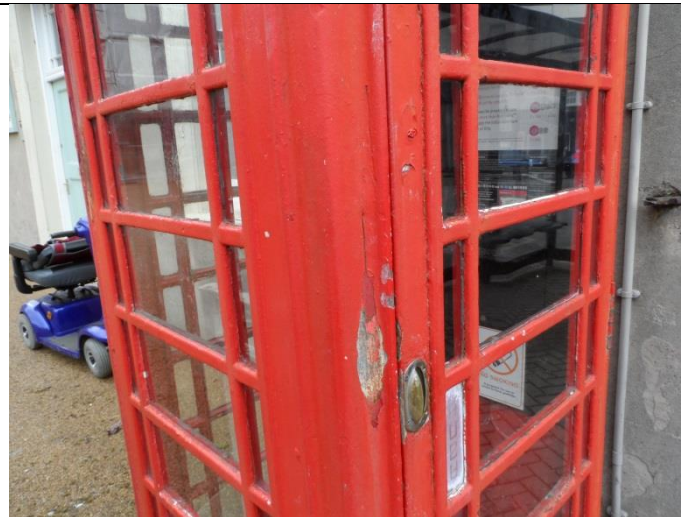
**Ref No:** SP6

**HAR Assessment:** rust on roof and base, deteriorating paint and signs of neglect.

**Recommendation:** repair and repainting required and treatment for rust.

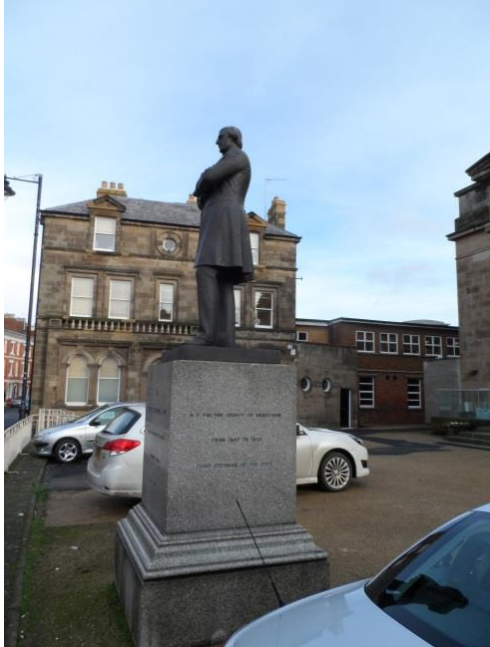
| | <b>Ref No:</b> SP7 | <b>Description:</b> Statue. c1864. By Baron Marochetti. Bronze; polished granite plinth. Sir George Cornwall Lewis: M.P. for the County of Hereford, 1847 to 1852; Chancellor of the Exchequer; Home Secretary; Secretary for War.<br><br><b>HAR Assessment:</b> Statue is in visually good condition, some of the lettering on the granite plinth are missing<br><br><b>Recommendation:</b> Replace missing lettering, continue to monitor and maintain.<br><br><b>VULNERABLE</b> |

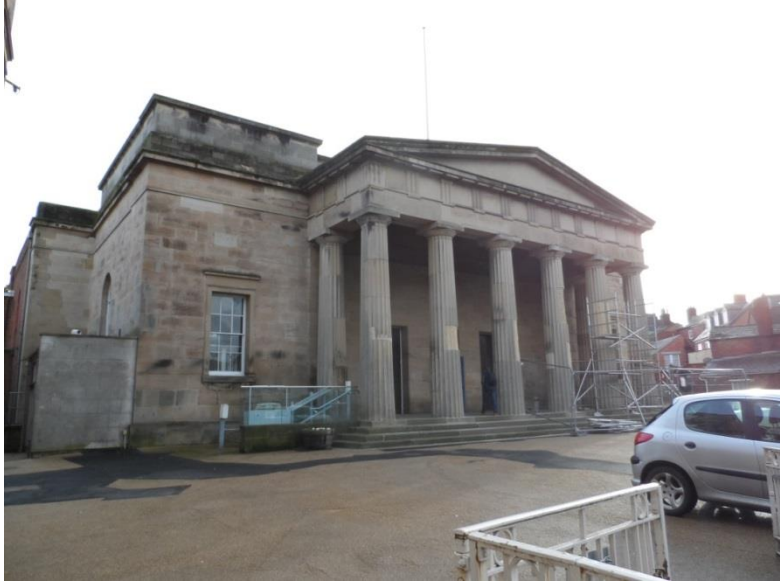
| | <b>Ref No:</b> SP8 | <b>Description:</b> Hereford Shire Hall constructed circa 1815-17 and designed by Sir Robert Smirke. 19 <sup>th</sup> Century extensions. Ashlar sandstone; brick; slate roof; various brick stacks in a neo-Classical style.<br><br><b>HAR Assessment:</b> Doric columns with scaffolding undergoing repairs. Some moss growth around cornice and cracked, missing masonry at height.<br><br><b>Recommendation:</b> Currently undergoing repair which should conserve building. Would be re-categorised as 'Not at Risk' after repairs are completed<br><br><b>LOW RISK</b> |

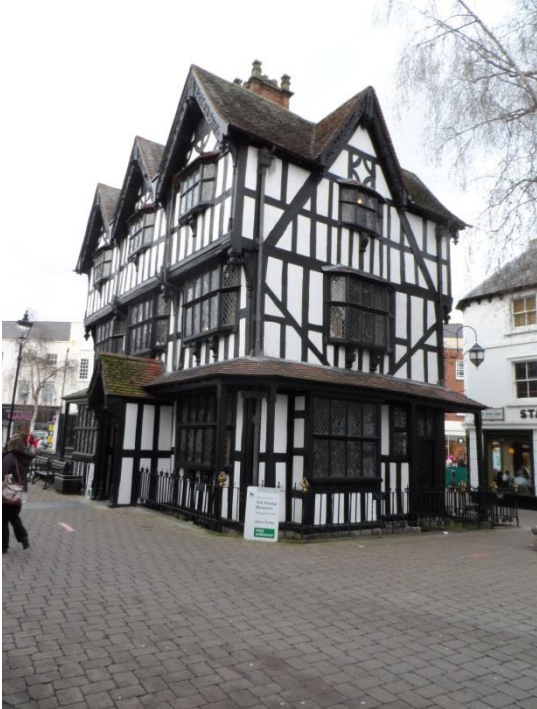
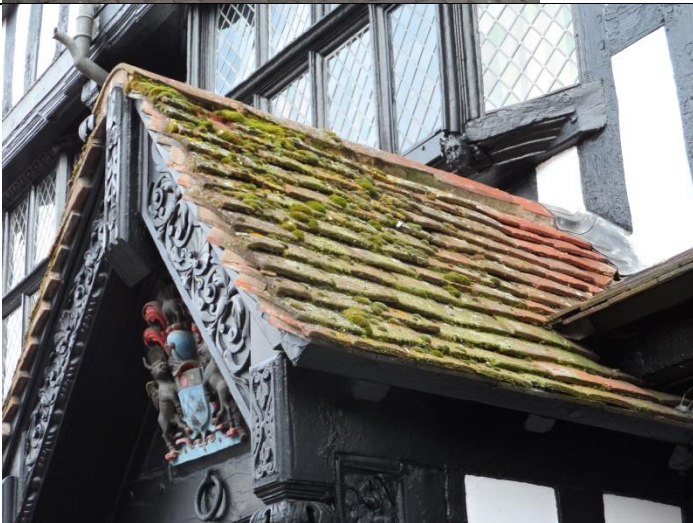
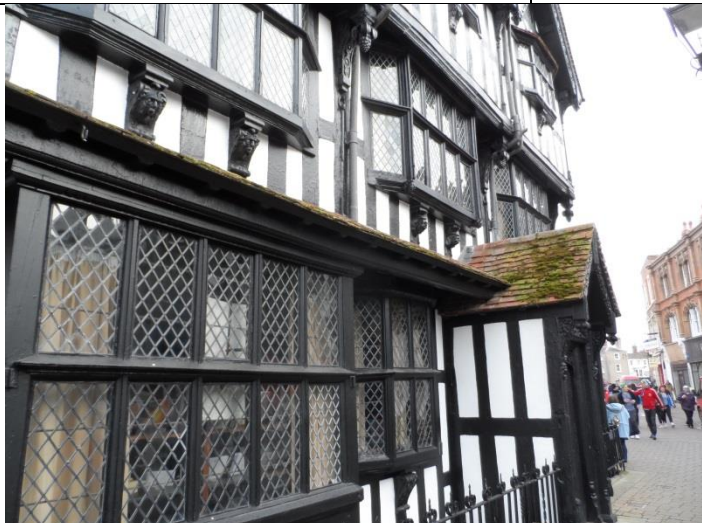
| | <b>Ref No:</b> SS1 | <p><b>Description:</b> Date 1621, Former Shop and dwelling, now museum. Post-and-pan timber-frame and plaster; plain tile roof with 3 gables; central brick stack with pilasters and stone finials. Three storeys, attic and cellar.</p> <p><b>HAR Assessment:</b> Roof slates appear very weathered with moss growth and pigeons nesting and causing damage.</p> <p><b>Recommendation:</b> Seek solutions to pigeon nesting such as netting, undertake assessment of roof slates.</p> <p><b>LOW RISK</b></p> |
| | <b>Condition:</b> Fair | |

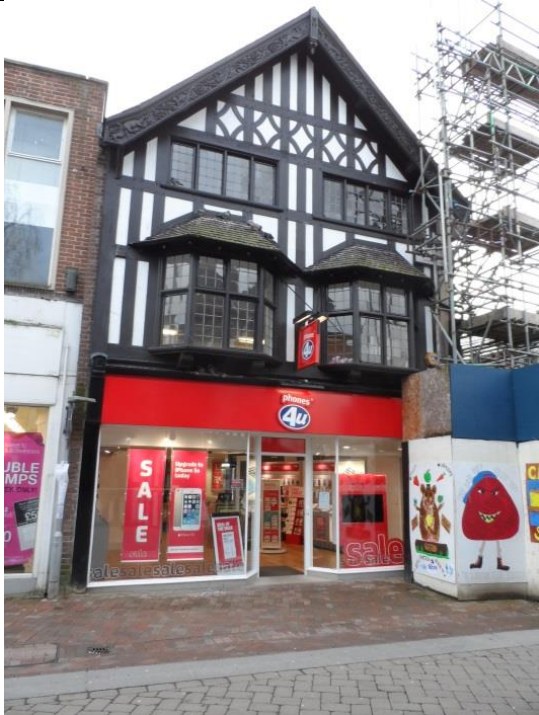
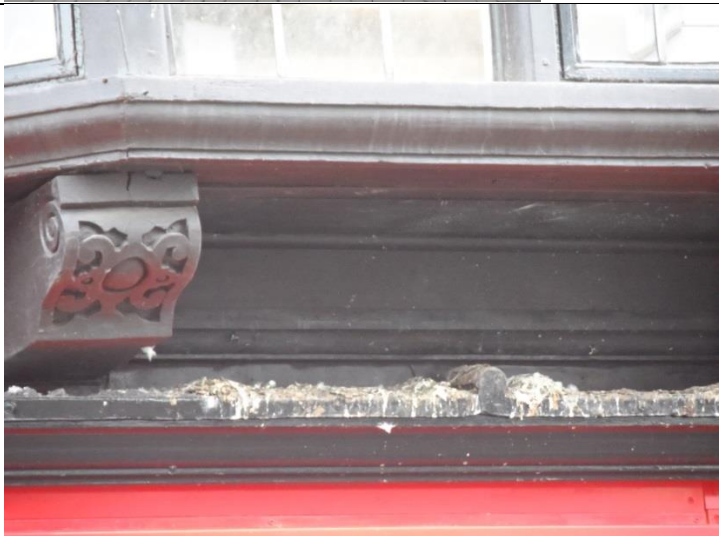
| | <b>Ref No:</b> SS2 | <p><b>Description:</b> Shop and dwelling. 20<sup>th</sup> Century façade with 16<sup>th</sup> Century core. Three storeys, timber-frame and plaster; Welsh slate roof, with 2 ridge-levels. Late C20 shop front, under earlier moulded hood. Right returned side: mutilated C16 timber-framing with brick infill, on stone rubble plinth.</p> <p><b>HAR Assessment:</b> Pigeons nesting in the façade which is causing damage.</p> <p><b>Recommendation:</b> Seek solutions to pigeon nesting such as netting or spikes.</p> <p><b>NOT AT RISK</b></p> |

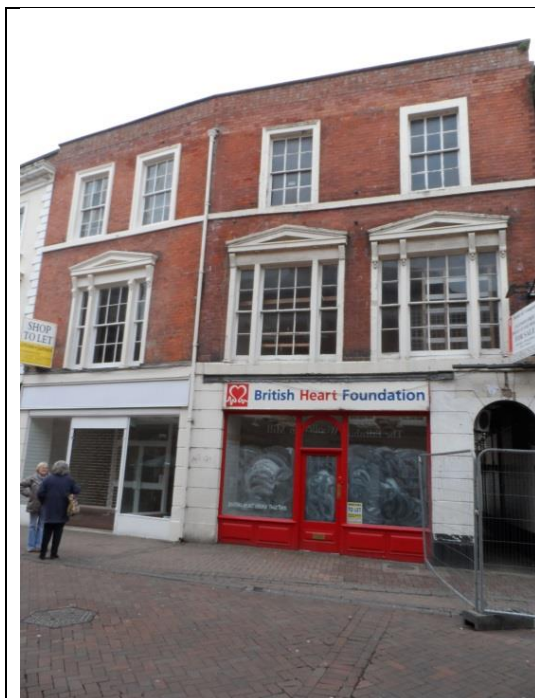
**Ref No:** SS3

**Description:** 18<sup>th</sup> and 19<sup>th</sup> Century shops. Constructed of brick and parapet roof (roof not visible). Two 20<sup>th</sup> Century shop fronts, and, to right, round-headed arch, in rusticated stucco. Below No.10 is a cellar of 15<sup>th</sup> Century in part with wide 4-centred vault.

**HAR Assessment:** Bricks on the façade are suffering from frost damage. Building is currently vacant which makes building vulnerable to heritage risk.

**Recommendation:** Seek occupation of building (currently occurring) and monitor brickwork and replace damaged bricks where appropriate.

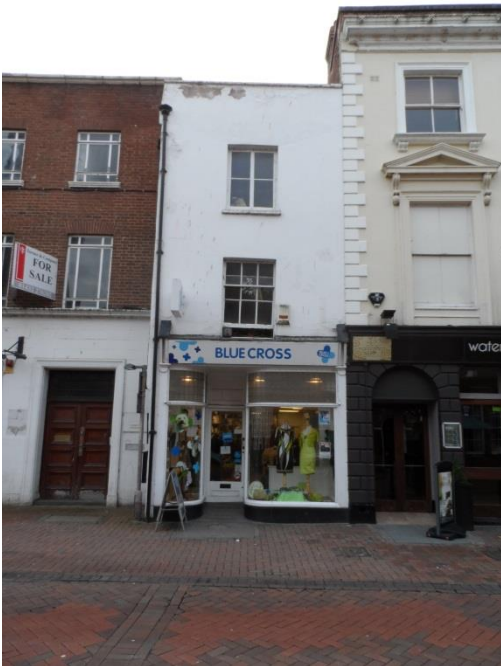
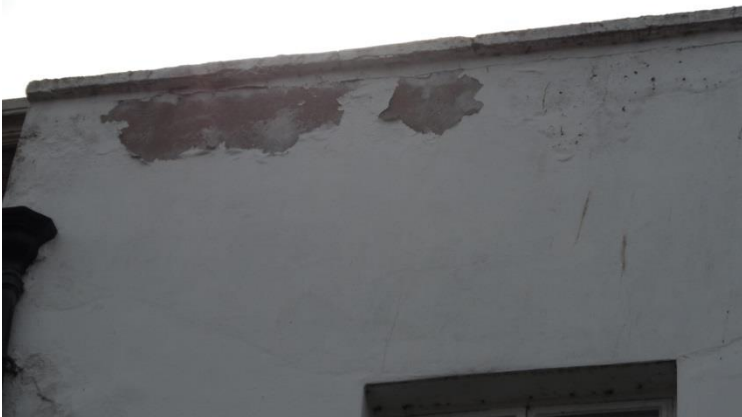
| | <b>Ref No:</b> SS4 | <b>Description:</b> 16 <sup>th</sup> -17 <sup>th</sup> Century shop with later alterations and late 18 <sup>th</sup> Century facade with 20 <sup>th</sup> Century shopfront. Three storeys with cellar, timber-frame with brick infill and stuccoed front; Welsh slate roof.<br><br><b>HAR Assessment:</b> Stucco cracking and blistering near parapet, could be blockage in parapet gutter or copings not performing properly.<br><br><b>Recommendation:</b> Roof survey required to determine whether problem with guttering or coping. Stucco requires replacement. Continue to monitor and maintain.<br><br><b>LOW RISK</b> |

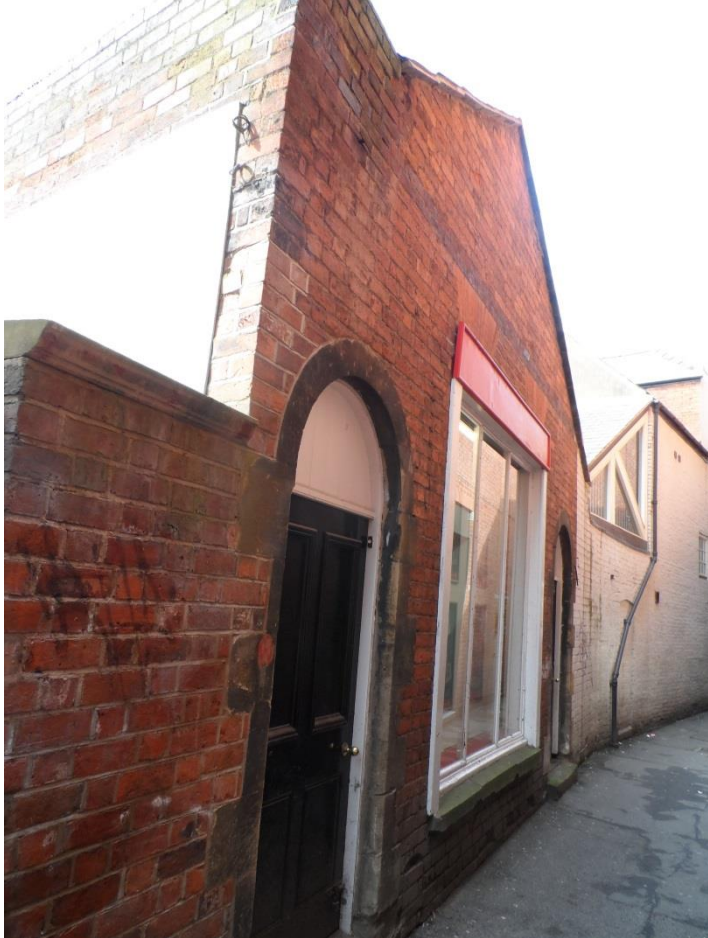
| | <b>Ref No:</b> UP1 | <p><b>Description:</b> Former Soup Kitchen of 1872 to rear of No.49 Commercial Street, now commercial premises. By Thomas Nicholson for the Hereford Society for Aiding the Industrious. Single storey constructed of Red brick with part slate, part glazed, roof. Gable end to Union Passage has 2 round-arched doorways and large window between. Roof has long raised louvre at apex with glazing to roof pitch</p> <p><b>HAR Assessment:</b> Good condition, not at risk.</p> <p><b>Recommendations:</b> Continue to monitor and maintain building.</p> <p><b>NOT AT RISK</b></p> |

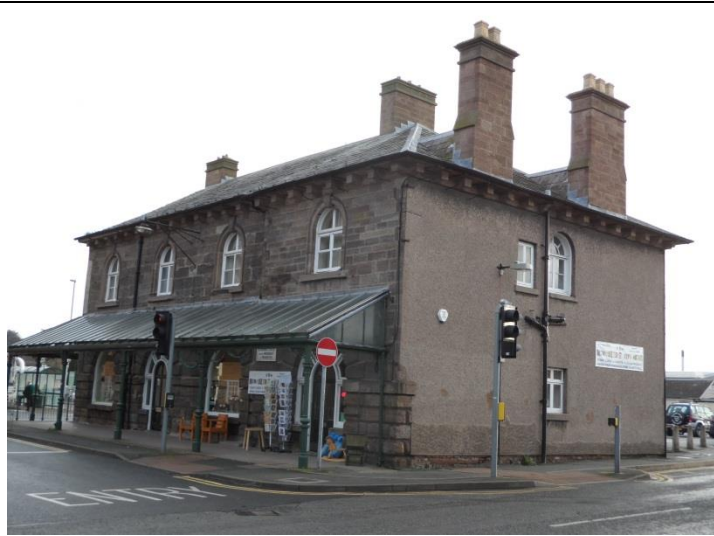
| <b>Ref No:</b> UW1 |

| <p><b>Description:</b> Early 19<sup>th</sup> Century Prison Governor's house, now bus station offices and information. Part of gaol complex built to designs of John Nash. Ashlar sandstone with a hand-cut slate roof, hipped to right, with gables. Two storeys. Glass verandah on cast-iron pillars continuing over 20<sup>th</sup> Century brick shelter to left returned side. Rear has remnant of early 19<sup>th</sup> Century brick wall on chamfered stone plinth.</p> <p><b>HAR Assessment:</b> Weed growth in gutters.</p> <p><b>Recommendations:</b> Unblock gutters, continue to monitor and maintain building.</p> <p><b>NOT AT RISK</b></p> |

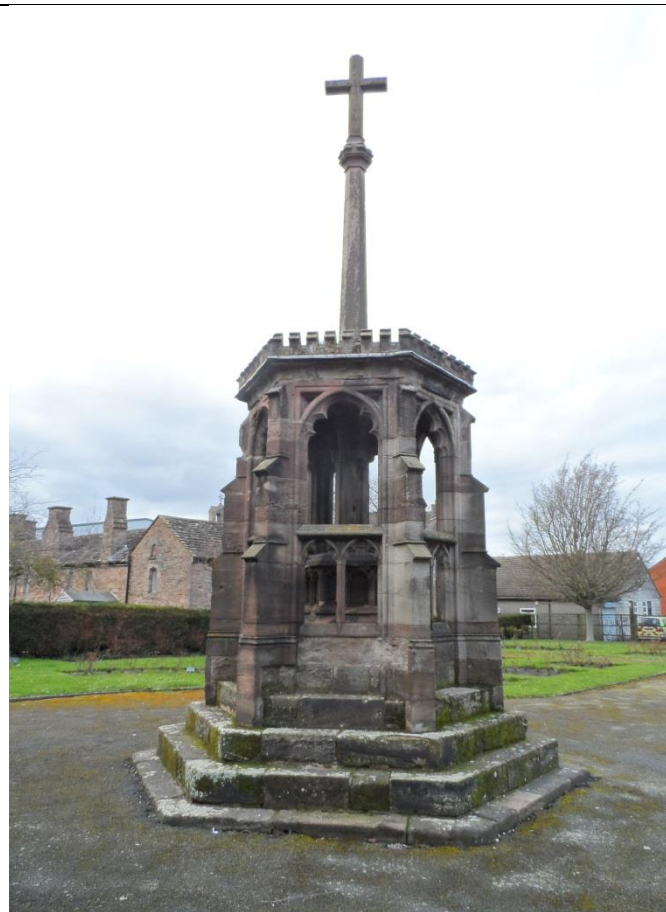
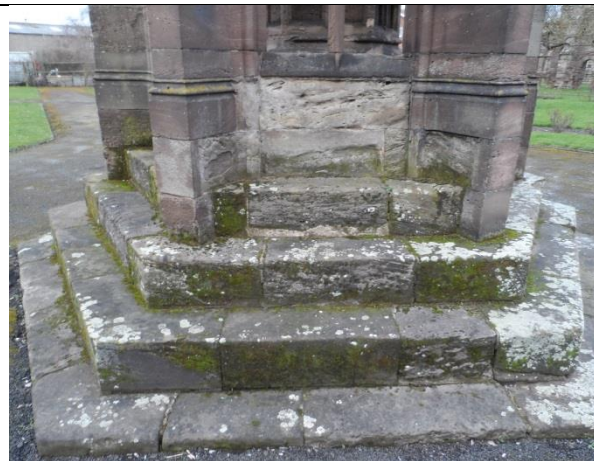
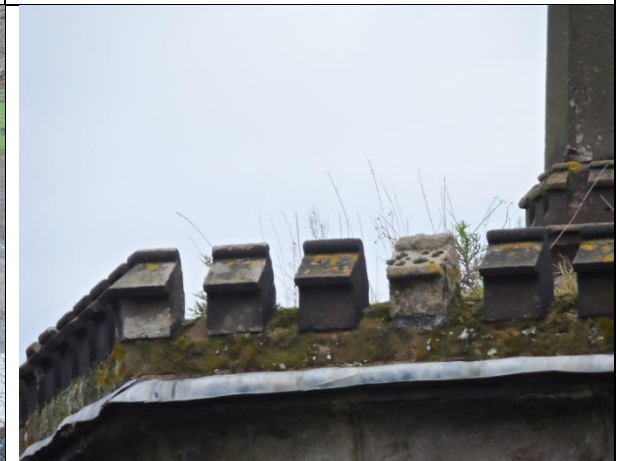
| <b>Ref No:</b> WS2 |

**HAR Assessment:** large amounts of moss and weed growth, particularly to top of monument. Some stones scaling and signs of deterioration.

**Recommendations:** Weed and moss growth treated with a herbicide and monitoring of stone. Investigate ways of better public visibility.

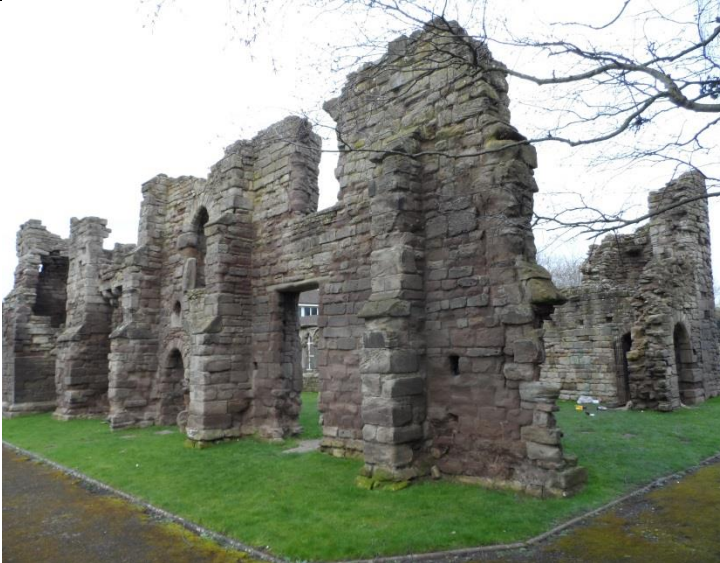
| | <b>Ref No:</b> WS3 | <p><b>Description:</b> Dominican friary, founded c1276. Existing ruins are the refectory and the Priors House, c1322. Certain additions were made in the C17. Restored 1962/63</p> <p><b>SAM ASSESSMENT:</b> As the building/structure forms a significant component of the site, it is assessed under the 'buildings and structures at risk' criteria.</p> <p><b>HAR Assessment:</b> Fair condition with structure hidden away from street with no overlooking and evidence of anti-social behaviour, including litter and graffiti, deliberately broken door which has dislodged stones. Signs of dislodged stones which most-likely due to anti-social behaviour. Moss and invasive tree growth.</p> <p><b>Recommendation:</b> Structure needs better maintenance and surveillance plan, possibly repair stone and make structurally stable. Investigate possibility of soft capping to structure.</p> <p><b>VULNERABLE</b></p> |

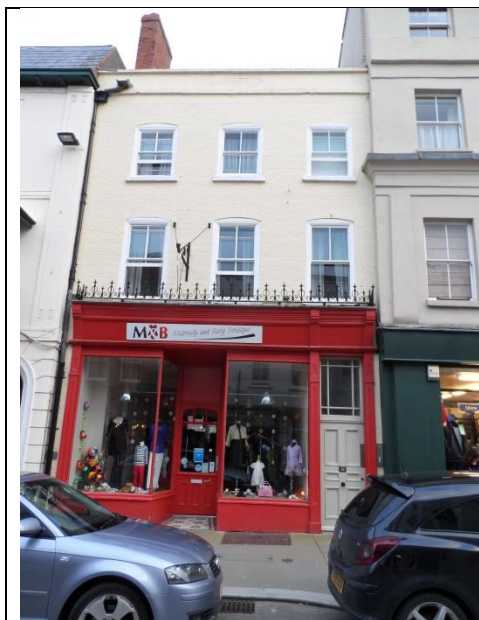
**Ref No:** WS6

**HAR Assessment:** Good condition, not at risk

**Recommendations:** Continue to monitor and maintain building.

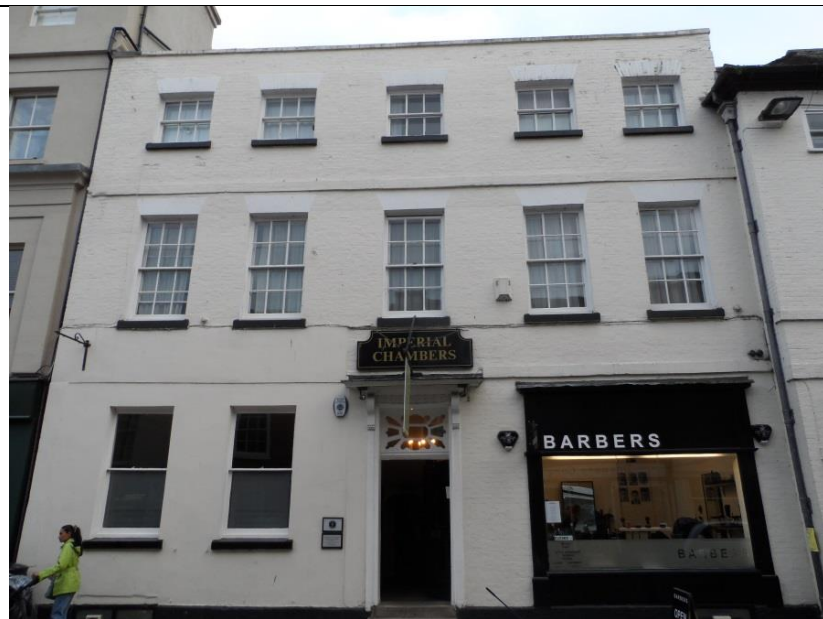
**Ref No:** WS7

**HAR Assessment:** Good condition, not at risk

**Recommendations:** Continue to monitor and maintain building

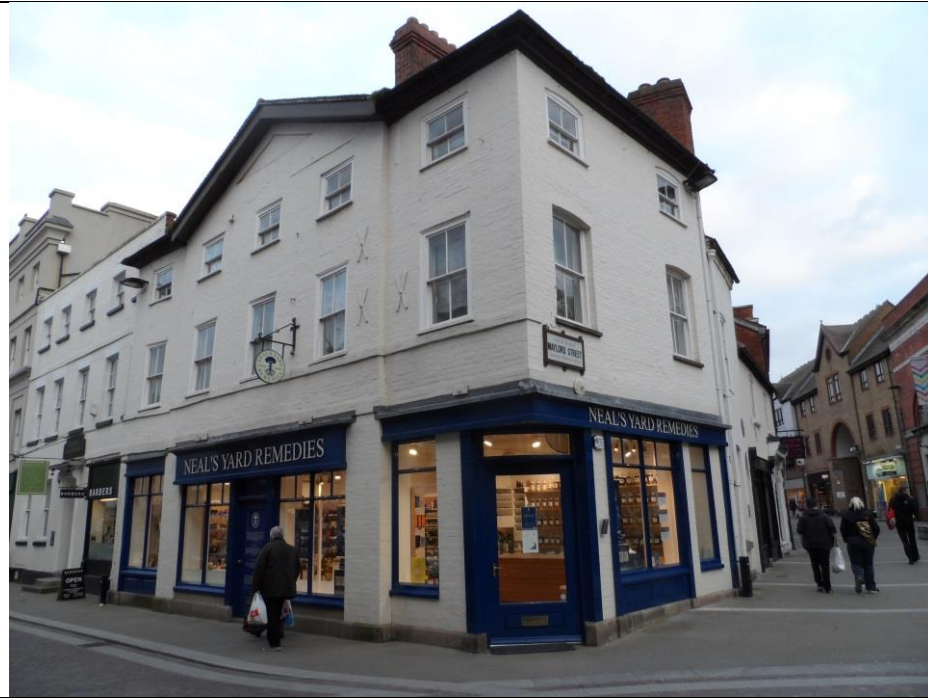
| <b>Ref No:</b> WS8 | <p><b>Description:</b> Early 18<sup>th</sup> Century house, now shop. Three storeys and attic, painted brick with hipped plain tile roof with gable to front. 20<sup>th</sup> Century shop front.</p> <p><b>HAR Assessment:</b> Weed growth in gutters.</p> <p><b>Recommendations:</b> Clear weeds from gutters, continue to monitor and maintain building.</p> <p><b>NOT AT RISK</b></p> |

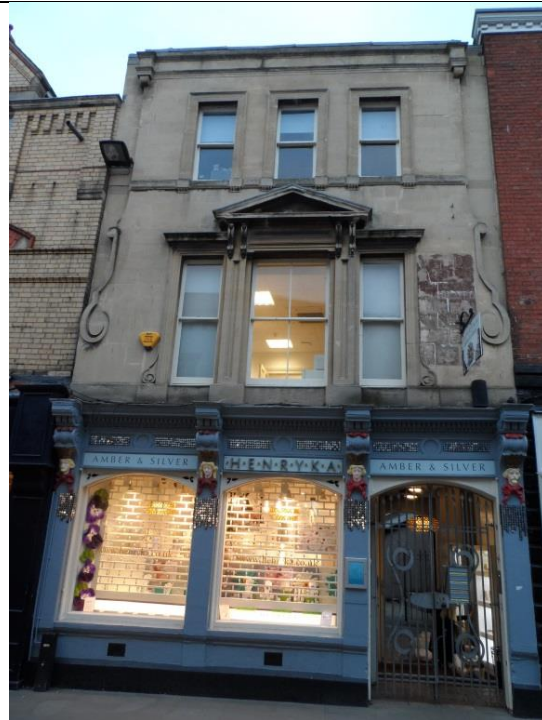
**Ref No:** WS9

**HAR Assessment:** Good condition, not at risk.

**Recommendations:** Continue to monitor and maintain.

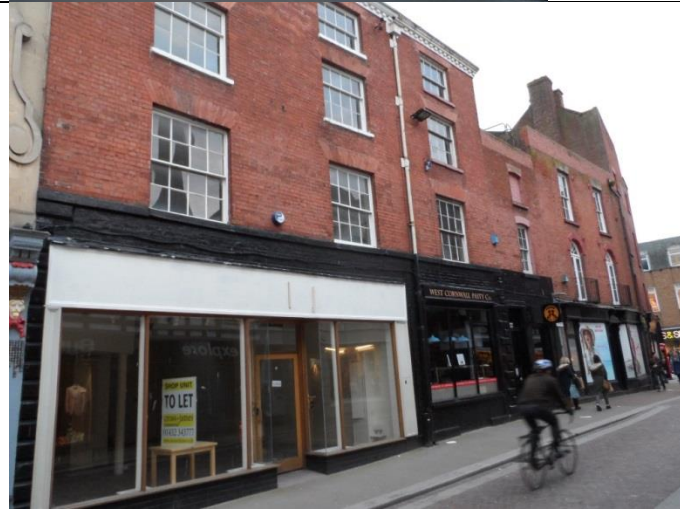
**Ref No:** WS10

**HAR Assessment:** Good condition, however is Low  
Risk as No.8 shop is empty, but seeking tenant.

**Recommendations:** Secure tenancy of shop,  
continue to monitor and maintain building.

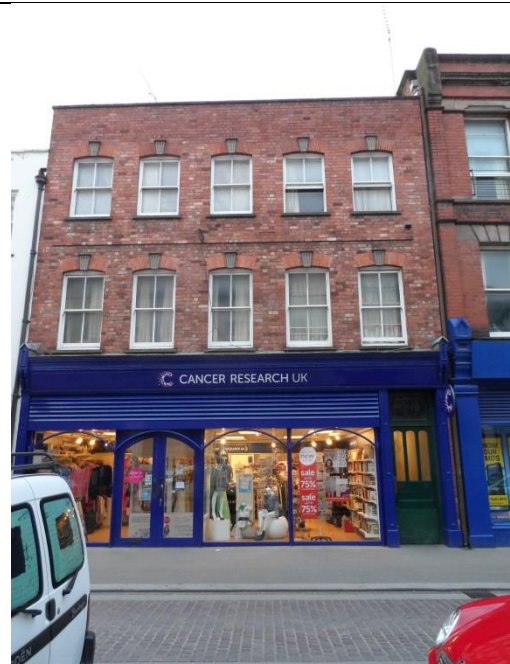
| | <b>Ref No:</b> WS11 | <p><b>Description:</b> Late 18<sup>th</sup> Century house, now shops and flats. Three storeys, brick; with probable slate 20<sup>th</sup> Century shop fronts.</p> <p><b>HAR Assessment:</b> Good condition, not at risk.</p> <p><b>Recommendations:</b> Continue to monitor and maintain building.</p> <p><b>NOT AT RISK</b></p> |

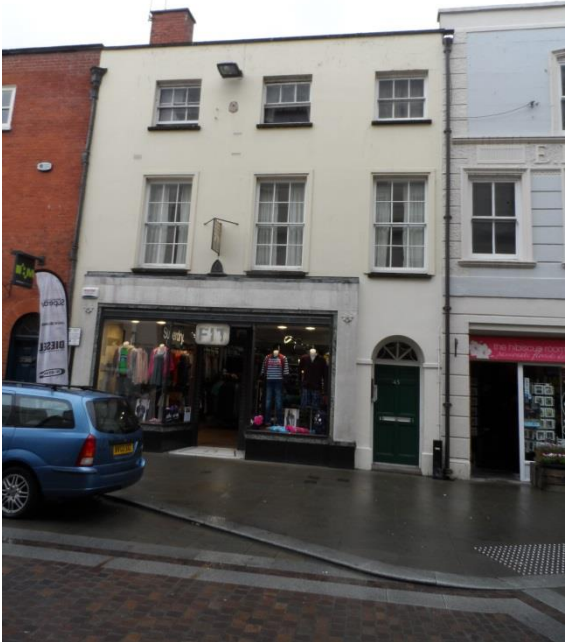
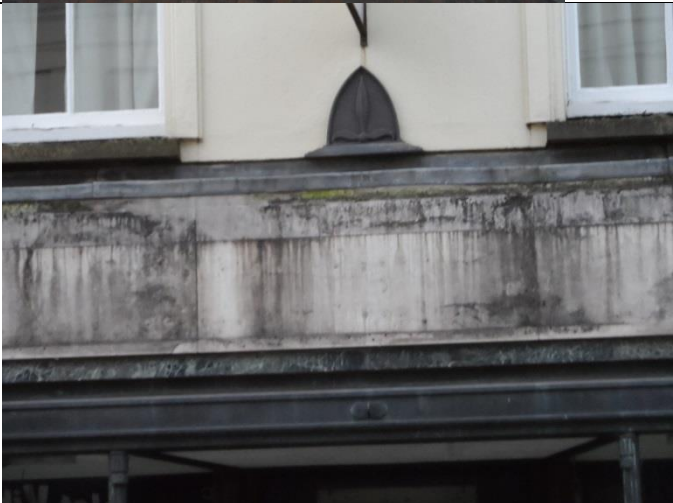
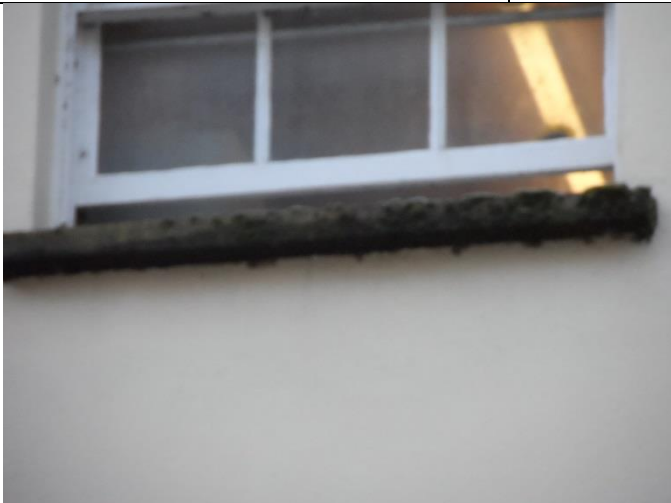
| | <b>Ref No:</b> WS13 | <p><b>Description:</b> Shop and dwelling. C19 front to C18 and possibly earlier core. Render, probably to brick; slate(?) roof; C20 brick ridge-stack to left. 3 storeys and cellar; 3-window range: early C19, 6/6 sashes, with moulded architraves; 3/3 sashes over; parapet. To right, early C20, 6-panel door, with swagged fanlight; to left, C20 shop front. C18 lead rainwater goods, to left. Included for group value.</p> <p><b>HAR Assessment:</b> Moss growth on window sills concrete above shop front.</p> <p><b>Recommendations:</b> Clean window sills and concrete above shop front, consider painting concrete.</p> <p><b>NOT AT RISK</b></p> |

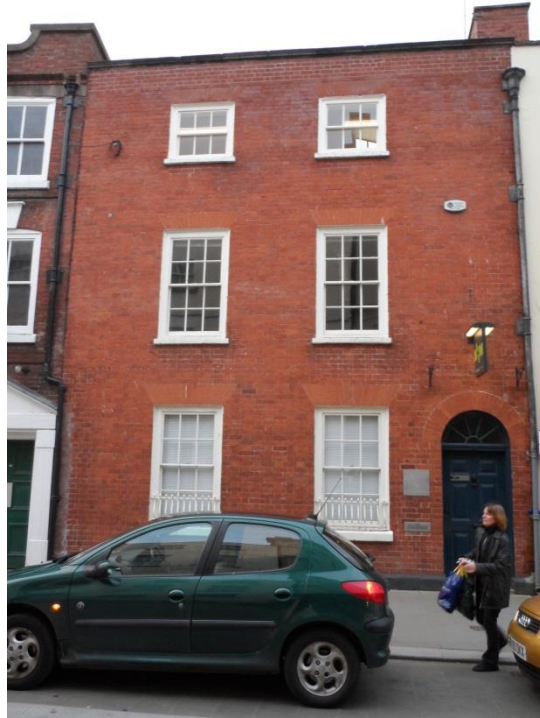
**Ref No:** WS14

**HAR Assessment:** Good condition, not at risk

**Recommendations:** Continue to monitor and maintain.

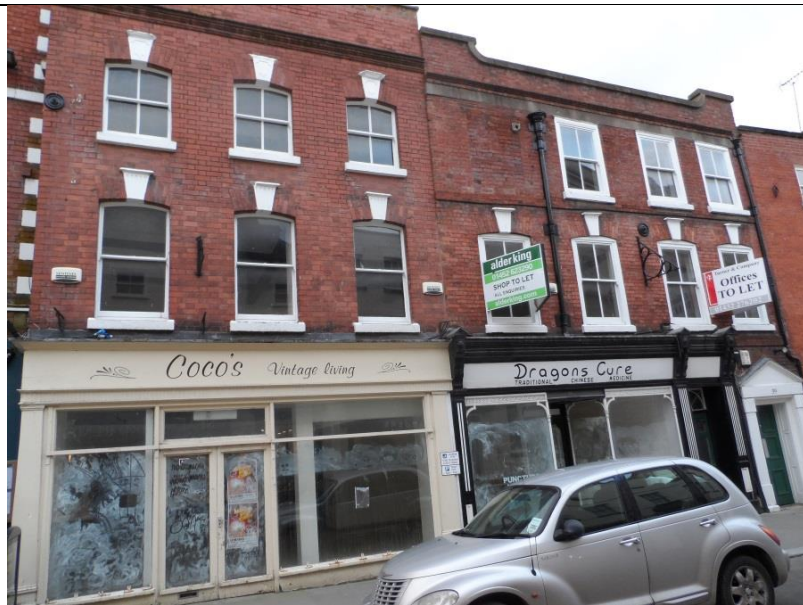
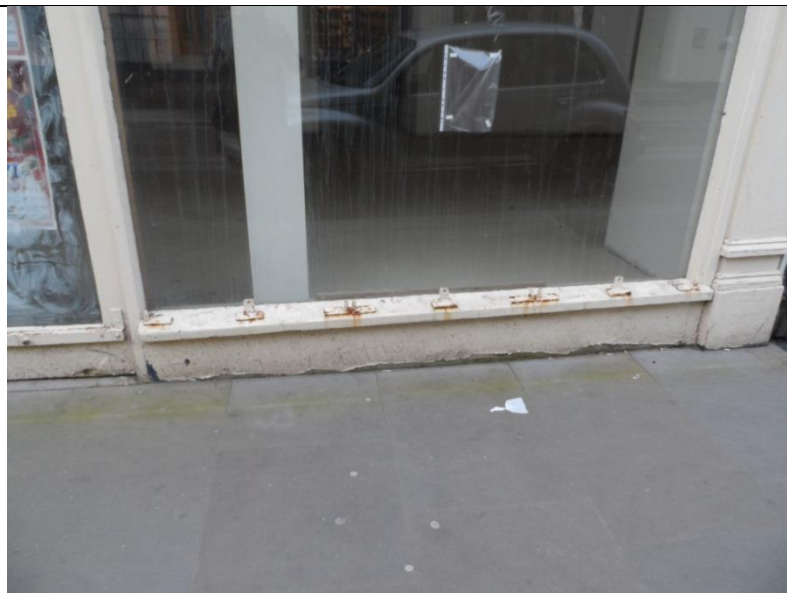
**Ref No:** WS15

**HAR Assessment:** shopfronts with small amount of rust, vacant shops and offices, however seeking tenancies.

**Recommendations:** Seek tenancies for building, re-paint shop front.

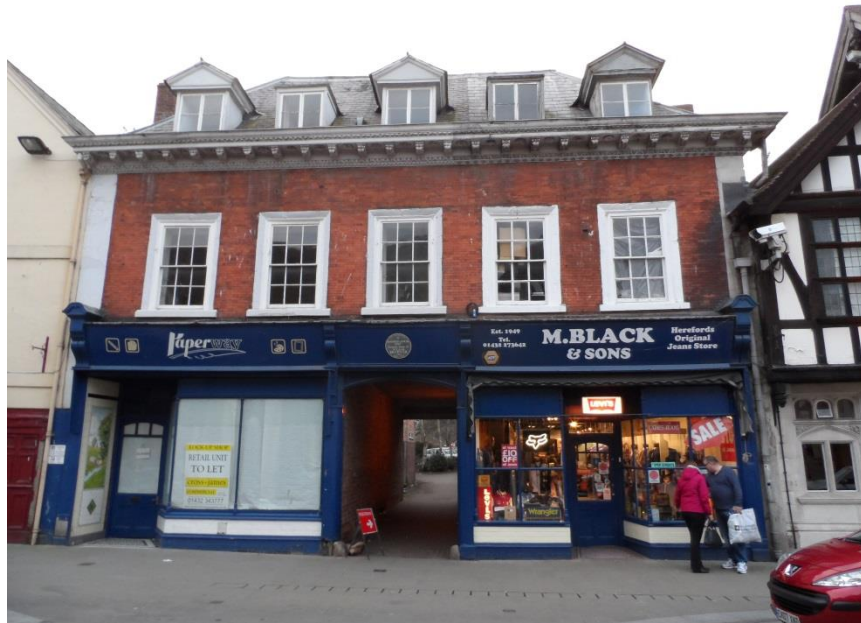
**Ref No:** WS16

**Condition:** Fair

**Recommendations:** Secure tenant for vacant part of building, clear guttering, and remove weed growth, repair leadwork. Continue to monitor and maintain.

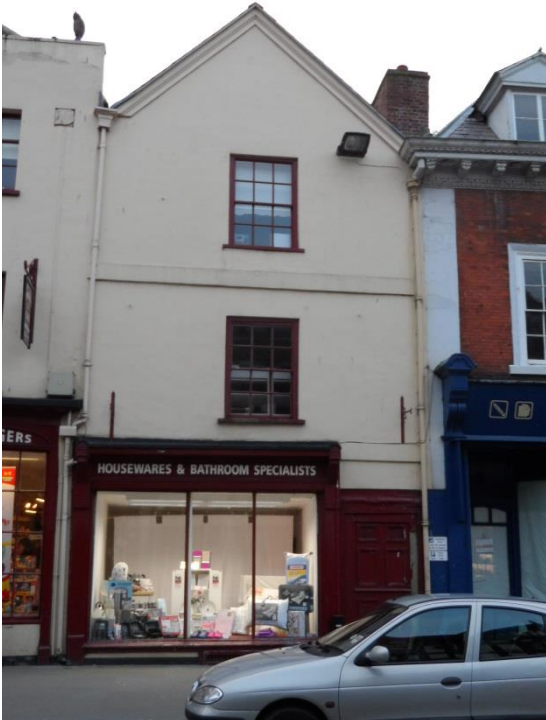
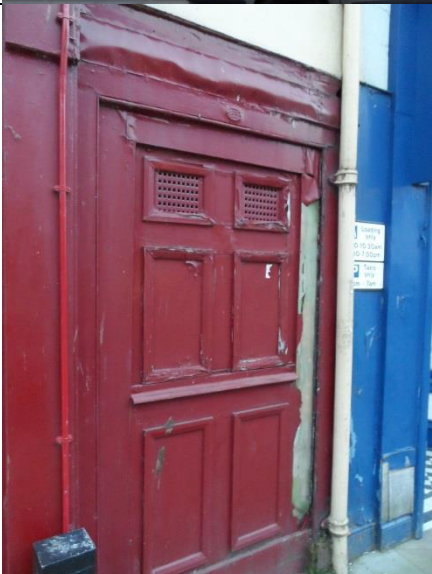
| | <b>Ref No:</b> WS17 | <b>Description:</b> Late 18 <sup>th</sup> Century house, now shop. Finished in stucco with corrugated-asbestos gable roof. Three storeys and cellar with 20 <sup>th</sup> Century shopfront.<br><br><b>HAR Assessment:</b> Door case damaged.<br><br><b>Recommendations:</b> Repair door case and repaint.<br><br><h1>NOT AT RISK</h1> |

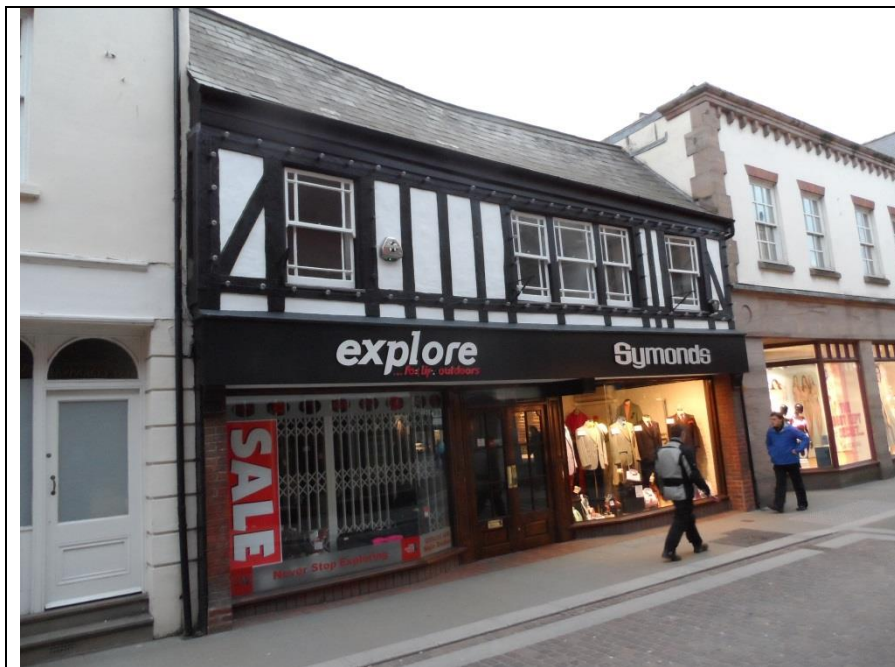
**Ref No:** WS19

**HAR Assessment:** Exterior is in good condition, not at risk

**Recommendations:** Continue to monitor and maintain building.
