# Preventative Conservation & Maintenance Theory; its application to the Hereford City Conservation Area. Part 2 - Appendices

**August 2014**

**JS Conservation Management  
& Town Planning Ltd**  
t: 07741091719  
e: [john@jsconservationplanning.com](mailto:john@jsconservationplanning.com)  
w: [www.jsconservationplanning.com](http://www.jsconservationplanning.com)

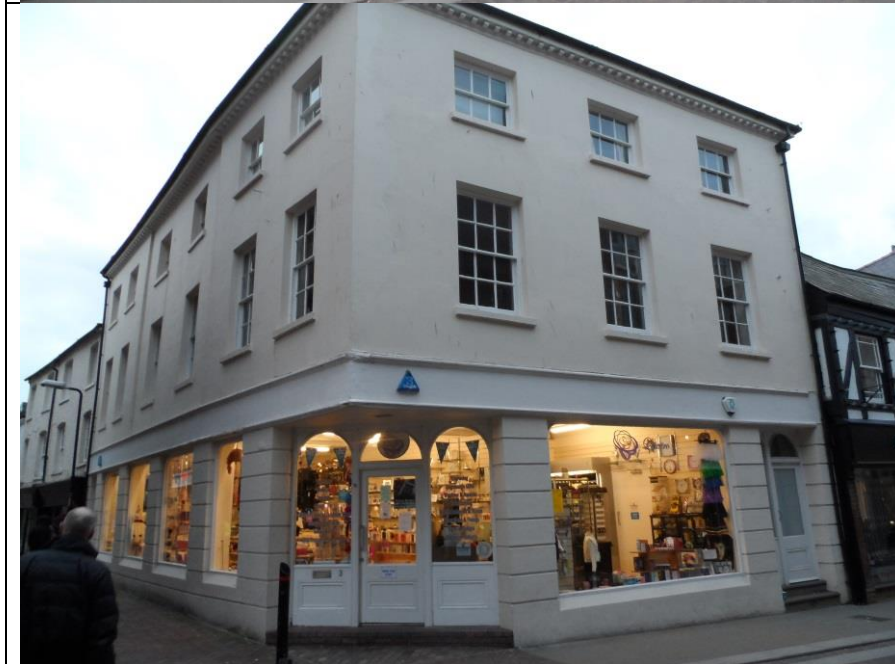
**Ref No:** WS20

**Condition:** Good

**Recommendations:** Clear guttering and chimney of weed growth. Continue to monitor and maintain.

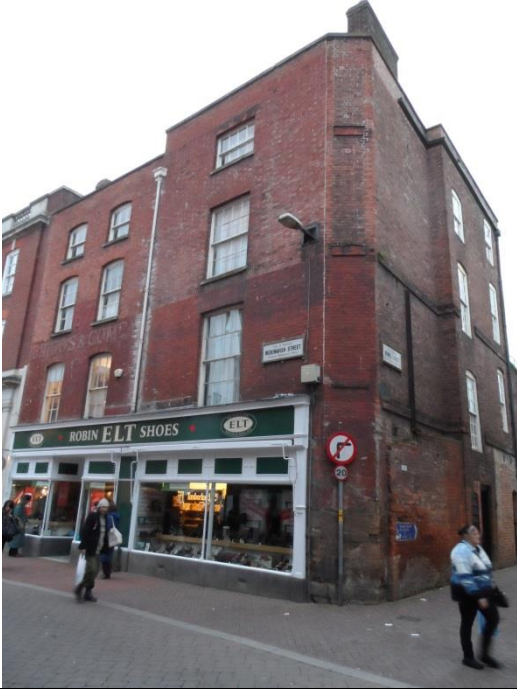
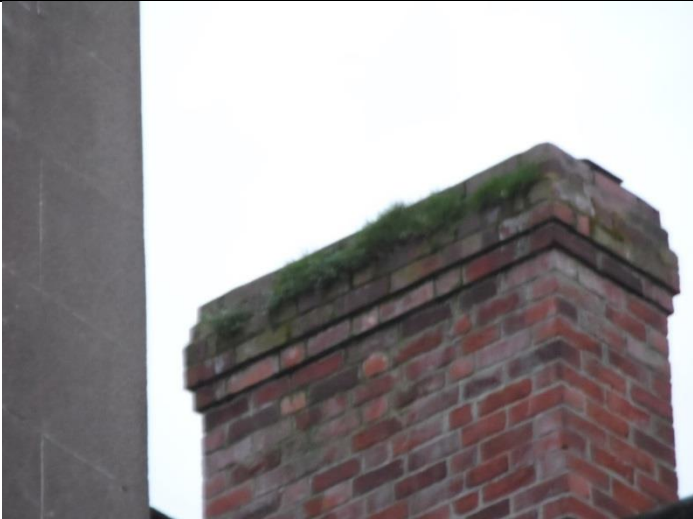
| | <b>Ref No:</b> WS21 | <p><b>Description:</b> 18<sup>th</sup> Century house with 19<sup>th</sup> Century front, now shop and dwellings. Four storeys and cellar, constructed of brick, with a slate roof and 20<sup>th</sup> Century shop front. Ground floor appears much altered with possible blocked shop window to left.</p> <p><b>HAR Assessment:</b> Showing signs of lack of maintenance, with weed growth on chimney and in brickwork, some bricks damaged and stained with gypsum growth evident.</p> <p><b>Recommendations:</b> Weed growth treated with a herbicide and take opportunity to clean and replace brick work where appropriate.</p> <p><b>NOT AT RISK</b></p> |

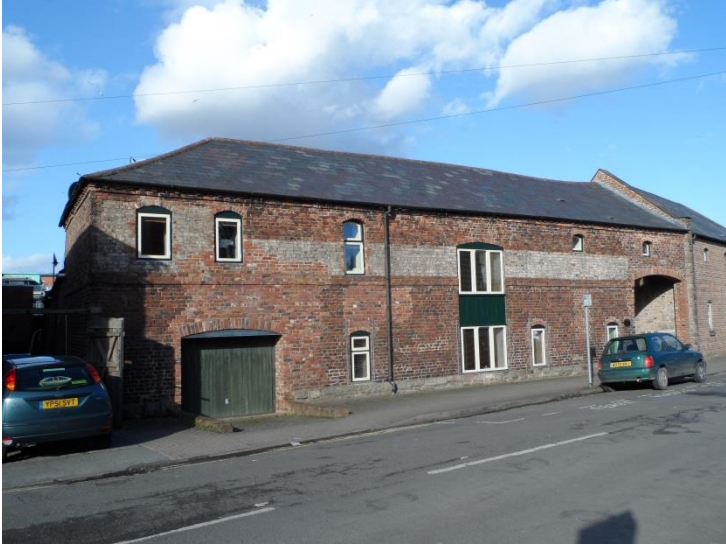
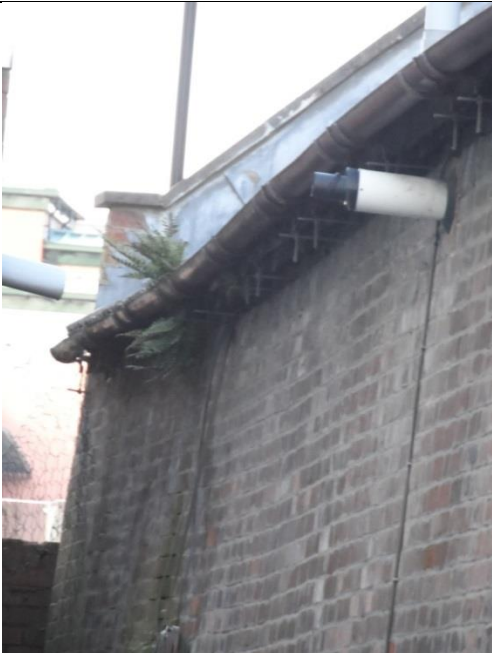
| | <b>Ref No:</b> WY1 | <p><b>Description:</b> Warehouse, now flats. 18<sup>th</sup> Century façade to 16<sup>th</sup> Century core. Constructed of brick with hipped Welsh slate roof to south pitch; pantiles to north; corrugated-iron and pantiles to west range. The surviving half of a U-shaped complex facing the Wye River, and recorded in Taylor's plan of Hereford, 1757. 16<sup>th</sup> Century part consists of a large square-panelled frame, with queen-strut and king-post trusses. 18<sup>th</sup> Century part is the external wall of English bond brickwork on sandstone plinth.</p> <p><b>HAR Assessment:</b> weeds growing from guttering on west range which is becoming detached from the façade.</p> <p><b>Recommendation:</b> Repair guttering and clear gutters and continue to monitor and maintain building.</p> <p><b>NOT AT RISK</b></p> |

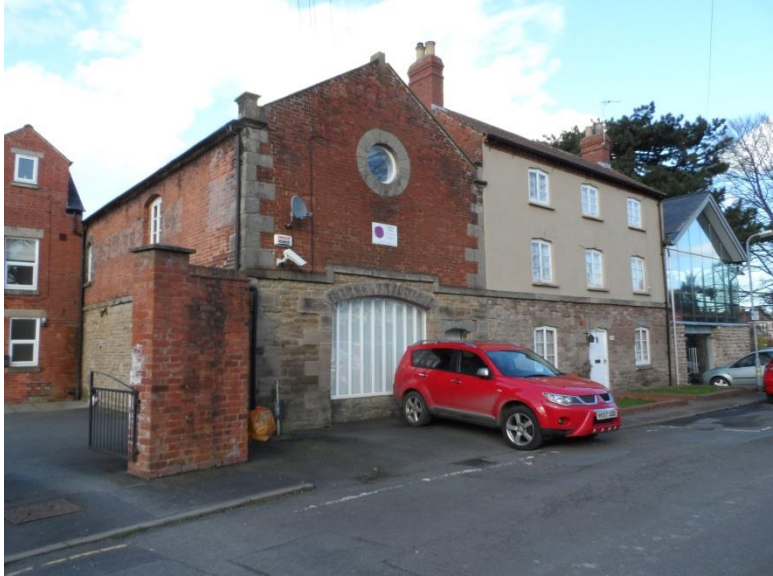
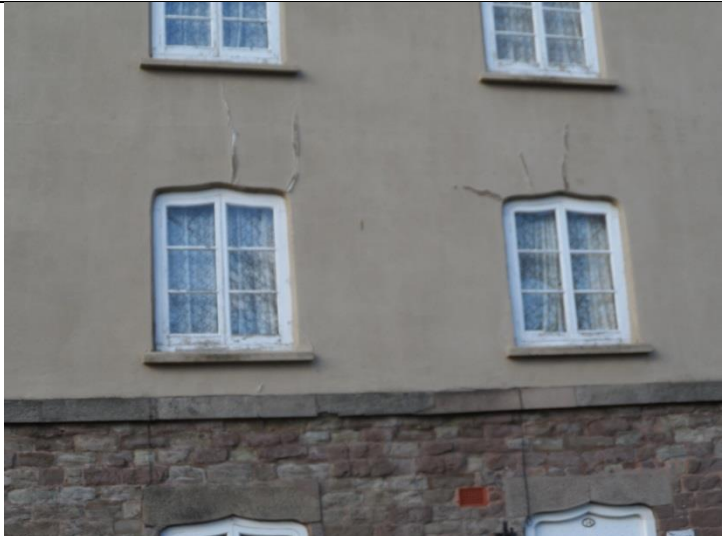
| | <b>Ref No:</b> WY2 | <p><b>Description:</b> Early to mid 19<sup>th</sup> Century House, stable block and perimeter wall. Three storeys. To left, rubble warehouse with brick loft: Left returned side has 2 casements to 1st floor, 1 in dressed stone quoins; coved stone eaves. Rear (river) elevation has round-headed light with plank riser, in quoined stone arch, over 20<sup>th</sup> Century door under stone lintel; stone bands and dressings. To right of house, coursed rubble shed with weatherboarded gable: rubble wall returned to side and rear, which has 2 stone arches.</p> <p><b>HAR Assessment:</b> House showing signs of lack of maintenance with stucco on house cracking and peeling which may be caused by water ingress.</p> <p><b>Recommendation:</b> Stucco requires survey to understand the causes of the cracking with repair/replacement possible. Continue to monitor and maintain Building.</p> <p><b>LOW RISK</b></p> |

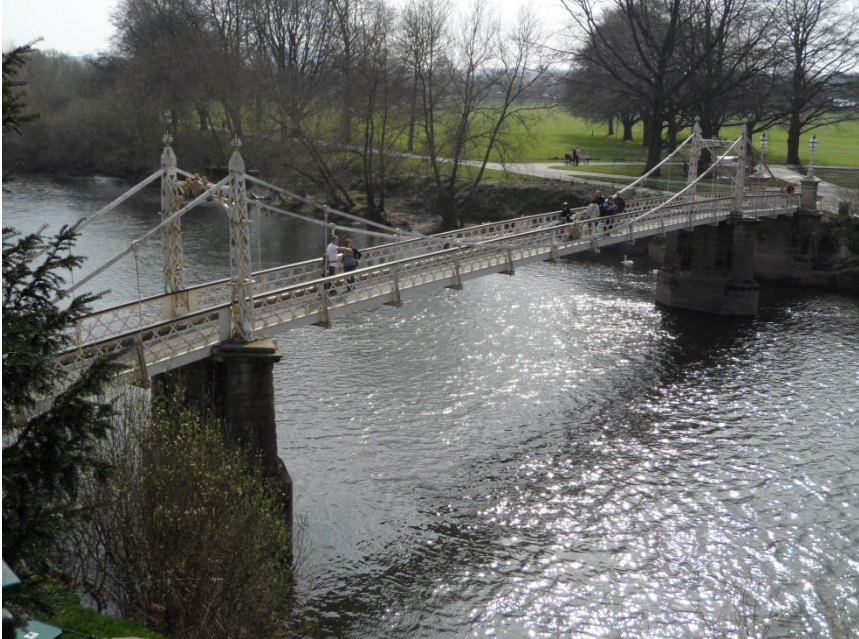
| | <b>Ref No:</b> VB1 | <p><b>Description:</b> Footbridge over River Wye circa 1897. Built by Findlay of Motherwell. Concrete piers with ashlar cutwaters; semi-suspension central span; lattice-work towers and parapets; terracotta piers with cast-iron lamp columns. Erected by public subscription to mark Diamond Jubilee of Queen Victoria.</p> <p><b>HAR Assessment:</b> showing signs of lack of maintenance, graffiti and rust evident</p> <p><b>Recommendation:</b> Bridge requires cleaning and re-painting. Continue to monitor and maintain.</p> <p><b>VULNERABLE</b></p> |
